Site Accessibility Evaluation
Americans with Disabilities Act
Title II (Public Services: State and Local Government)

CITY MAIN LIBRARY
145 Washington Ave
Santa Fe, NM 87501

Report Date: 02/03/2025

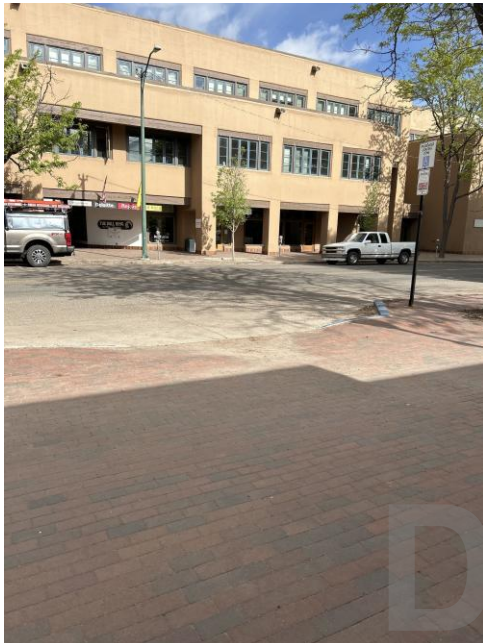
Finding: 1

The access aisle and/or the vehicle pull-up space surface is not firm, stable, and slip resistant.

Access aisle is not clearly visible or defined and also irregular surface in pavement need to be addressed.

Clean, refinish and redefine the surface of Passenger Loading Zone.

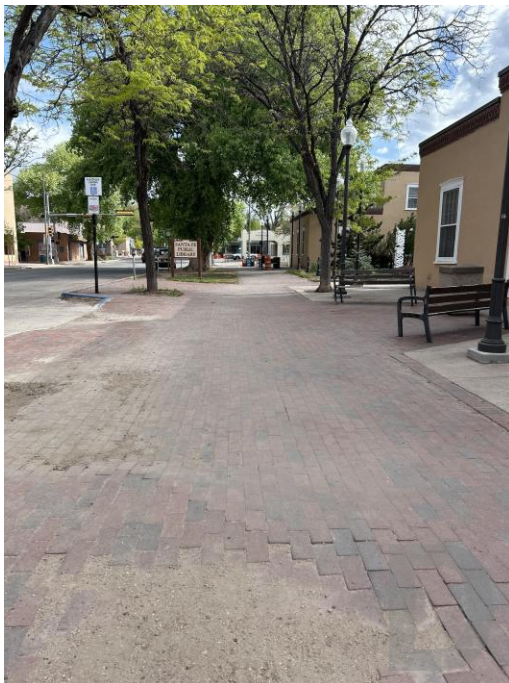
Finding: 2

The accessible path of travel has cross slopes greater than 2%.

The cross slope of the pedestrian access route exceeds the maximum required slope of 2% due to the brick pavers

Repair and correct pavers as necessary to not exceed the required maximum cross slope of 2%

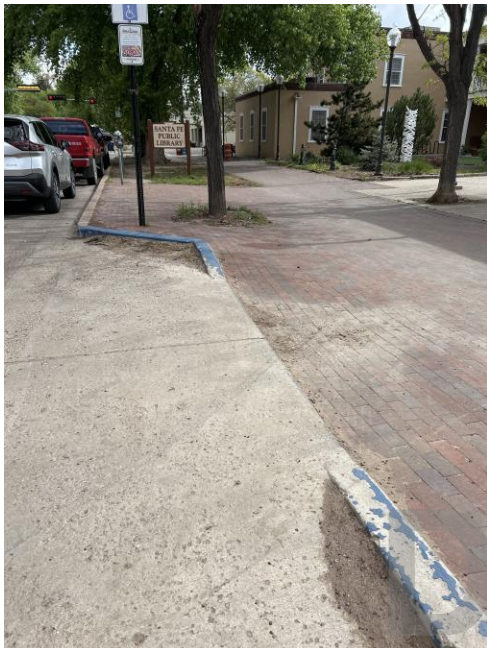
Finding: 3

The truncated domes do not have the correct spacing.

Passenger Loading Zone has no truncated domes

Install truncated domes 36' wide band, contrasting color, band of domes between pedestrian and vehicular area.

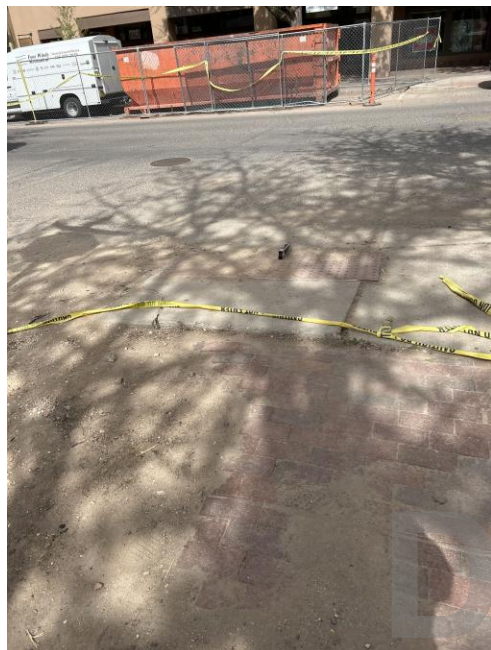
Finding: 5

The perpendicular curb ramp is not nearly compliant.

Running slope is 11.4%, Change in level exceeds 1/2 inches

Demolish existing and provide a new curb ramp, including detectable warning surfaces and the required landings (top and bottom)

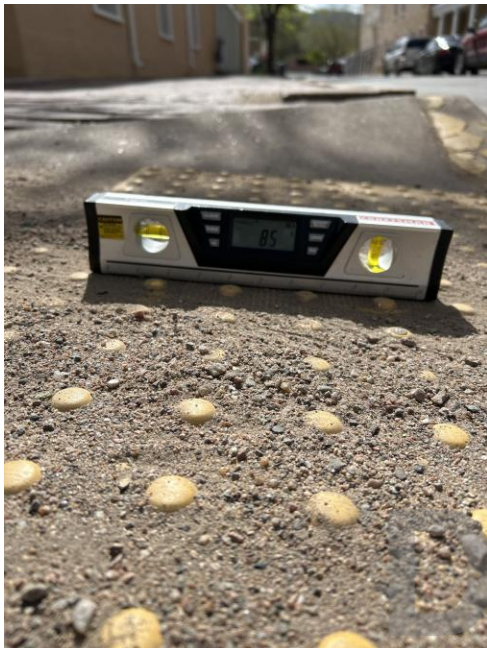
Finding: 6

The perpendicular curb ramp is not nearly compliant.

Running slope is 8.4%, flared sides slopes are 26.2% and 24.5% and gutter cross slope is 4.3%

Demolish existing and provide a new curb ramp, including detectable warning surfaces and the required landings (top and bottom)

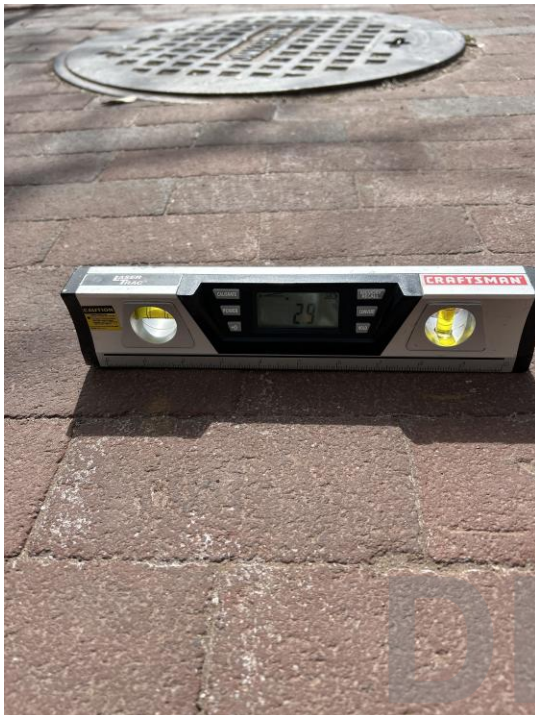
Finding: 7

The accessible path of travel has cross slopes greater than 2%.

At drive way location, cross slope is 2.9%

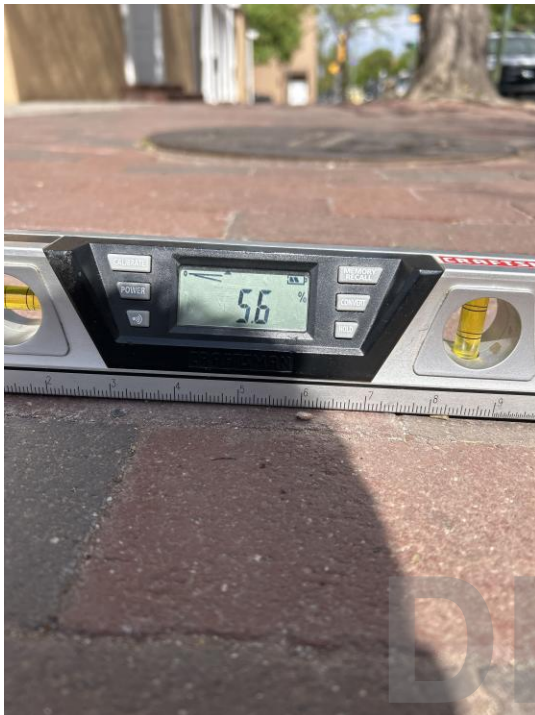
Finding: 8

The accessible path of travel has cross slopes greater than 2%.

Adjacent to driveway, portions of the brick paved route are 5.6% or greater.

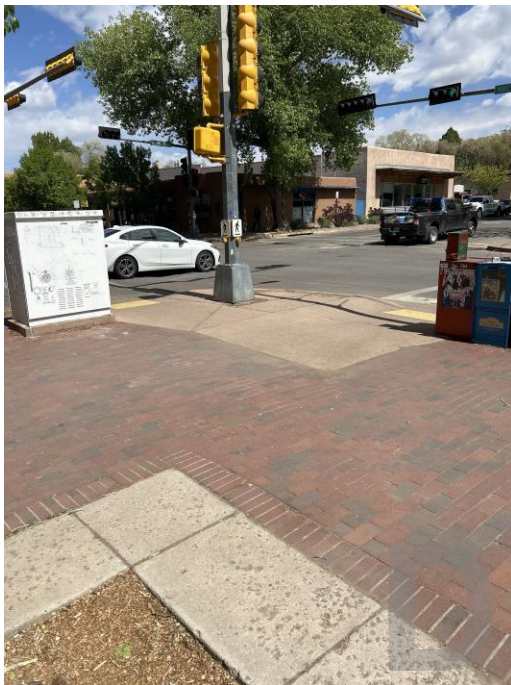
Finding: 10

The perpendicular curb ramp is not nearly compliant.

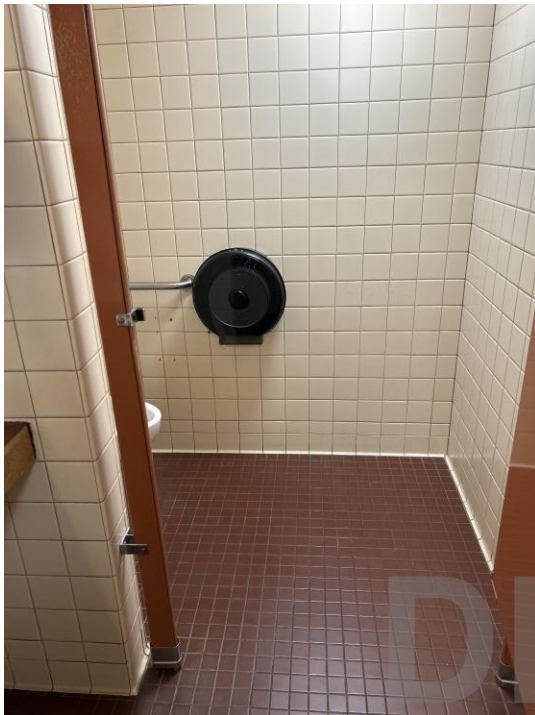
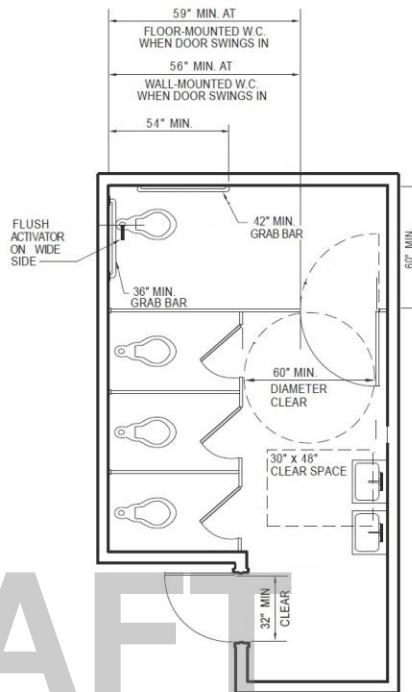
Finding: 33

The stall does not have the required minimum clear floor space or maneuvering clearances for the toilet. Grab bars are missing and/or incorrectly installed, accessories, such as toilet seat covers, toilet paper holders, and garbage cans are either too high, without clear floor space or both, the floor level changes greater than a 1/2 inch at the floor drains.

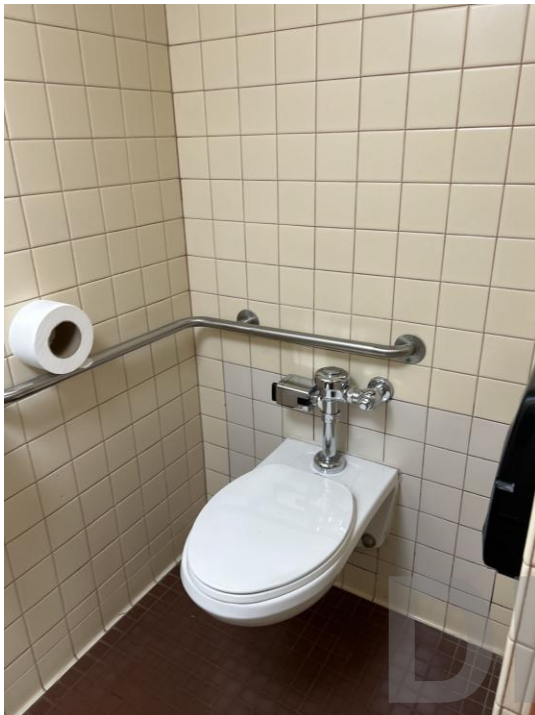
The stall does not have the required minimum clear floor space or maneuvering clearances for the toilet, Grab bars are missing and/or incorrectly installed, accessories, such as toilet seat covers, toilet paper holders, and garbage cans are either too high, without clear floor space or both, the floor level changes greater than a 1/2 inch at the floor drains.
