Chapter 2

Existing Conditions

Chapter 2 presents the existing conditions of the City of Santa Fe's pedestrian network. This chapter provides a brief overview of the methodology used during the ADA accessibility field survey, equipment used during the survey, and the database analysis that was conducted as part of the quality assurance and quality control portion of the survey. This chapter also details the existing conditions in the order of curb ramps, intersections, and sidewalks. The associated analysis begins with an overview of the categorical documentation of each element, followed by a categorized break-down of the accessibility condition ranking and a side-by-side comparison of each City Council District.

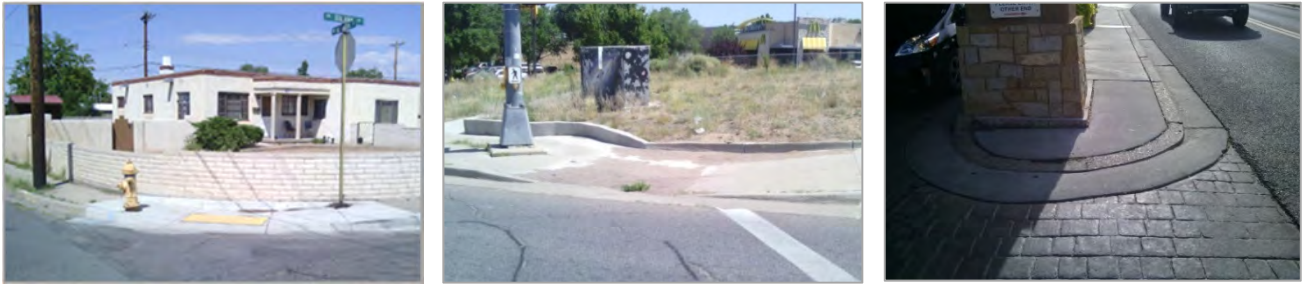
Figure 2-5: Common Curb Ramp Obstructions

Curb ramp obstructions largely consist of light poles, street sign poles, utility poles, and fire hydrants. The category “other” mostly represents fences, walls, and traffic bollards. Figure 2-4 illustrates the most common curb ramp obstruction types. As the chart shows, light poles make up the largest share of curb ramp obstructions (29%) and street sign poles were the second most common (25%) obstruction. Figure 2-5 provides examples of common curb ramp obstructions.

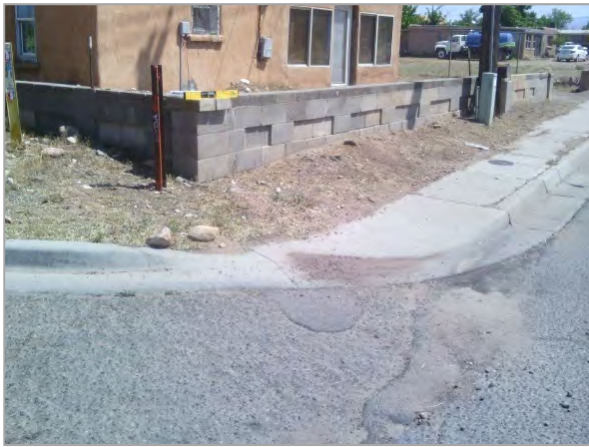
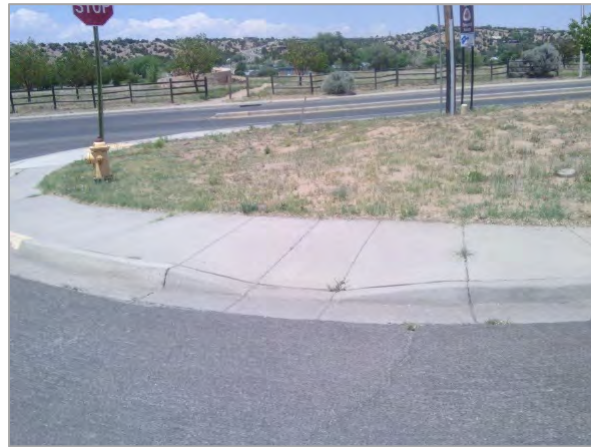
Figure 2-7: Curb Ramps Less Than 36 Inches in Width

A curb ramp with a width of less than 36 inches is non-compliant under ADA guidelines (ADA requires a width of no less than 48 inches), and inaccessible for a wheelchair user. As seen in Figure 2-6, only 3% of curb ramps surveyed are less than 36 inches wide. Figure 2-7 shows curb ramps with a ramp width below 36 inches.

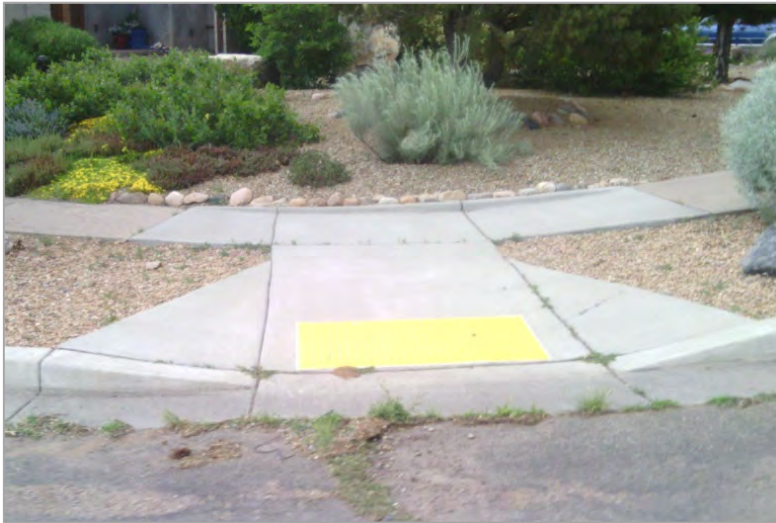
Figure 2-8: Curb Ramp with Non-Functional Flares

The flare exception isolates curb ramps that do not have functional flares. The exception includes curb ramps that meet all other ADA guidelines but have flare slopes that exceed 10% slope. A curb ramp with non-functional flares can be seen in Figure 2-8.

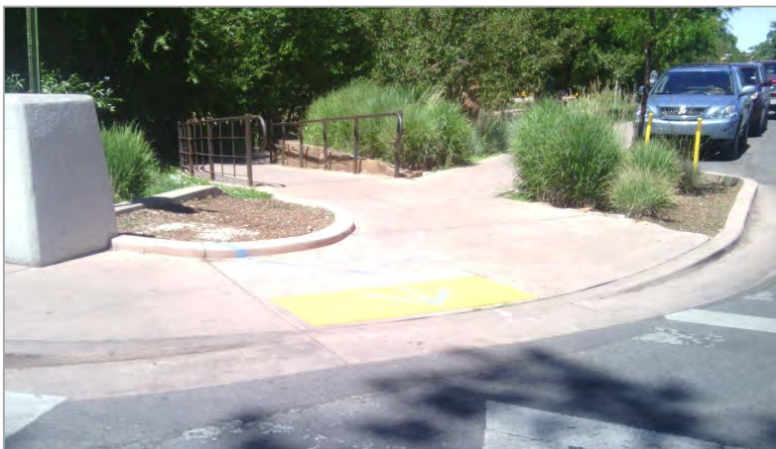
Figure 2-9: Curb Ramp without a Top Landing

The second functional exception is the top landing exception. These curb ramps either do not have a top landing or have a top landing that is less than 48 inches by 48 inches. As seen in Figure 2-9, the curb ramp does not have a top landing but provides a suitable surface for transitioning to the sidewalk.
