## SIDEWALK EVALUATION AND METHODOLOGY

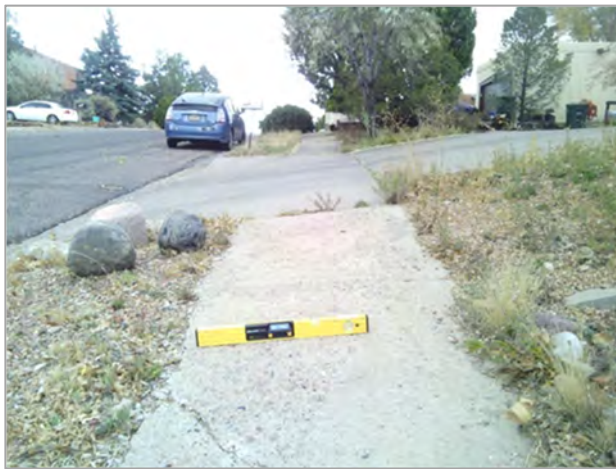
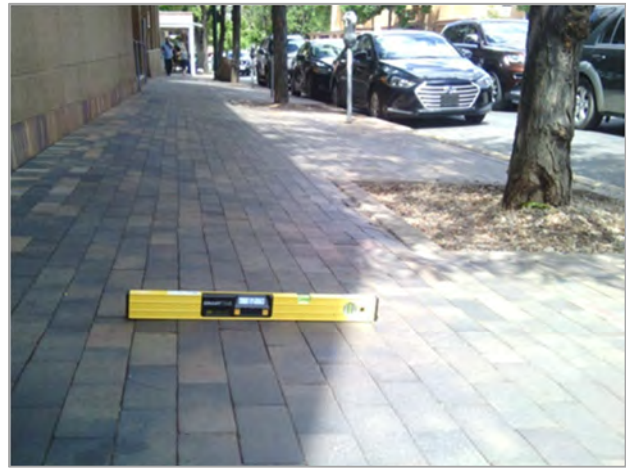
**Figure 2-33: Non-Compliant Cross Slopes**

For the purposes of this study, field surveyors noted any cross slope greater than 2% for three feet or longer. A total of 3,214 cross slope issues were documented. As seen in Table 2-10, these deficiencies are mostly minor with a combined total of 57.1% falling into the 2.1% to 4% slope range. Figure 2-33 below provides images of the severe cross slope issues.

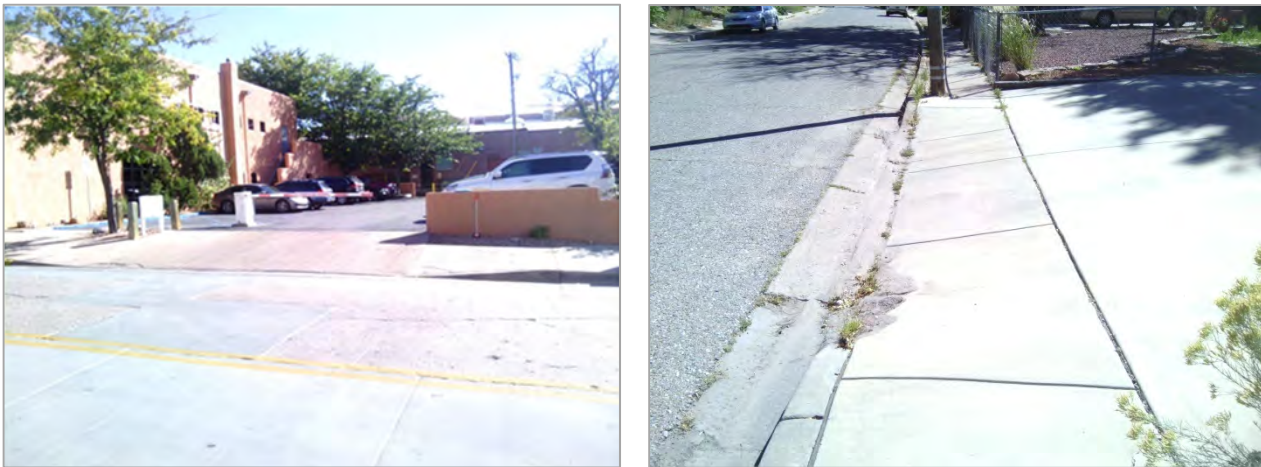
**Figure 2-34: Non-Compliant Driveways**

Survey results revealed that a total of 10,466 driveways in Santa Fe are not currently compliant with ADA guidelines. Figure 2-34 provides two images of non-compliant driveways.

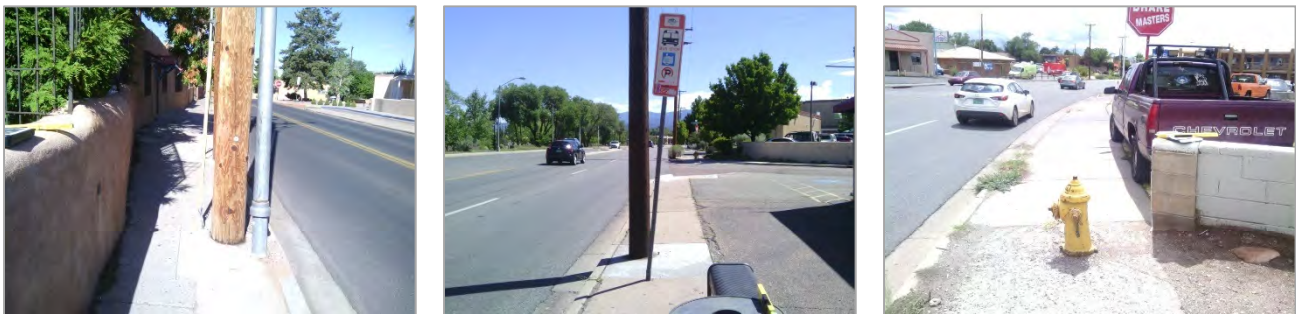
**Figure 2-35: Sidewalk Obstructions**

Obstructions are objects that reduce the walk path to less than 48-inches in width, rendering the walk path unusable to those with mobility impairments. As seen in Table 2-11, common obstructions in Santa Fe include utility poles, street sign poles, and mailboxes. Common sidewalk obstructions are shown in Figure 2-35.

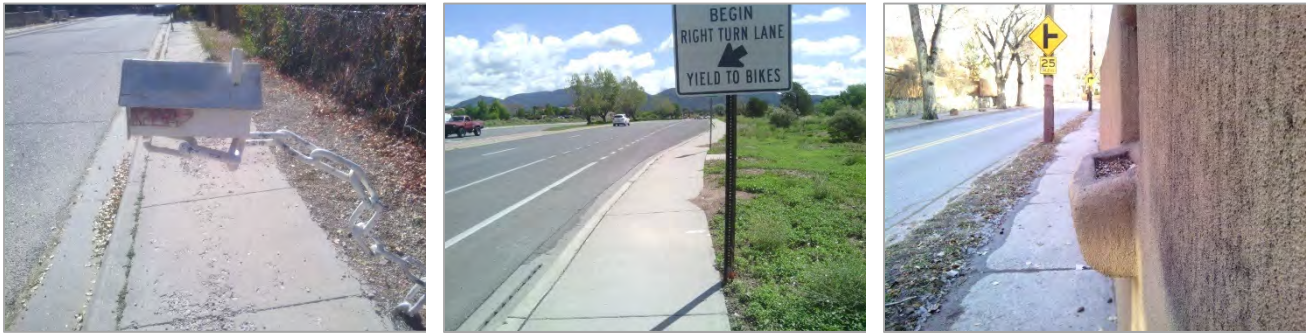
**Figure 2-36: Sidewalk Protrusions**

Protrusions were the least common sidewalk deficiency with 153 recorded instances. Common protrusions are shown in Figure 2-36. Table 2-12 shows that protrusions were most commonly mailboxes (64.1%) followed by street sign edges (17.0%).

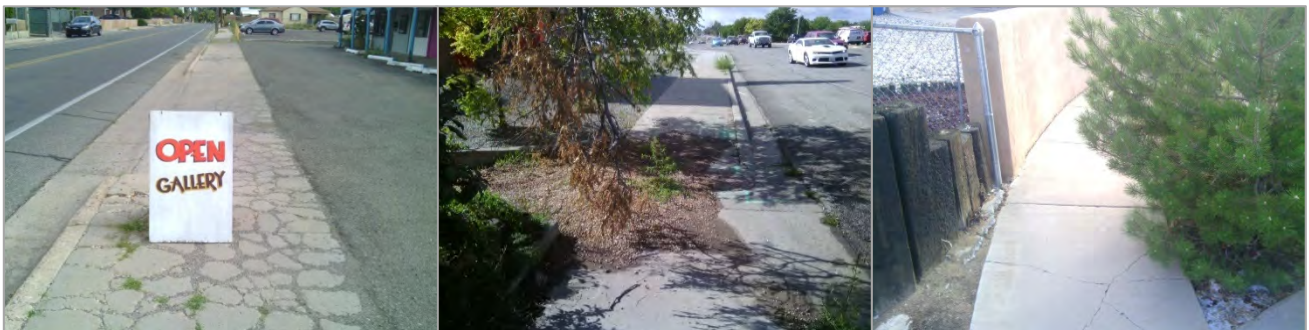
**Figure 2-37: Common Removable Barriers**

The removable barrier classification essentially draws from the previously mentioned obstruction and protrusion deficiencies; the key difference is that removable barriers may be easily removed without extensive engineering work or coordination with property owners. Figure 2-37 shows some of the common removable barriers in Santa Fe including overgrown vegetation, erosion debris, and a “sandwich” board. Table 2-13 highlights the types of removable barriers that were cataloged during the field survey. Out of a total of 8,382 recorded instances, overgrown vegetation was the biggest issue being documented in 93.8% of the noted instances.

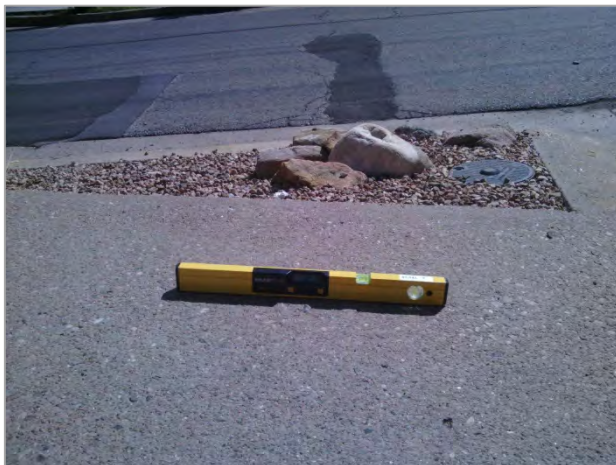
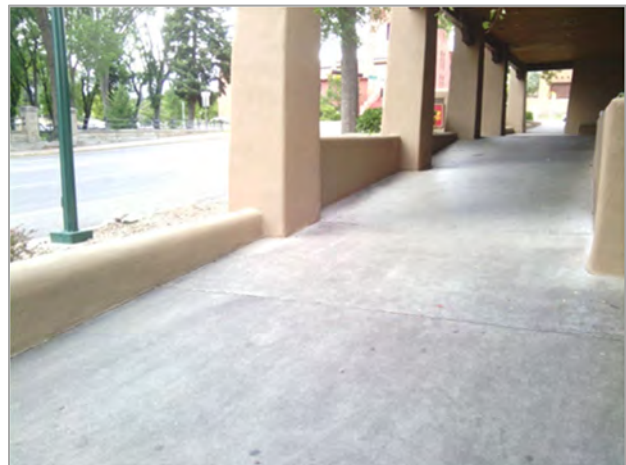
**Figure 2-38: Non-Compliant Running Slopes**

Under ADA guidelines, the sidewalk's running slope is required to match that of the road or not deviated beyond 5% of the road's slope. During the field survey, a total of 220 running slope issues were noted. As seen in Table 2-14, nearly two-thirds of the running slope issues were between 5.1% and 10% with the other third accounting for more severe slopes over 10%. Figure 2-38 shows some examples of running slope deficiencies.

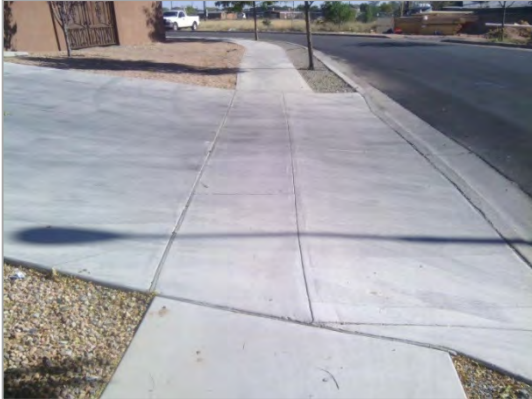
#### **Grade Break**

The final sidewalk deficiency is surface obstructions. Surface obstructions are a catch all for surface issues including grade breaks, surface gaps, uneven pavement, and vertical discontinuities; these are all shown in Figure 2-39. During the field survey a total of 14,663 surface obstructions were recorded; this represents the single largest category of sidewalk deficiencies. As seen in Table 2-15, the most common surface obstruction was vertical discontinuities noted on 63.4% of the recorded obstructions. However, the most impactful surface obstruction is uneven pavement which accounts for approximately 28 miles of sidewalk.
