# FACILITY ASSESSMENT REPORT

**Garson Studios**

January 4, 2023

January 4, 2023  
WCI Project #: 21-600-030-10

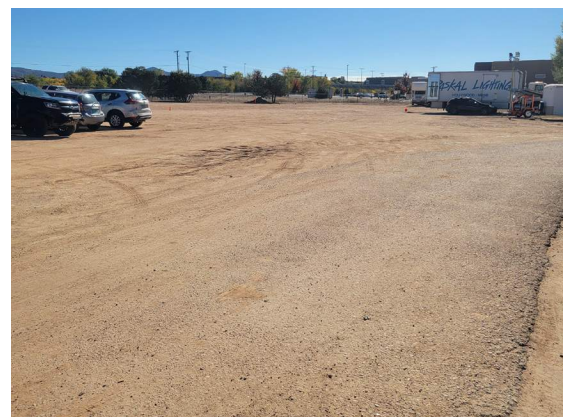
Rear parking lot | A3

poor condition. The parking lot behind the building to the northeast is only partially paved. The lot is very worn and in poor condition (A3). According to the remodel drawings from 1989, the gas connection appears to enter the building at a gas regulator at the western corner of the building. The wastewater connection enters the building under the front facade on the southeast side of the building. The same drawings also show the electrical connection first entering the above-ground electrical box at the northern corner of the facility, then splitting off into three lines, with one connecting to the three transformers on the northeastern elevation before entering into the electrical room on the other side of the wall.

- The parking lot and access road with parking should be repaved.
- Landscaping should be addressed by a professional landscaper. Overgrown plants should be trimmed, volunteer plants removed or adapted, and dead plants removed (A26).

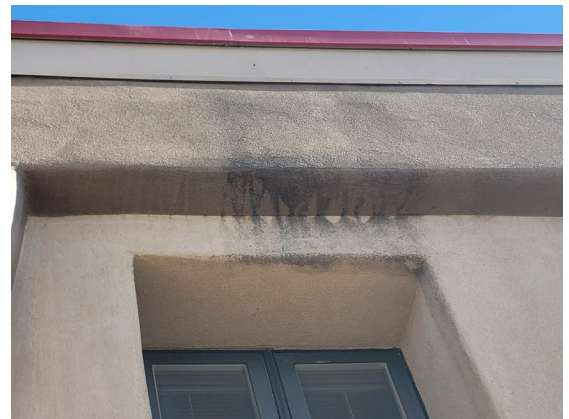
Discoloration from water | A5

Most exterior walls are CMU with a stucco finish system on the exterior. Some exterior walls are metal studs with stucco on exterior-rated gypsum board. For the most part, the stucco finish is in acceptable condition. However, there is some cracking on the front (southeastern) facade around some ground-floor windows. There is also some discoloration from water on the front facade around the window to the director’s office. There is also visible damage to the stucco on the underside of the soffit around the tallest portion of the building, Sound Studio A. Some of this damage is visible from the ground, but the damage is much more significant on the roof area near the access ladder (see roof section below). Other minor stucco damage is found in several places around the exterior, primarily on the walls facing southeast.

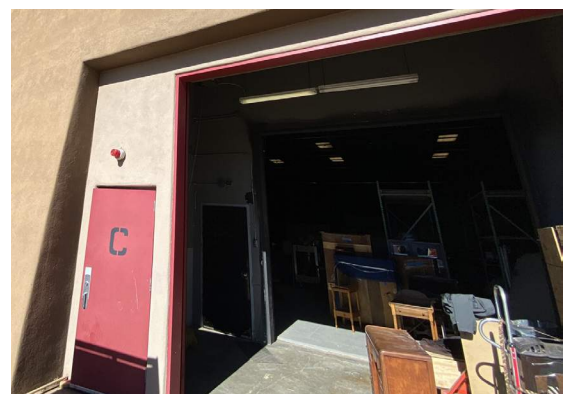
Roll door and hollow metal door | A7

The exterior doors are a mixture of three door types. Hollow metal doors and roll-up metal doors are found at the vestibule entrances into the sound studios (A7). Metal doors with glazing are found at the front entrance (room 100), the theater entrance (room 123), and the rear entrance (room 138). The hardware is not all ADA-compliant but appears to be in acceptable condition. The three primary entrances do not have modern, ADA-compliant automatic openers. The overall

condition of the exterior doors is fair.

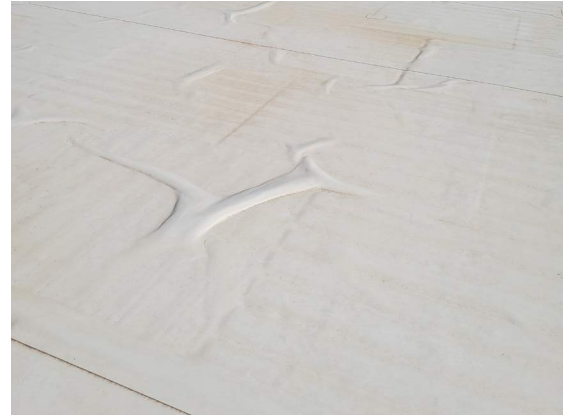
EPDM Roofing Membrane | A8

The roofing system appears to be a Thermoplastic Polyolefin (TPO) membrane roofing assembly. The renovation drawings indicate that the structure underneath the assembly is a steel deck on structural steel channels or bar joists. There is fiberglass batt insulation under the steel deck. There is some rippling and bubbling observable on the roof membrane (A8). There are also a few places where the flashing or sealant is worn or damaged.

- Commission a full roof inspection by a licensed roofing contractor to verify the estimated life left in the current roofing system. All flashings and sealants should also be inspected.
- Replace or refurbish the roof hatch.
- Repair failing stucco on the roof where the two roof elevations intersect. Add drip edge to prevent further damage.
- Replace the roof ladder between levels with an OSHA-compliant ladder.
- Repair stucco and flashing where gas pipe rises from lower roof to upper roof.
- Reinstall rooftop exhaust fan caps.
- Clean debris around roof drains.
- Address the drainage issue at the director's office window with a licensed roofing contractor (A31).

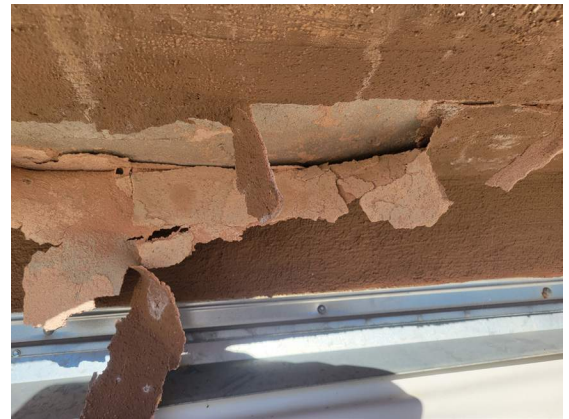
Damaged stucco | A9

As stated above, there is significant damage to the stucco finish present on the wall where Sound Studios A and B meet (A9). Sound Studio A is several feet taller than Sound Studio B, leaving a short section of the exterior wall exposed on the roof where problems will not be observed by regular users of the facility. A gas pipe runs up this wall, connecting to the RTUs on the roof of Sound Studio A. It appears as though this pipe used to intersect with the flashing and finish of the wall, and portions of both were removed to accommodate the pipe. Now, the pipe has moved away from the wall, exposing this condition and allowing for water and pest infiltration (A10). On the same wall, above the stucco, is an area of cast concrete with a paint finish. This finish is degraded and flaking off, exposing the concrete underneath.

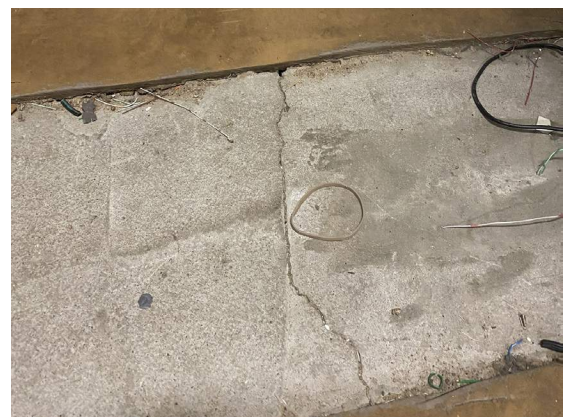
Patched floor in electrical room | A11

**Concrete:** Located in sound stage 3 and utility areas such as electrical rooms, janitor closets, and the sound stage vestibules. Some of the areas have been sealed or painted, and some are bare concrete. In the electrical room (144) there is a portion of the floor that appears to have been cut away and removed, then filled back in. The filler concrete has a rough finish and is not level with the existing floor, creating a tripping hazard in a high-hazard space (A11). There is visible damage to the concrete floor in the storage room in Sound Studio B.

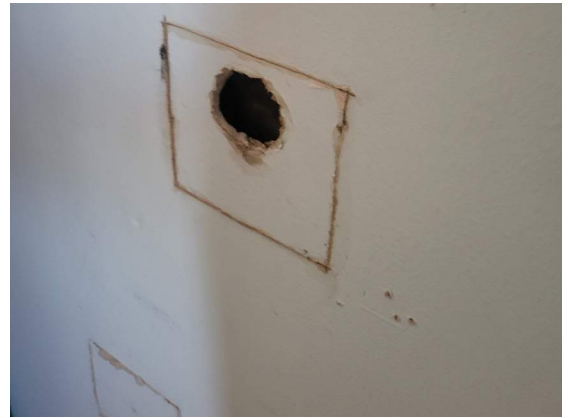
Wall damage | A12

Overall, the interior partition walls are in acceptable condition with notable damage in a few areas. The small office adjacent to the theater lobby has some damage to the gypsum board including a small hole (A12). Outside the projection room is what appears to be a large hole in the wall covered with foil tape. Right next to this is a hole where some conduit goes through the wall, the hole has not been filled and sealed around the conduit (A13).

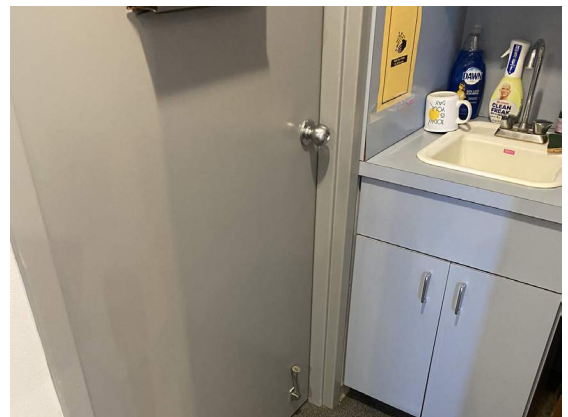
Typical interior door hardware | A14

Most interior doors are painted solid wood. Besides typical wear and tear, the doors are in acceptable condition. However, the hardware is not ADA-compliant and should be replaced with lever handles (A14).

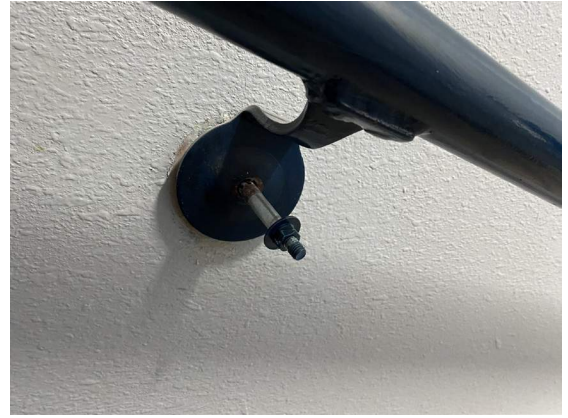
Handrail bolt falling out | A16

Studios. There is an elevator near stairway #1, located in the lobby, that leads to the reception area (201) on the 2nd floor. This elevator appears to be operable and code-compliant. Stairway #1 does not have code-compliant handrails (A15). Also, the low headroom area below the stairway does not have cane protection. Stairway #2 is in an enclosed stairwell. There is a block of wood glued to the floor behind the second-floor door, acting as a doorstop. Above this is a poorly repaired area of the wall where the door handle had caused damage. One of the bolts attaching the handrail to the wall is falling out and is no longer providing support to the handrail (A16).

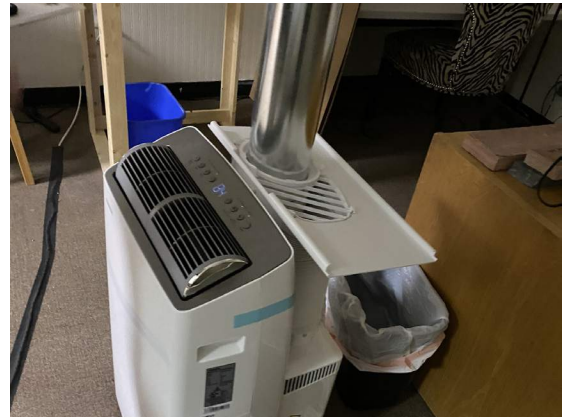
Portable AC unit in room 142 | A17

During the site visit, we observed a portable air conditioner in use inside room 142. The exhaust air appears to have been ducted into the plenum space. The reason for this is unclear, though it may be a balancing issue.

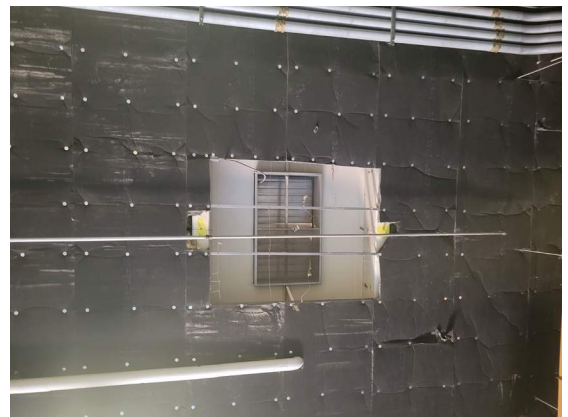
Exhaust fan | A18

There are also 11 exhaust fans, which are used to clear the air in the sound studios rapidly for the use of effects that create smoke or dust. This is according to the facility director during the site visit. There is also an exhaust fan in the projection room (124A) and another across the hall in room 127. B&D did not report any anticipated repairs on this equipment.

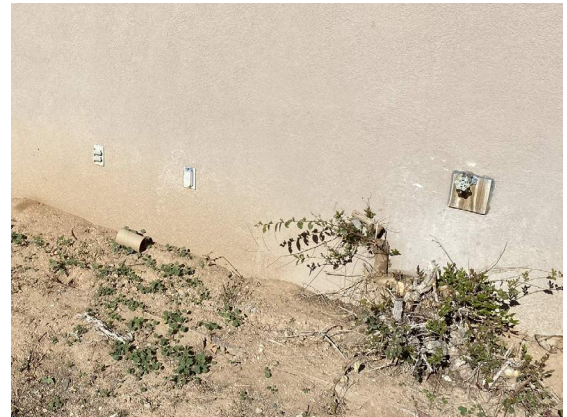
Water spigot | A21

Several water connections are located on the exterior of the building. One connection near the east corner of the building has a plywood wall patch around it (A21). This is not a good long-term solution.

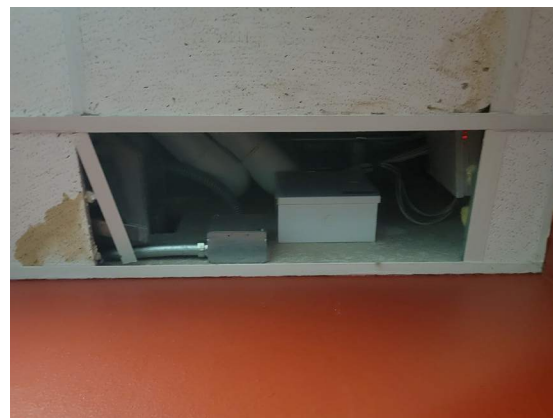
Access Control and Telecom | A24

Access Control system hardware was observed above the ceiling tiles in the hallway just outside the theater lobby (A24). The system appears limited to this area and it was unclear if it is functional.

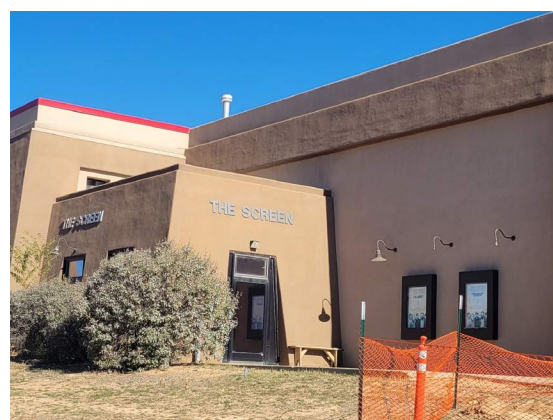
Lighting at theater entrance | A26

The exterior lighting appears to be in fair to acceptable condition with a few exceptions. The lighting outside the theater entrance is in poor condition (A26). Emergency egress lights are not present on the exterior. Some of the recessed can lights on the northwest elevation are starting to come out of their seating. Site lighting is provided by LED downlights on poles. Exterior building fixture types are as follows:
