FACILITY ASSESSMENT REPORT

Garson Theater

January 4, 2023

January 4, 2023
WCI Project #: 21-600-030-10

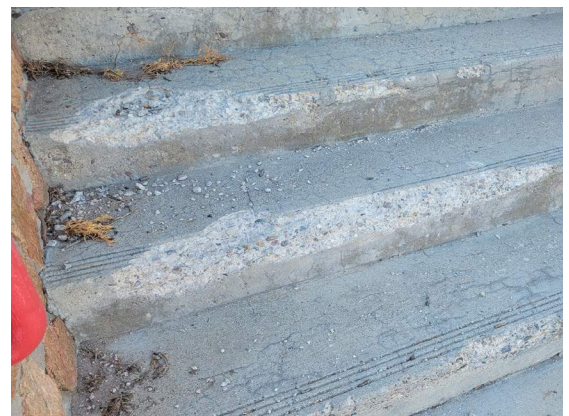
Concrete sidewalks, ramps and stairs around the site range from acceptable to poor condition (A3). The asphalt parking lot was formerly the main visitor lot. It is very worn and in poor condition. The striping is mostly gone.

Exterior stairs damage | A3

- Repave and re-stripe the parking lot and access road. Repair/replace the damaged concrete stairs and ramp in front of the building. Repair/replace damaged portions of the sidewalk.

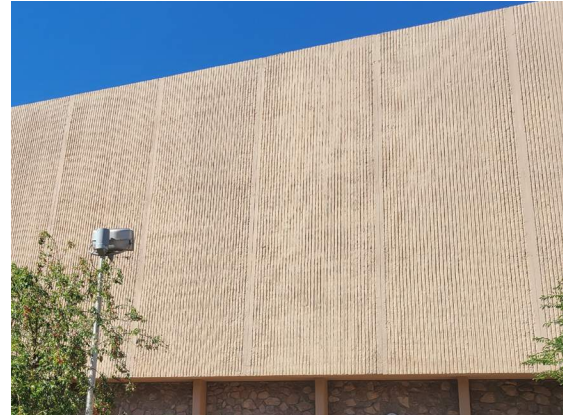
The exterior walls are constructed of a mixture of several materials. The tallest part of the structure uses precast concrete panels with sealant in the joints (A4). The single-story part uses brick veneer, stone veneer, and stucco over concrete block. The sealant between the precast concrete panels is failing and light is visible in some places at the joints on the interior. There is a louvered vent installed on the northwest elevation of the building and the brick work around is damaged (A5).

Precast concrete panels | A4

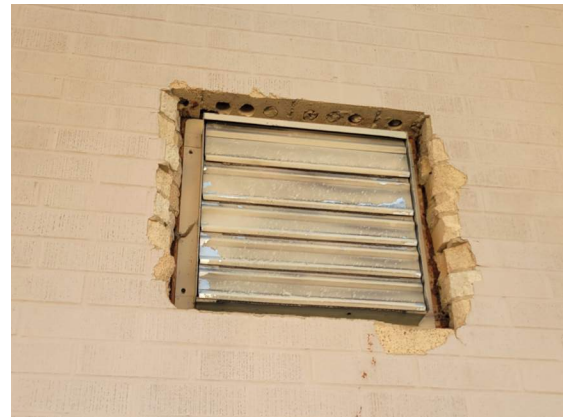
Damage at exterior louvre | A5

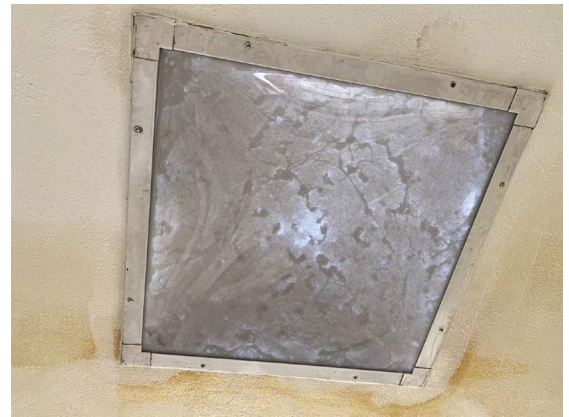
A few rooms around the single-story part of the building have sky lights. Most of these are very dirty and do not supply much light to the room (A6). There is some evidence of damage around some of the skylights. This may be evidence of a leak.

Dirty skylight | A6

- Replace existing skylights with energy code compliant skylights or solar tubes. Repair ceiling damage around skylights.
- Replace VCT floors throughout the building. Replace OSB floor in dance room (new floor will depend on future use).
- Remove the acoustic tiles adhered to the ceiling of the ensemble room and repair the ceiling finish.
- Fully renovate the dressing rooms.
- Inspect the fire suppression system for leaks and evaluated it for code compliance.
- Move the large number high value items (i.e. pianos and shop tools) to a proper storage facility.

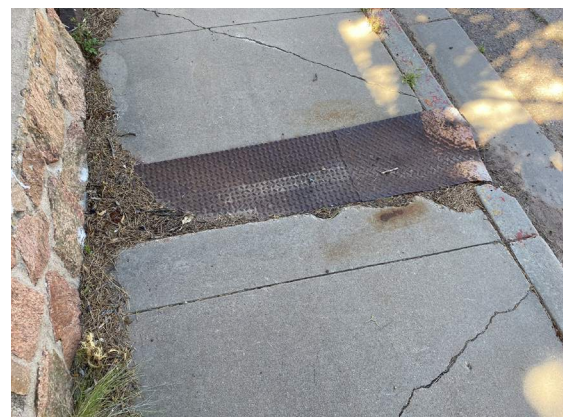
There are a few external drain spouts around the building, many of which do not have a splash block present. Erosion has occurred in these locations. A rock catch basin with a small retaining wall is present at one drain spout on the northwest elevation. A channel through the sidewalk then allows water to exit to the parking lot. A painted diamond pattern steel plate bridges the channel in the sidewalk. This steel plate is in poor condition (A7).

Plate over drainage | A7

- Landscaping should be addressed by a professional landscaper. Trim overgrown plants, remove or adapt volunteer plants, and remove dead plants (A26).
- Replace the steel plate that bridges the channel in the sidewalk. Repair/replace the damaged sidewalk on either side of the plate.

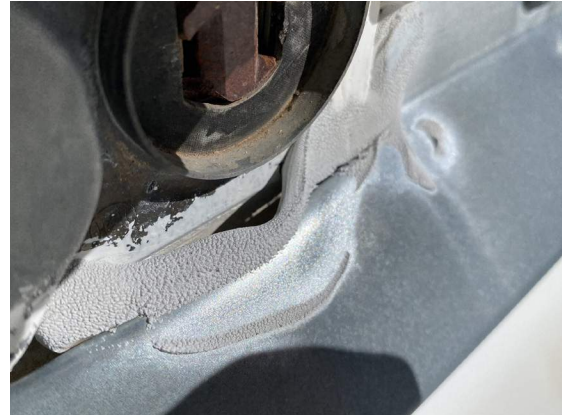
The roofing system appears to be a thermoplastic polyolefin (TPO) membrane roofing assembly. The age of the roof is unknown. In general, the roof is in good condition with no noticeable leaks, cracks, or seam issues. The roof drains appear functional, and no ponding was observed. Metal flashing at the edge of the membrane appears to be in good condition (A8). Sealant around an outlet on the roof is beginning to fail. The stucco finish on the concrete wall cap is failing in some places. Overall, the roof is in acceptable condition.

Metal flashing at roof membrane edge | A8

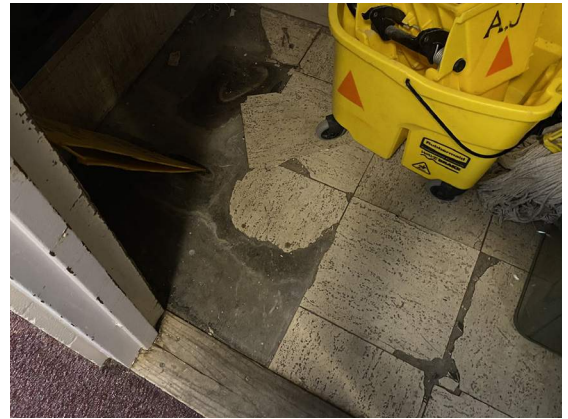
VCT: Located in janitor closets, ticket office, costume room, hallways, dressing rooms, projection room, technical director's office, practice room. Given the age of the facility, VCT should be tested for hazardous materials before any work occurs. The condition ranges from poor to acceptable (A9).

Poor condition VCT in janitor closet | A9

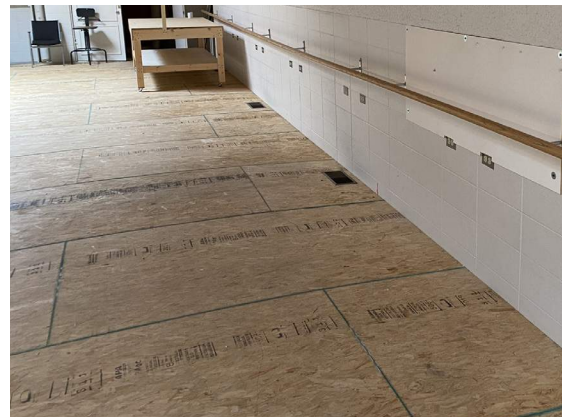
Plywood/OSB: Located in the black box theater and the main stage, painted black. Also present in the dance studio, unpainted and bowing up several inches (A10).

OSB in dance studio bowing up | A10

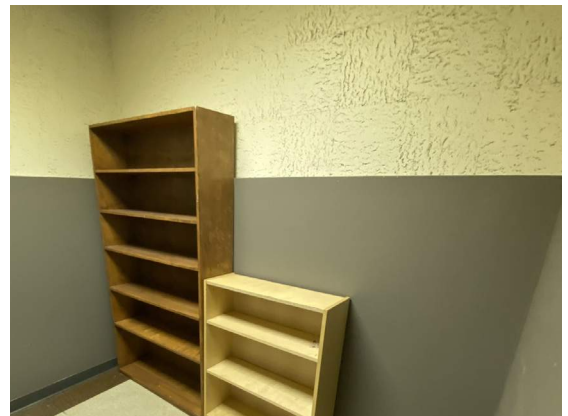
A majority of the partitions are painted CMU. The restrooms have floor-to-ceiling tile on the walls, and a few rooms have acoustic tiles adhered to the CMU (A11). The dance studio also has some plywood screwed to the walls. Overall, the interior partition walls are in good to acceptable condition.

Acoustic tiles adhered to CMU | A11

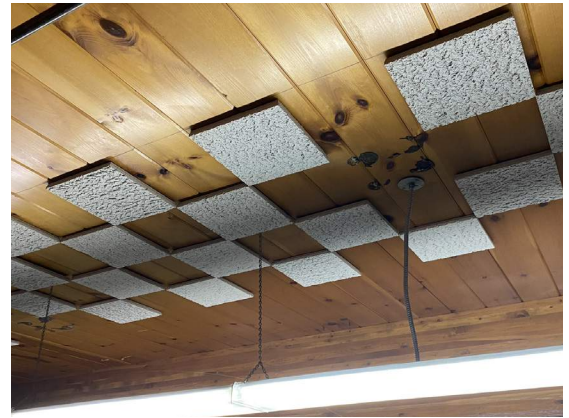
Glue-lam and Wood Ceilings: Present in classrooms, ensemble room, dance studio, and the shop. The wood ceiling above the glue-lam structure and appears to be tongue-and-groove. The ensemble room has acoustic tiles adhered to this ceiling type (A12). Many of these tiles have fallen off. There are a few ceilings that have damage around the skylight as referenced above. The gypsum ceiling in one of the dressing rooms has been stained. Otherwise, these ceilings appear to be in acceptable to good condition.

Acoustic tile adhered to wood ceiling | A12

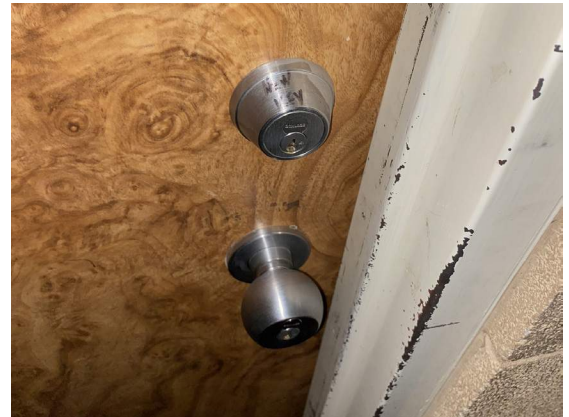
Interior doors include solid wood doors and a few hollow metal doors in the stage area. Several doors and a portion of the walls in the outer lobby are covered with a wood-effect veneer. This veneer is bubbling up and peeling off in several places. Only a few doors have accessible hardware, most have door knobs that appear to be original (A17). The door between the second floor music room and the adjacent office is missing hardware. Overall, these doors are in fair to good condition.

Door hardware example | A17

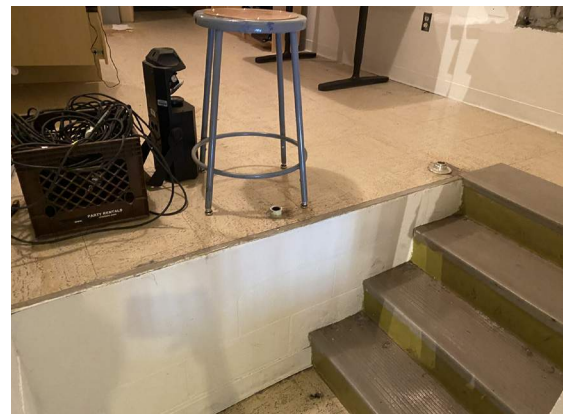
The first stair is from the main lobby up to the exhibit lobby which branches into two at the landing. This stair is carpeted and is in good condition. The second stair is at the back of the auditorium, leading up to the control rooms, and then up to the "attic". This stair is bare concrete with anti-slip metal nosings. The third stair connects the dance studio to the sunken ensemble room. This stair is bare concrete with anti-slip metal nosings. The fourth stair is in the hallway outside the dressing rooms. This stair is concrete covered with VCT and rubber nosings. The VCT and rubber nosings are in poor condition and portions of the material are missing, exposing the concrete underneath. The fifth stair connects the ensemble room to the hallway. This stair has been covered up with a steep wooden ramp with anti-slip material at regular intervals. This ramp is not ADA compliant, or safe. The fifth stair connects the technical director's office to the exhibit lobby. This stair seemingly used to have a railing that was removed at some point (A19). This missing railing is a code violation.

Technical director office stair | A19

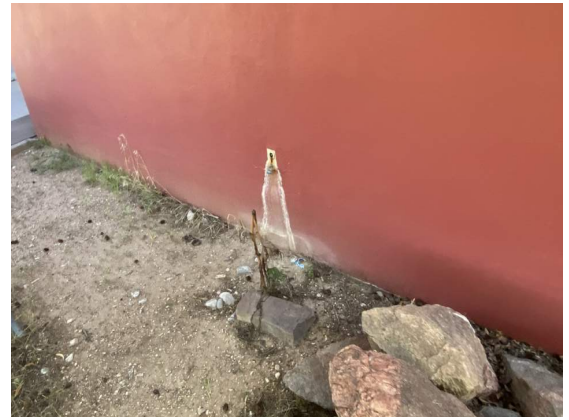
Several water connections are located around the exterior of the building in the exterior wall. Some show evidence of leaking (A24).

Water connection on exterior | A24

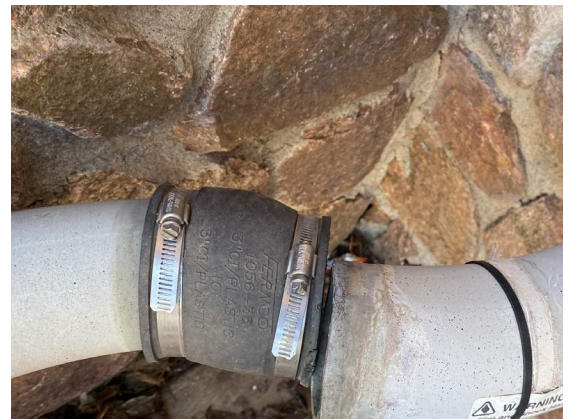
There is a fire suppression sprinkler system installed in the building, but it does not appear in every room. The staining to one of the dressing room ceilings may be evidence of leaking. The fire line appears to enter the building next to the stage cargo entrance where the pipe connection has come detached (A25).

Fire water line is detached | A25

- Replace missing or moved splash blocks.
- A full roof inspection by a licensed roofing contractor is recommended to verify the estimated life left in the current roofing system. Inspect all flashings and sealants on the roof and repair as necessary.
- Remove and replace the failing sealant between the precast panels on the exterior.
- Repair the damaged brick work around the louvered vent on the northwest elevation.
- Replace the door hardware on the doors to the dance studio back entrance and the shop back entrance with panic hardware. Replace the cargo doors at the back of the stage with insulated code-compliant doors.
- Replace the stucco finish on the wall caps on the roof.
- Fix the fire water connection next to the stage cargo doors.

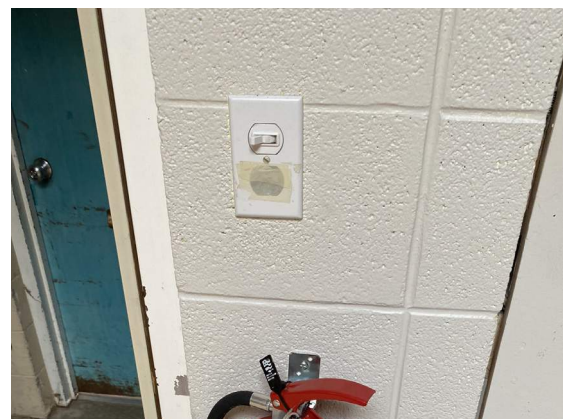
Some wiring devices appear to have been added somewhat recently. These are of a newer design and in good condition. Older wiring devices are in fair to acceptable condition. There are a few wiring devices that will require replacement due to code or condition. The overall appearance of the wiring devices in the building is acceptable.

Older light switch with taped outlet | A26

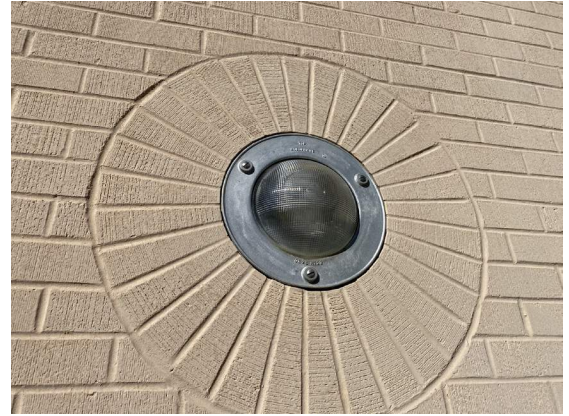
The exterior lighting appears to be in good condition (A28). Emergency egress lights are installed at exits. Site lighting is provided by circular downlights on poles as well as pole lights pointed at the building's exterior. Exterior building fixtures are round and recessed into the wall.

Recessed exterior light | A28
