FACILITY ASSESSMENT REPORT

Driscoll Fitness Center

January 11, 2023

January 11, 2023
WCI Project #: 21-600-030-10

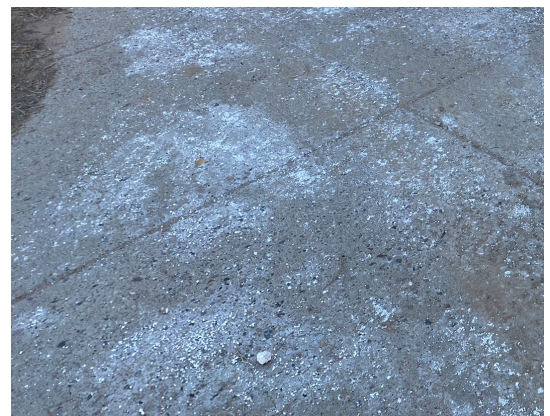
Concrete sidewalks around the site are mostly in fair condition and are getting worn (A3). This facility shares a parking lot with Onate Hall. This parking lot is worn and in fair to poor condition, with the striping being mostly gone. There is a large empty lot on the southeast and southwest sides of the building.

Exterior sidewalk with salt | A3

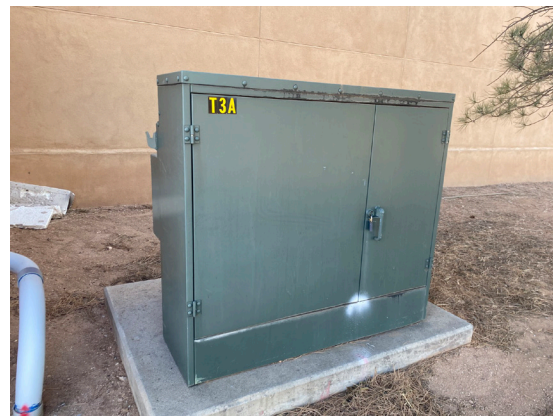
The gas connection appears to enter the building at a gas regulator on the southeast side of the building next to a maintenance room entrance. The sewer connection location is unclear. The electrical connection appears to enter the facility via a transformer on the northwest face of the building, to the right of the entrance (A4). Original facility drawings were not provided for this report.

Pad-mounted Transformer | A4

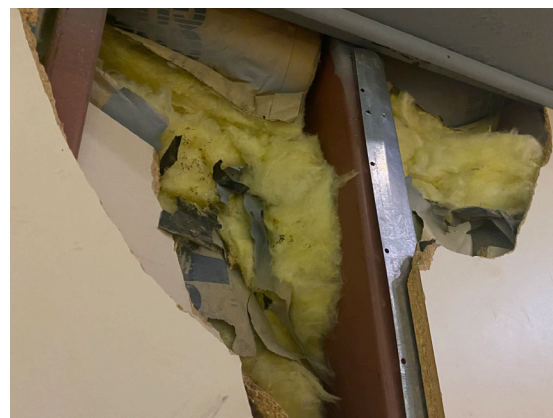
Wall damage allowed for a small amount of investigation inside the wall assembly. Most of the exterior walls appear to be constructed of metal studs with gypsum wallboard on the interior and exterior-rated gypsum sheathing with a stucco system on the exterior. The indoor sports court has exposed steel frames as primary structure. The walls are a combination of steel structural elements and metal studs (A5). MDF panels with laminate facing is used for interior finish here. Exterior sheathing is likely exterior-rated gypsum and the same stucco finish is present here. Exterior damage to the stucco was observed in many areas around the court, though the damaged areas are all small.

Example of wall damage | A5

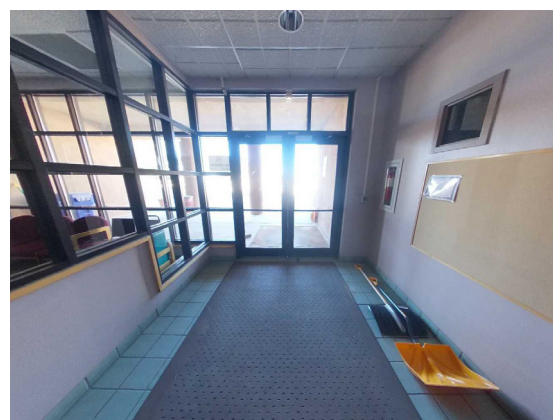
The exterior doors are a mixture of three door types. Hollow metal storefront doors are found at the entrance, as well as at externally accessed mechanical spaces. The hardware does not appear to be ADA-compliant (A6). Entrance doors appear not to have the proper accessible hold open hardware. The overall conditions of the exterior doors is acceptable.

Storefront Entrance Doors | A6

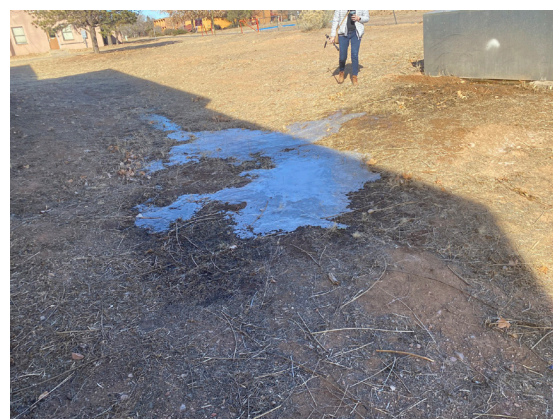
There are several external drain spouts around the building, many of which no longer have a splash block present. There is also some ponding water on the North East side of the building (A7). If not addressed, this could cause issues at the exterior of the building.

Ponding water | A7

Re-grade surrounding site to slope away from the building where there is ponding water.

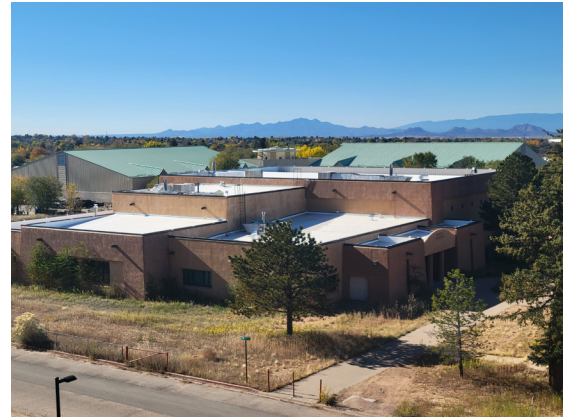
The current roof appears to be a TPO membrane roofing assembly (A8), however the original building drawings show the roof as a metal panel assembly from the building manufacturer. It was undetermined when the TPO roofing was installed and its age. From afar, the roof appears to be in good condition with no noticeable issues. A full roofing inspection is recommended. Metal flashing appears to be installed.

TPO roofing | A8

A full roof inspection by a licensed roofing contractor is recommended to verify the estimated life left in the current roofing system. All flashings and sealants should also be inspected.

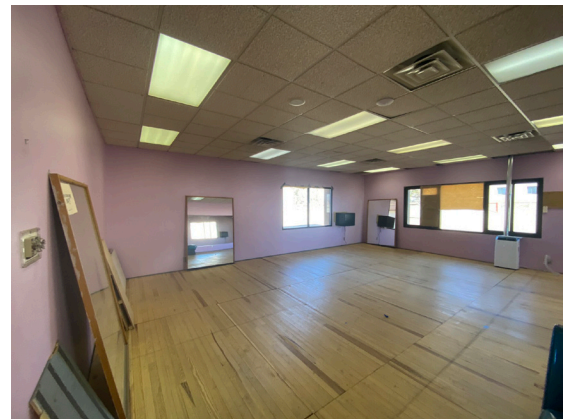
Wood Flooring Located in the large open studio room the condition appears to be in poor condition (A9).

Studio room | A9

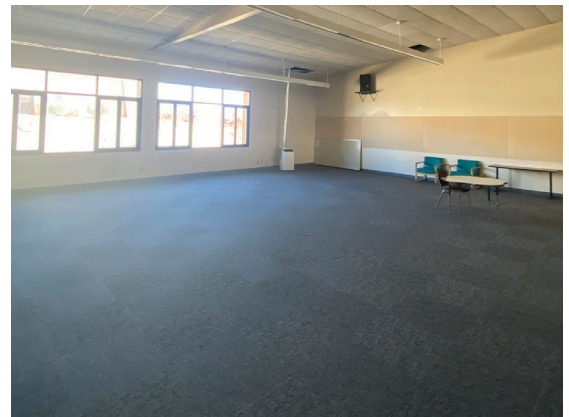
Carpet: Located in the lobby, offices, and gathering space (A10) the carpet is in fair to poor condition, with some areas showing more significant wear than others.

Gathering Space | A10

All carpet shall be replaced.

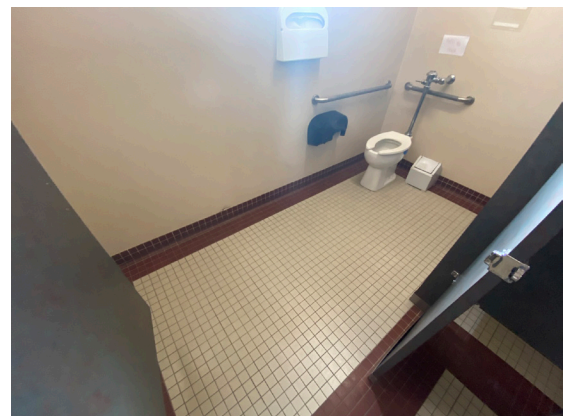
Tile: Located in the locker rooms and some bathrooms. Dirty and outdated, but in acceptable condition (A11)

Tile flooring | A11

The tile in the bathrooms should be fully cleaned, although it is recommended to update for aesthetics.

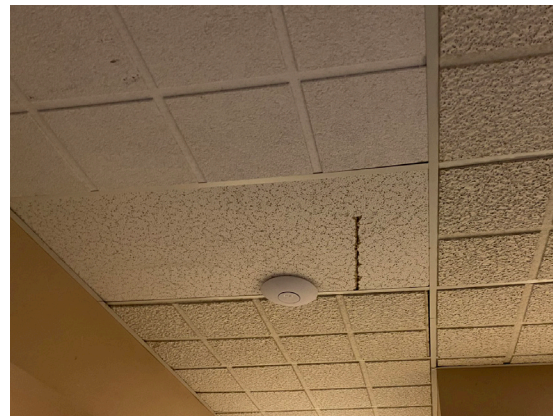
Lay-in Acoustical Ceilings Tiles (ACT): Areas with ACT are in poor condition. The ceiling tiles are dirty, stained, outdated and don't match (A12). Some are offset to accommodate temporary HVAC solutions.

Typical Acoustic Ceiling Tile | A12

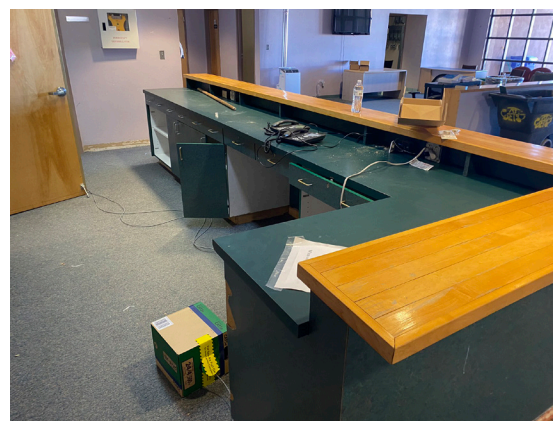
Casework mostly exists at the reception desk. It is outdated and doesn't meet ADA. Without the ADA compliance it will likely need to be demolished and replaced.

Reception Desk | A13

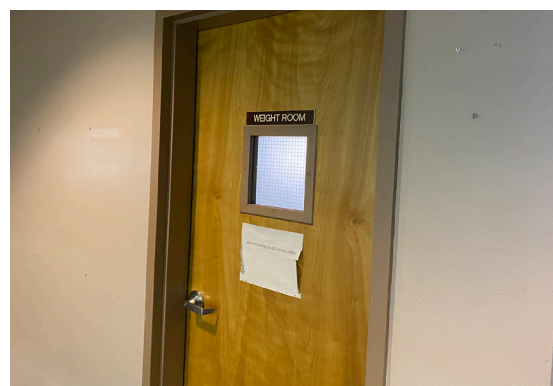
Interior doors include custom solid wood doors (with or without small windows)(A14), painted solid wood doors with hollow metal doors frames. They are not ADA-compliant. Overall, the interior doors are in fair condition.

Typical interior door & hardware | A14

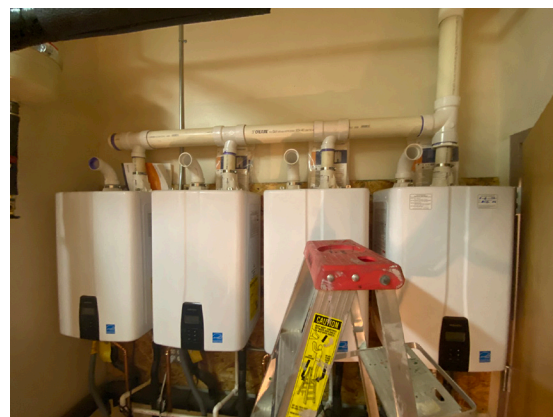
The mechanical systems include (4) tankless water heaters (A15), (6) Exhaust fans, (1) roof mounted damper, (6) Evaporated coolers, (6) Furnaces. Some equipment is located on the roof. It appears as though the majority of the system is shut off due to needed water line repairs. Temporary, portable AC units were present in a few rooms.

Tankless water heaters | A15

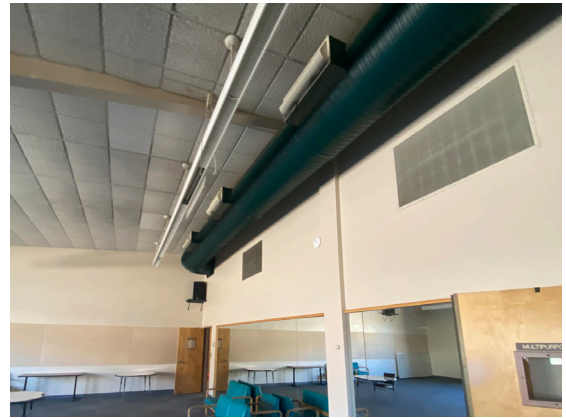
Portions of ductwork throughout the building are exposed. The visible ductwork appears in fair to good condition (A16).

Ceiling and HVAC ductwork | A16

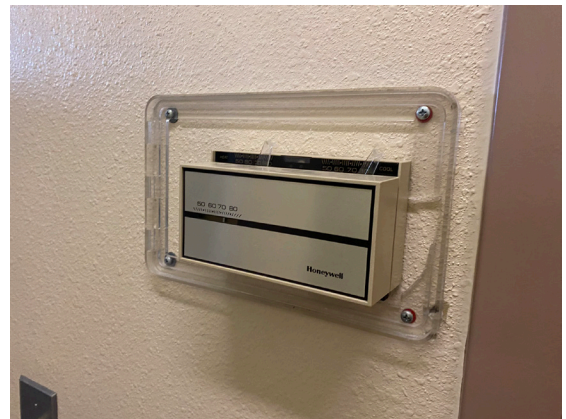
The overall appearance of the wiring devices for the building ranges from fair to good. Several thermostats are dated (A17). The building's telecommunications and IT systems is recommended to be fully inspected.

Dated Thermostat | A17

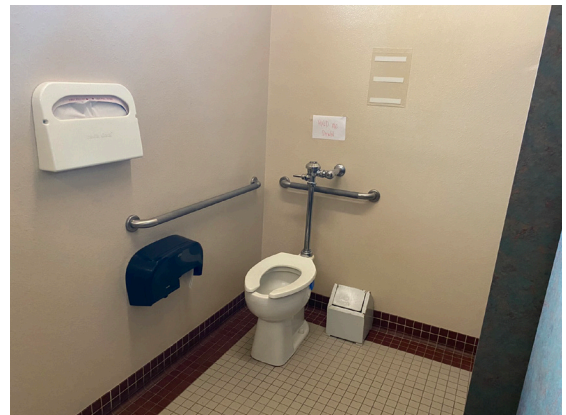
A wide variety of plumbing fixtures are present. All fixtures are manually actuated. Restrooms have dual-handle faucets, wall-mounted soap pumps, and a mixture of wall-mounted and countertop lavatories. Toilets are floor mounted with manual flush valves. Urinals are floor/wall mounted with manual flush valves (A18). No ADA compliant water fountain appear to be present. Plumbing fixture clearances and heights do not appear to be fully ADA-compliant throughout the facility.

Typical plumbing fixture | A18

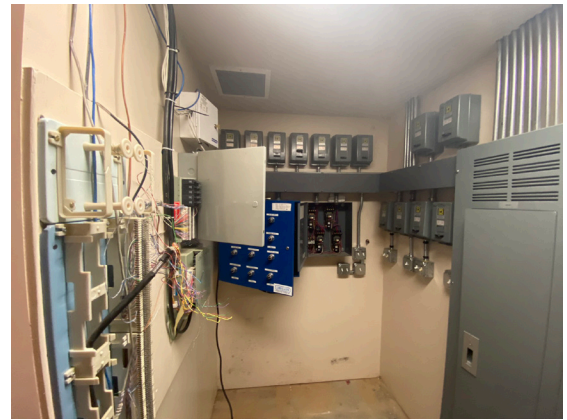
Electrical appears to enter the building at the north side of the building. An electrical room off of the main lobby contains the primary electrical equipment (A20). Other distribution panels are located throughout the building.

Electrical Room | A20

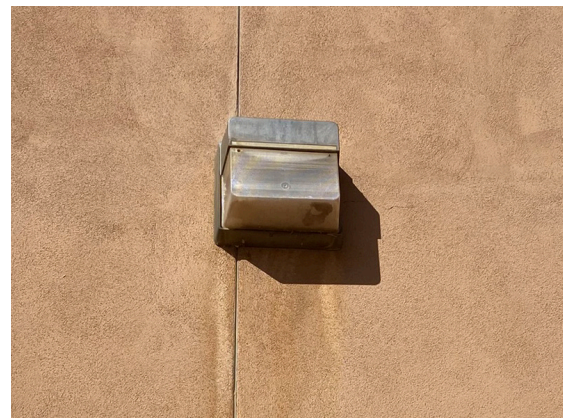
The exterior lighting consists of wall packs (A21) and recessed down lights. It is undetermined if these fixture are in working order; observation occurred during the day. Site lighting is not present in the immediate vicinity of the building.

Typical exterior wall pack light | A21

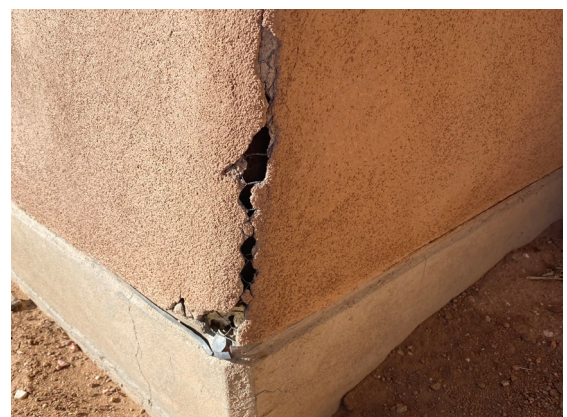
Stucco Damage | A23

All stucco needs to be patched and repaired where there is noticeable damage (A23-A24).

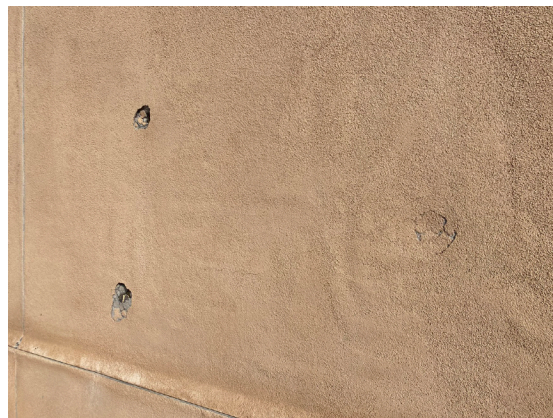
Stucco damage at east corner | A24

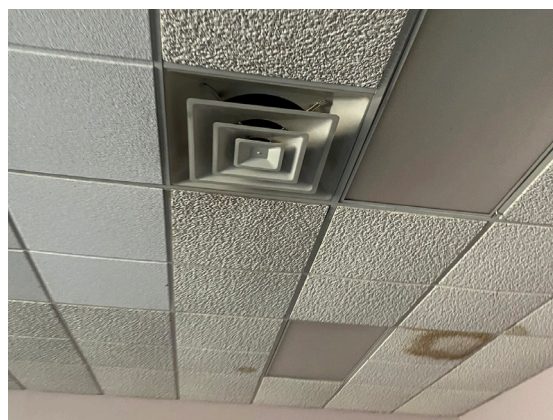
Ceiling, Lighting, HVAC and stains | A25

Damaged ceiling tiles need to be replaced (A25). The gymnasium ceiling will need to be inspected to properly repair damage.
