March 8, 2010

RE: Asbestos Survey-College of Santa Fe
Task 1 - Main Campus
Task 2 - T-Buildings & Barracks
ATC Project No. 44-39545-0001

Building T-64 Sample Location Map

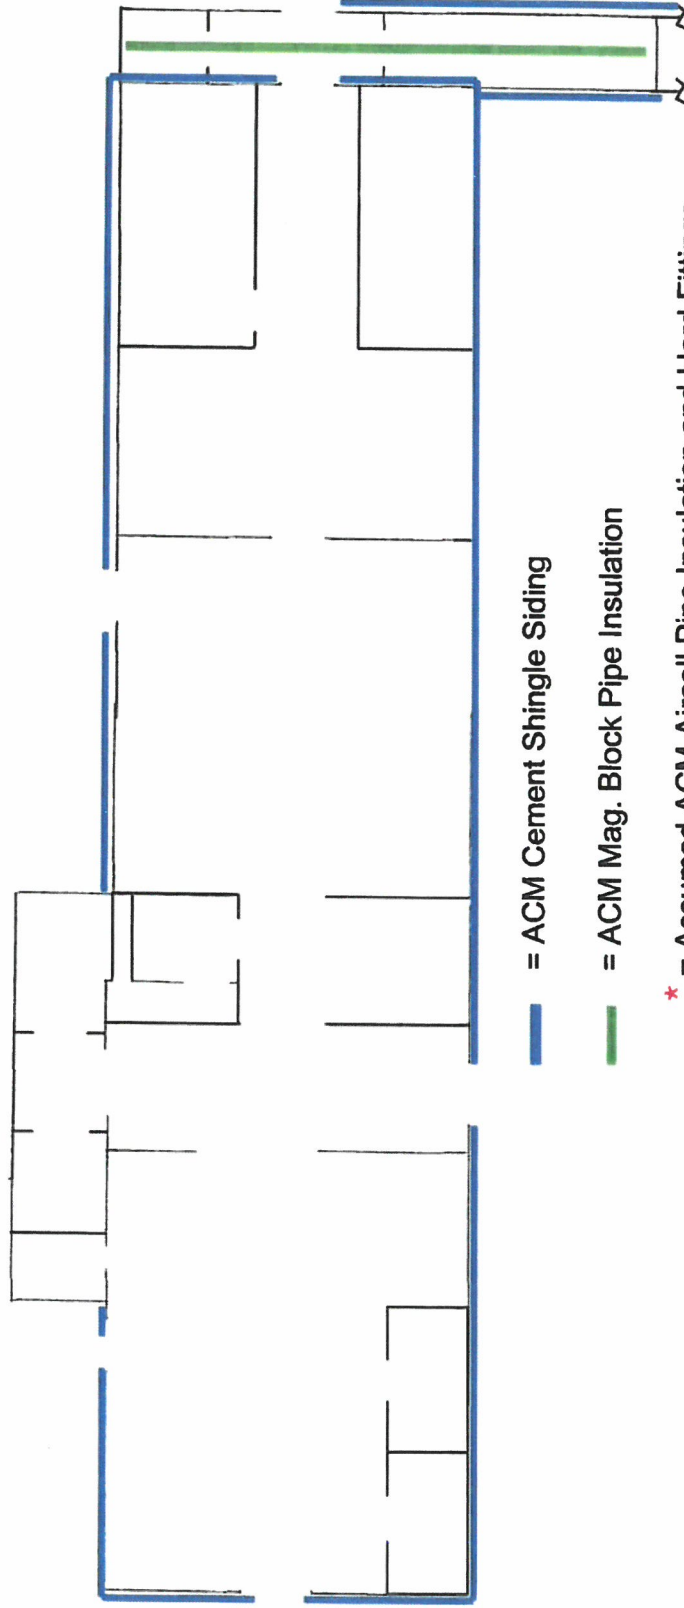
Building T-64 Asbestos Location Map

The results of the asbestos survey conducted at Building T-64 indicated **four suspect materials that were sampled and were determined to be asbestos-containing materials (ACM)**. The identified Asbestos Containing Materials are as follows; pipe insulation, exterior window caulk, exterior cement shingle siding and roof flashing mastic- as listed above in Table 1. Assumed asbestos containing hard fittings and pipe insulation are presumed to exist in the inaccessible ceiling space and crawl space.

— = ACM Cement Shingle Siding

— = ACM Mag. Block Pipe Insulation

* = Assumed ACM Aircell Pipe Insulation and Hard Fittings
Located in Crawl Space and Ceiling Space.

** = ACM Exterior Window Caulk Located Around the
Perimeter of all Windows

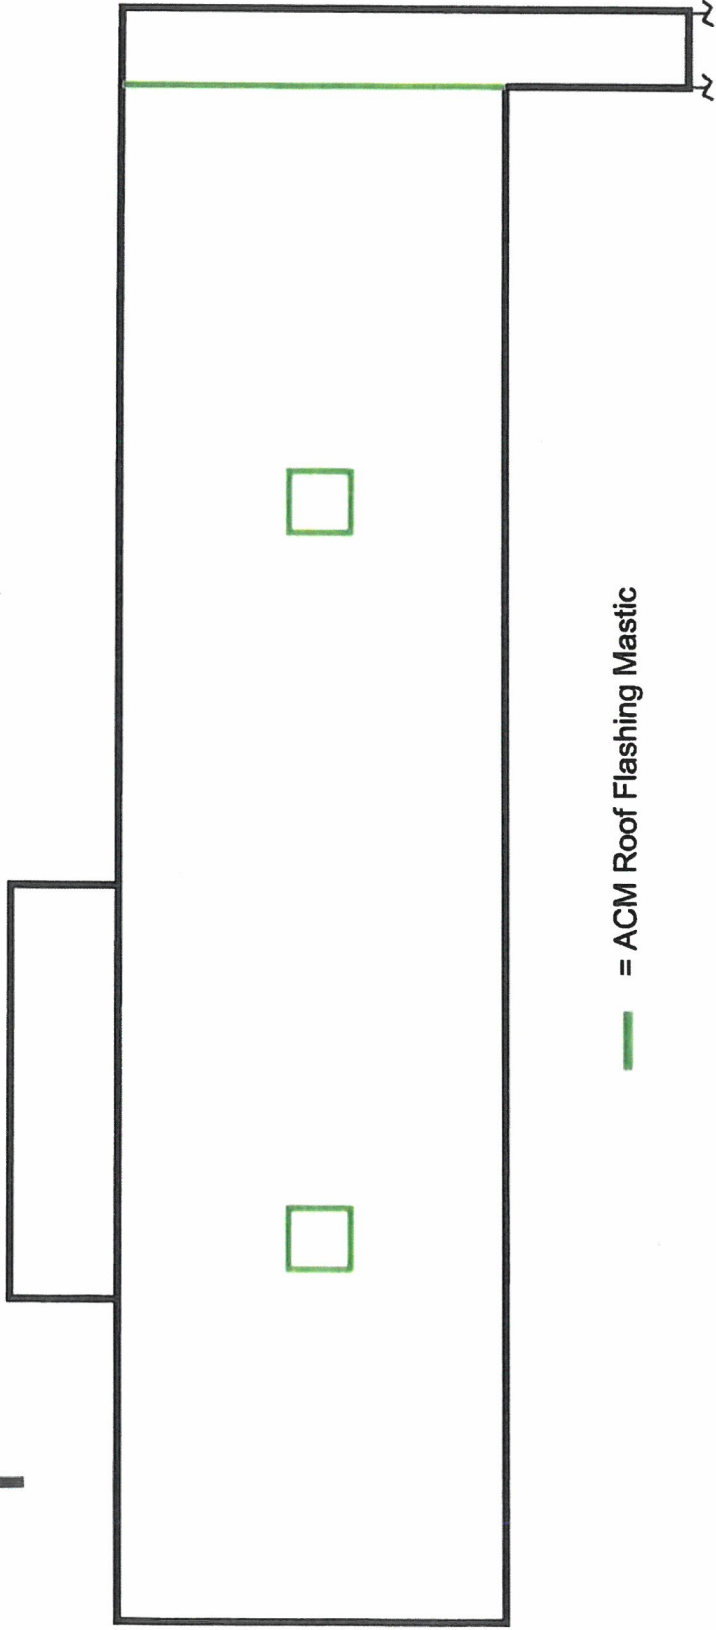
Building T-64 Roof
Asbestos Location Map

The exterior window glazing and a roof core tested “trace” for asbestos; however, the lab noted that the trace result in the roof core sample appeared to be located in roofing mastic. Additional analysis of those samples using the EPA Point Counting method confirmed that those materials contained less than one percent (1.0%) asbestos, thus not meeting the definition of an “asbestos-containing material” under the OSHA Asbestos in Construction Standard (29CFR1926.1101). However, certain precautions set out in paragraph (g) of the Standard are universal and apply to all work with asbestos, regardless of airborne exposures, or asbestos content of previously installed materials. These requirements are to utilize wet methods, to the extent feasible, (paragraph (g)(1)(ii)); and to promptly clean up and dispose in closed containers, waste and debris contaminated with asbestos (paragraph (g)(1)(iii)).

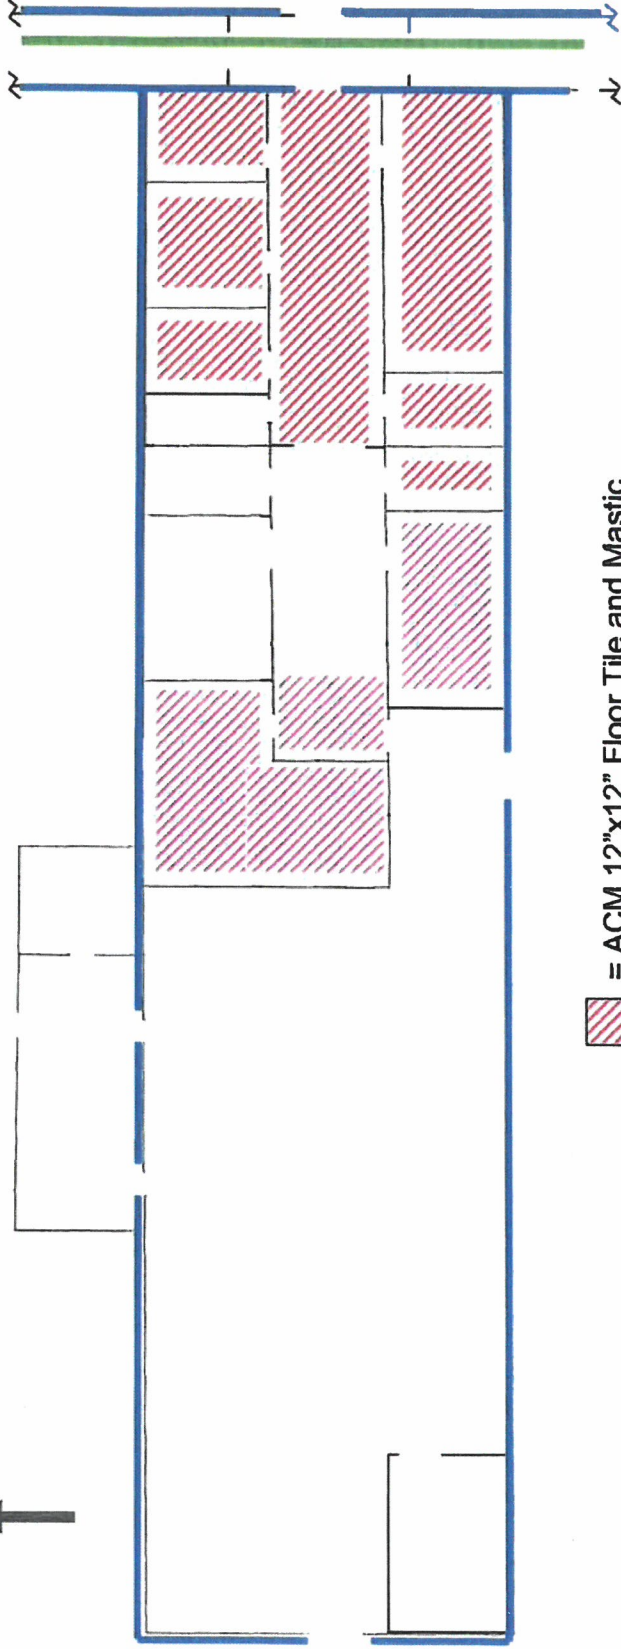
Building T-65 Asbestos Location Map

The results of the asbestos survey conducted at Building T-65 **indicated six suspect materials that were sampled and were determined to be asbestos-containing materials (ACM)**. The identified Asbestos Containing Materials are as follows; 2 different 12'X 12" floor tiles, pipe insulation, exterior window caulk, exterior cement shingle siding and roof flashing mastic- as listed above in Table 1. Assumed asbestos containing hard fittings and ACM pipe insulation was observed in the ceiling space and is presumed to exist in the crawl space under the building

= ACM 12"x12" Floor Tile and Mastic
-

= ACM 12"x12" Floor Tile
-

= ACM Cement Shingle Siding
-

= ACM Mag. Block Pipe Insulation
- * = ACM Aircell Pipe Insulation and Hard Fittings Located in Crawl Space and Ceiling Space.
- ** = ACM Exterior Window Caulk Located Around the Perimeter of all Windows

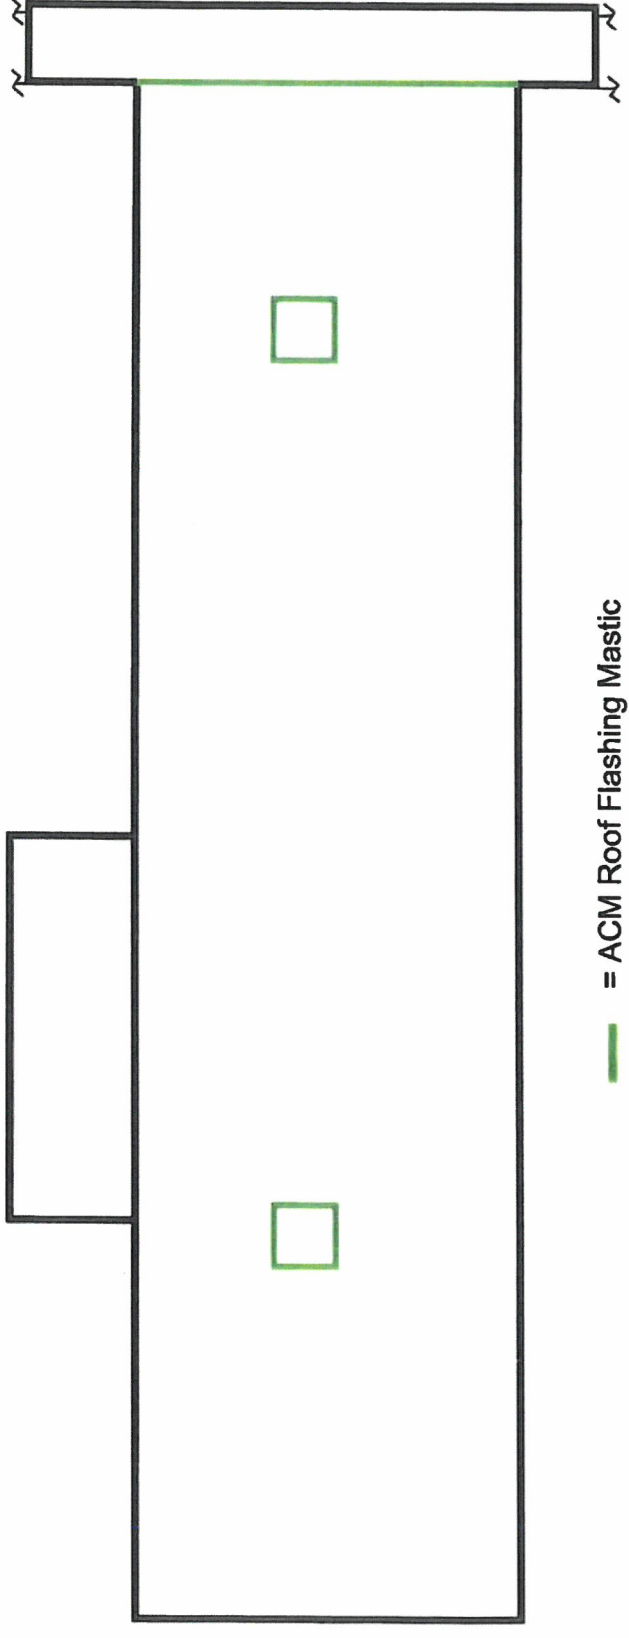
Building T-65 Roof
Asbestos Location Map

— = ACM Roof Flashing Mastic

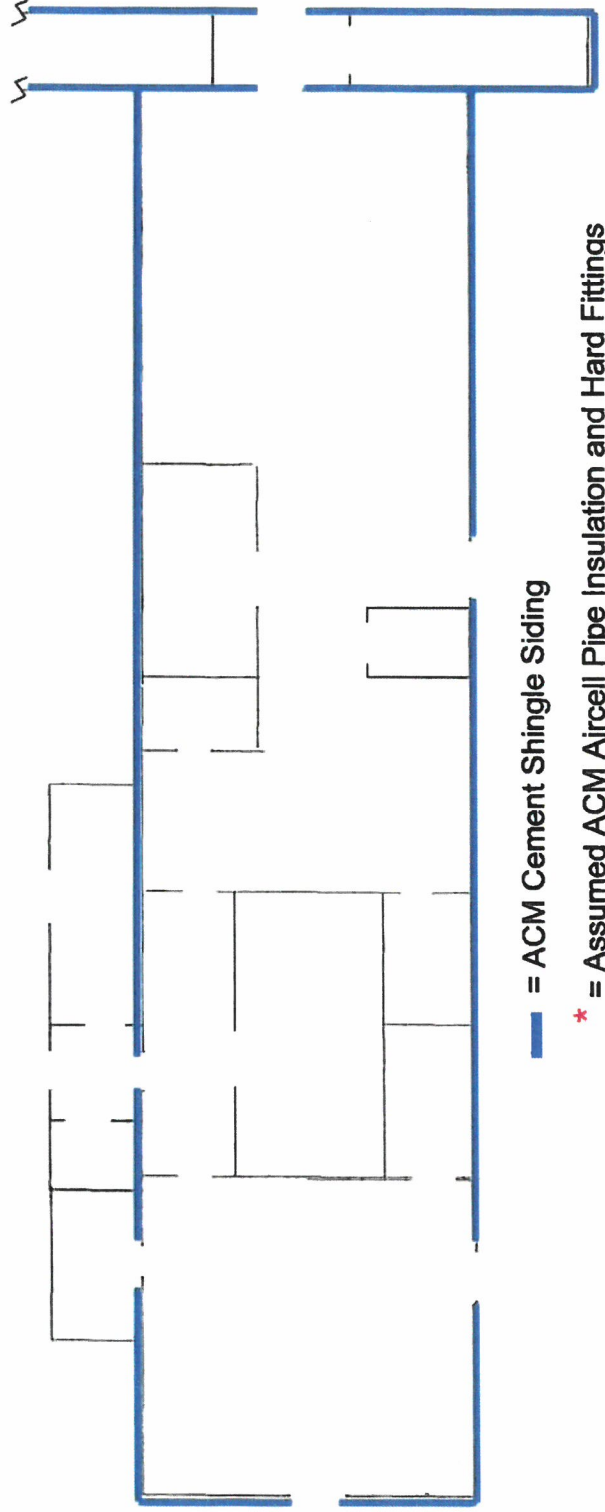
Building T-66 Asbestos Location Map

- = ACM Cement Shingle Siding
- *** = Assumed ACM Aircell Pipe Insulation and Hard Fittings Located in Crawl Space and Ceiling Space.
- **** = ACM Exterior Window Caulk Located Around the Perimeter of all Windows

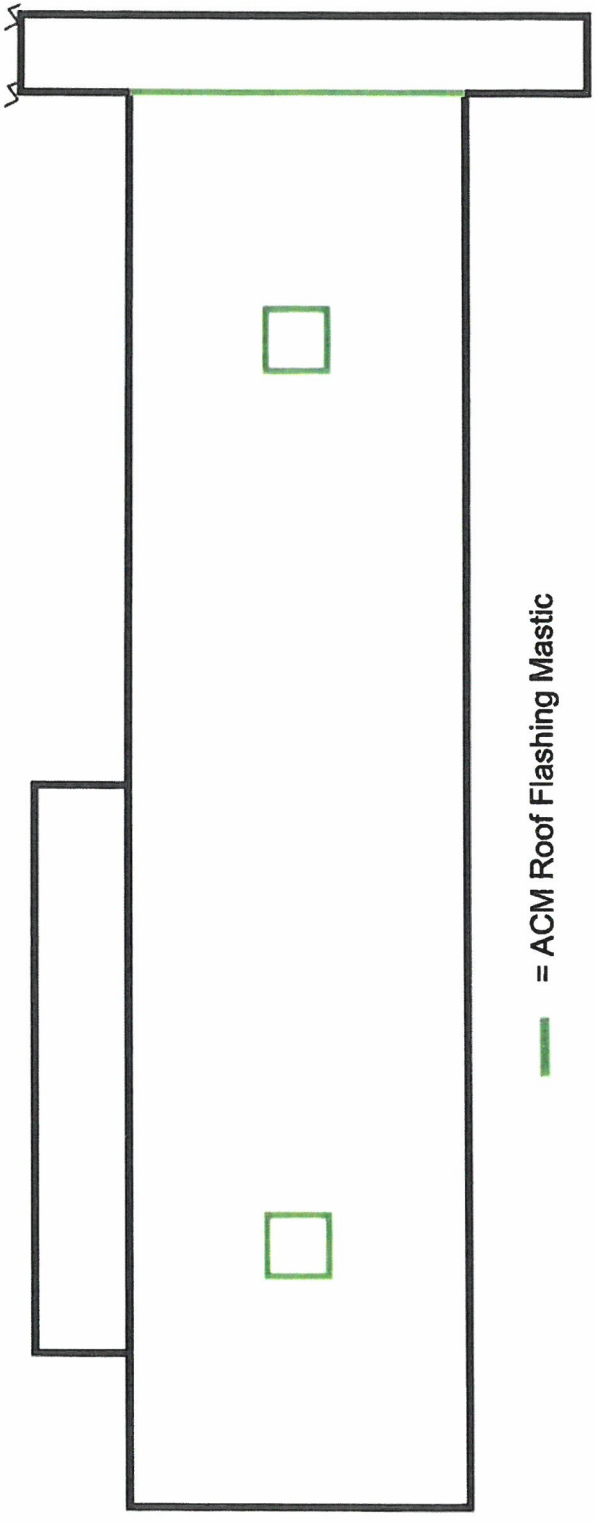
Building T-66 Roof
Asbestos Location Map

— = ACM Roof Flashing Mastic
