# FACILITY ASSESSMENT REPORT

**Visual Arts Center**

January 4, 2023

January 4, 2023 WCI Project #: 21-600-030-10

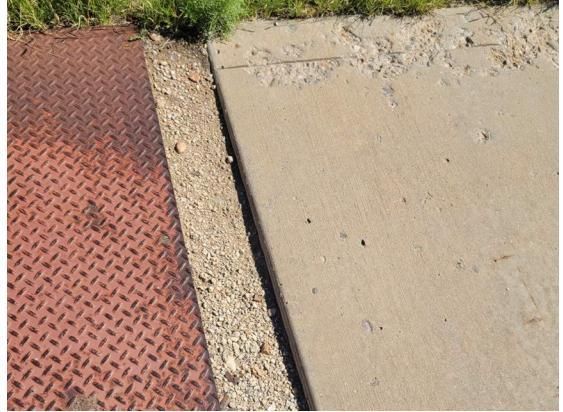
Concrete sidewalks around the site are mostly in good working order except for a few areas where water damage has lowered the condition to poor or critical (A3). The asphalt parking lot was formerly the main visitor lot. It is very worn and in poor condition. The striping is mostly gone, and the curb between the Visual Arts Center and the parking lot is broken. Parking spaces are also present along the road to the

Exterior Sidewalk Condition | A3

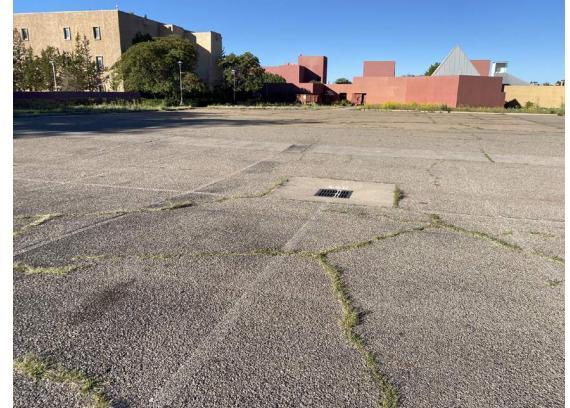
northwest. Handicapped spaces are in this area, next to the building. These handicapped spaces are not placed very well, as there are spaces closer to the door that would be better suited. This pavement is in similarly poor condition (A4).

Parking lot condition | A4

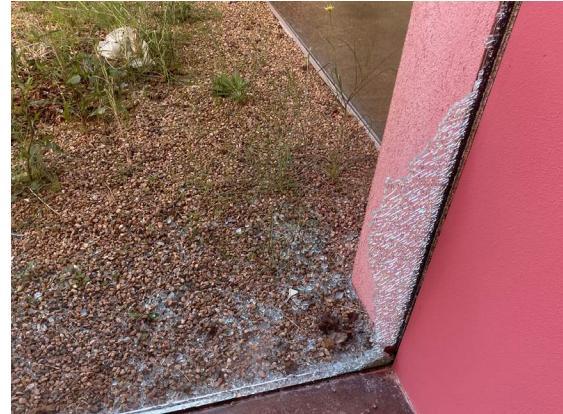
All windows appear to be custom. Many are fixed, double-pane windows with concealed frames. Most offices have square operable windows, most of them are double-pane, though some are single-pane. The operable windows have four latches around the perimeter and swing out on three hinges. One of the large, fixed windows looking into the courtyard from Tishman has had the external pane of glass shattered. The second pane is still intact on the interior (A5). The overall condition of the windows is acceptable.

Window with external pane shattered | A5

• Replace the broken glass in the window in Tishman. Retrofit

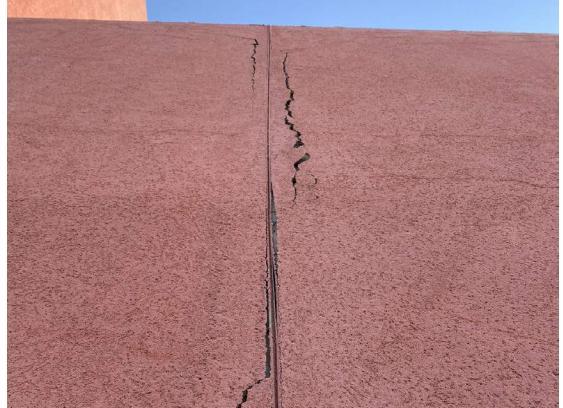
The exterior walls are constructed of metal studs with gypsum wallboard on the interior and exterior-rated gypsum sheathing with a modified stucco system on the exterior. A small number of walls are CMU including the bellow-grade portion of the walls of the utility basement in Thaw. Exterior damage to the stucco was observed in a few places, but only one was immediately concerning. There is a crack in the exterior wall near the southern corner of Tishman Hall. This crack seems to correspond to a crack in the slab (see Floor section, below) (A7).

Crack in exterior wall | A7

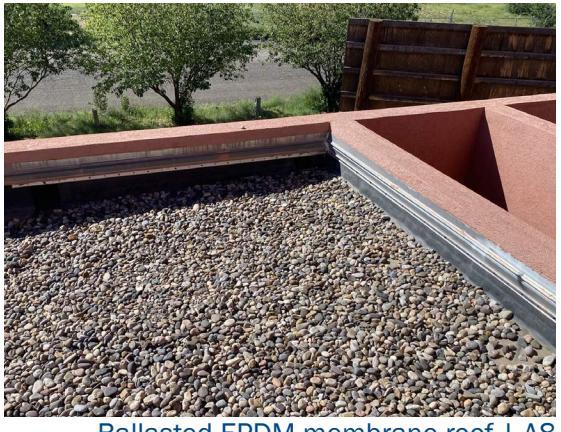
propylene-diene terpolymer (EPDM) membrane roofing assembly on 1" polyisocyanate insulation over a 22ga metal deck on steel joists. 1/4"/ft. slope to roof drains. This was confirmed by the original drawings. The age of the roof is assumed to be 23 years, the same age as the building. Roofs of this type have been commercially available for about 30 years and have so far proven to be a durable roofing system. The average lifespan is currently estimated to be over 30 years, though there is minimal real-world data past that mark. In general, the roof is in good condition with no noticeable leaks, cracks, or seam issues. The roof drains appear functional, and no obvious ponding was observed. Metal flashing at the edge of the membrane appears to be in good condition (A8).

Ballasted EPDM membrane roof | A8

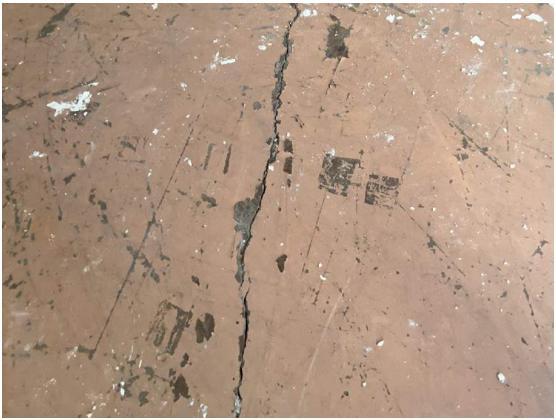
The first floor rooms at the southern corner of Tishman appear to be mid-renovation. The carpet has been removed from the room, revealing a long crack in the slab (A10). This crack may be related to a crack in the exterior wall, as they appear to align. This appears to be evidence of settling at this corner of the building.

Crack in slab | A10

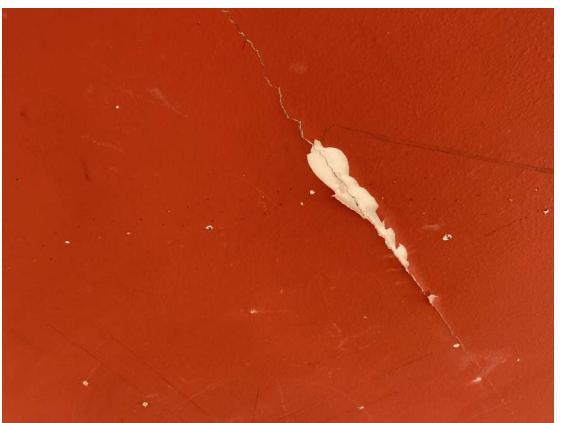
Overall, the interior partition walls are in good condition with only minor damage in a few areas. The large bay window in the Tishman stairwell has some damage to the gypsum board, including some damage that may indicate a small leak in the bay roof (A11).

Bay window gypsum board damage | A11

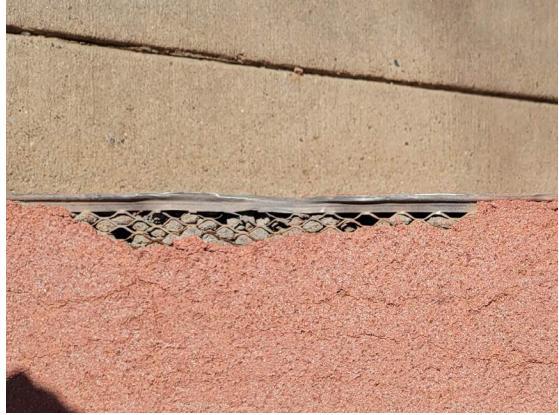
Stucco damage at east corner | A29

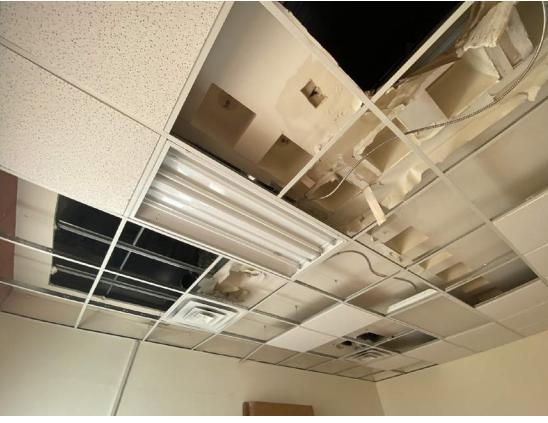
Incomplete renovation in Tishman | A30

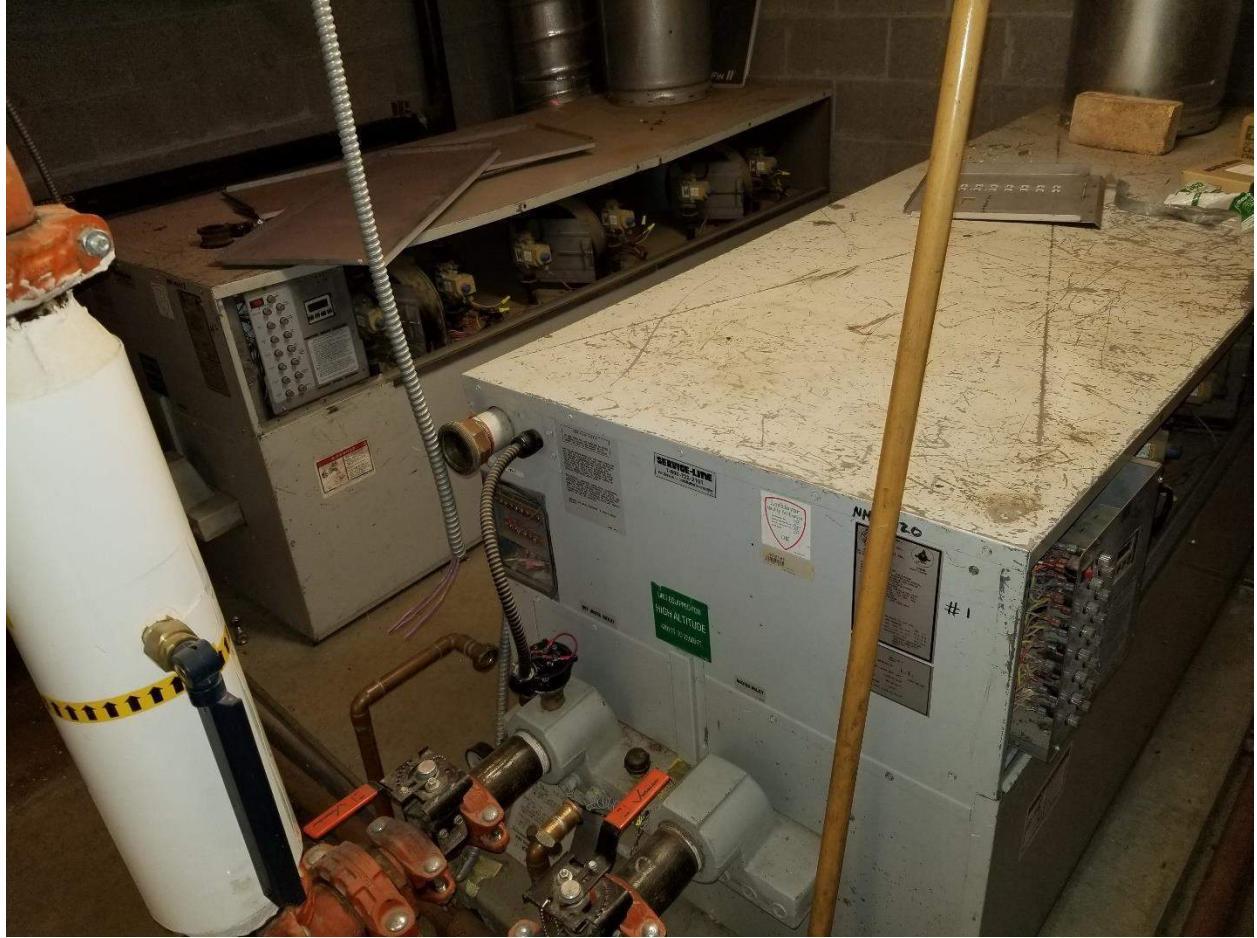
Figure 2 - Existing Boilers at Thaw/Tishman Building

- a. Boilers: The two (2) existing boilers that serve the Thaw/Tishman buildings are Lochinvar Models CHN 2070 cast-iron, natural gas-fired boilers with copperfinned tube heat exchangers. Each boiler has an input rating of 2,070,000 BTU /H and an output rating of 1,738,000 BTU/H.
  - (1) Age: The existing boilers appear to be from the original construction, which would make them approximately 25 years old. According to the *American Society of Heating, Refrigerating and Air-Conditioning Engineers* or *ASHRAE*, the maximum serviceable lifespan of a cast-iron boiler is 35 years, with a median age of 30 years. This is provided the boilers have been properly designed, installed and maintained, as well as no damage or unforeseen wear and tear has occurred throughout the boiler's lifespan.

- c. Condition/History:
  - (1) Boilers: The boilers appeared to have been moderately maintained over the years, but there are other factors that have impacted the longevity of the boilers. The boilers are located in the basement and, according to the City, there was a major leak in one of the main water pipes and the basement flooded with water 1-2 feet deep. This caused major damage to the electronic components within the boilers and consultation with the manufacturer and B&D resulted in the acknowledgement that energizing the boilers and testing them would be a safety risk. Additionally, the heat exchangers in both boilers have been found to be completely impacted/plugged due to lack of water treatment and maintenance over the years.

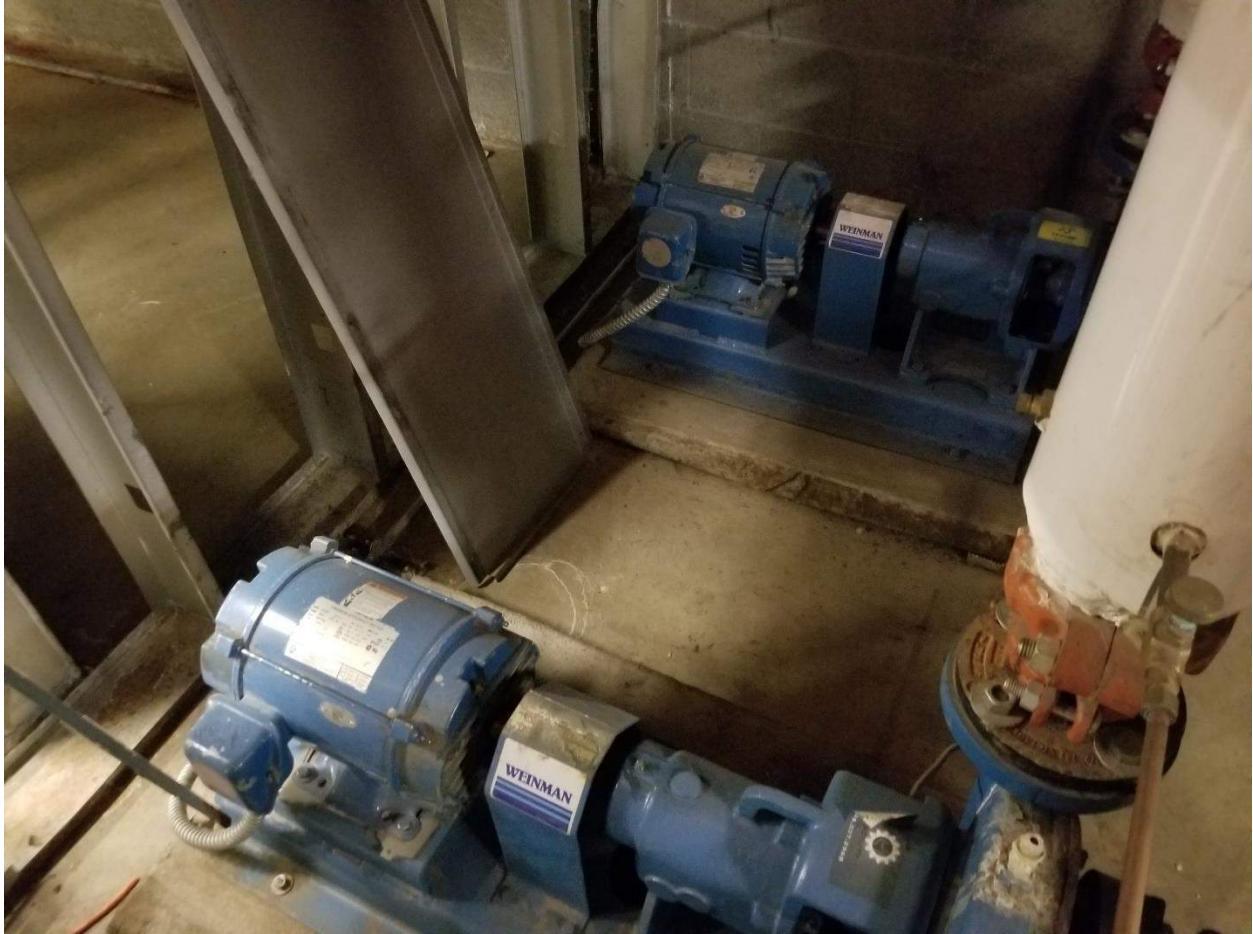
Figure 3 - Hot Water Hydronic Pumps at Thaw/Tishman

- Pumps/Hydronic Operation: The two (2) existing hot water circulation pumps are end suction, centrifugal pumps sized at 5 HP manufactured by Weinman/Crane Pumps.
  - (1) Age: These are also from the original construction installation and are approximately 25 years old. According to *ASHRAE*, the maximum serviceable lifespan of hydronic pumps is 20 years.

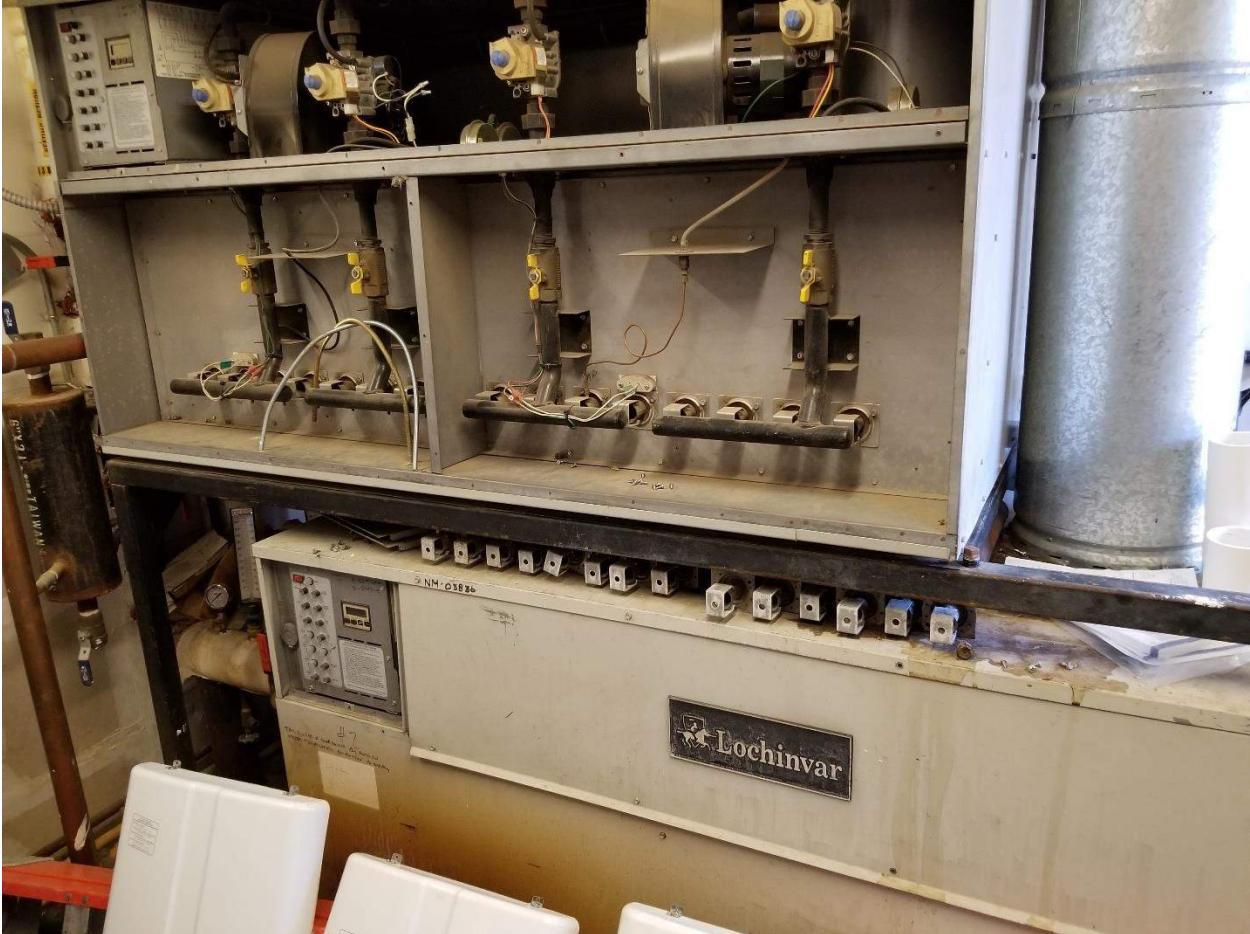
Figure 4 - Marion Boilers (Stacked - Top with Side Panel Off)

- a. Boilers: The two (2) existing boilers that serve the Marion buildings are Lochinvar Models CHN 2070 – cast-iron, natural gas-fired boilers with copperfinned tube heat exchangers. Each boiler has an input rating of 1,440,000 BTU/H and an output rating of 1,209,000 BTU/H.
  - (1) Age: The existing boilers appear to be from the original construction, which would make them approximately 25 years old. According to the *American Society of Heating, Refrigerating and Air-Conditioning Engineers* or *ASHRAE*, the maximum serviceable lifespan of a cast-iron boiler is 35 years, with a median age of 30 years. This is provided the boilers have been properly designed, installed and maintained, as well as no damage or unforeseen wear and tear has occurred throughout the boiler's lifespan.

- c. Condition/History:
  - (1) Boilers: The boilers appeared to have been poorly maintained over the years and are not currently operational. They have been decommissioned and are in poor condition and should be replaced. Additionally, the heat exchangers in both boilers have been found to be completely impacted/plugged due to lack of water treatment and maintenance over the years.
  - (2) Pumps/Hydronic Operation: The two (2) hot water circulation pumps are vertical inline centrifugal pumps sized at 2 HP. These pumps were originally sized to provide 72 GPM at 50' of head. The pumps appear to be in moderate to poor condition, but the pumps were decommissioned and could not be verified to be operational. Please see calculations below for additional assessment information.

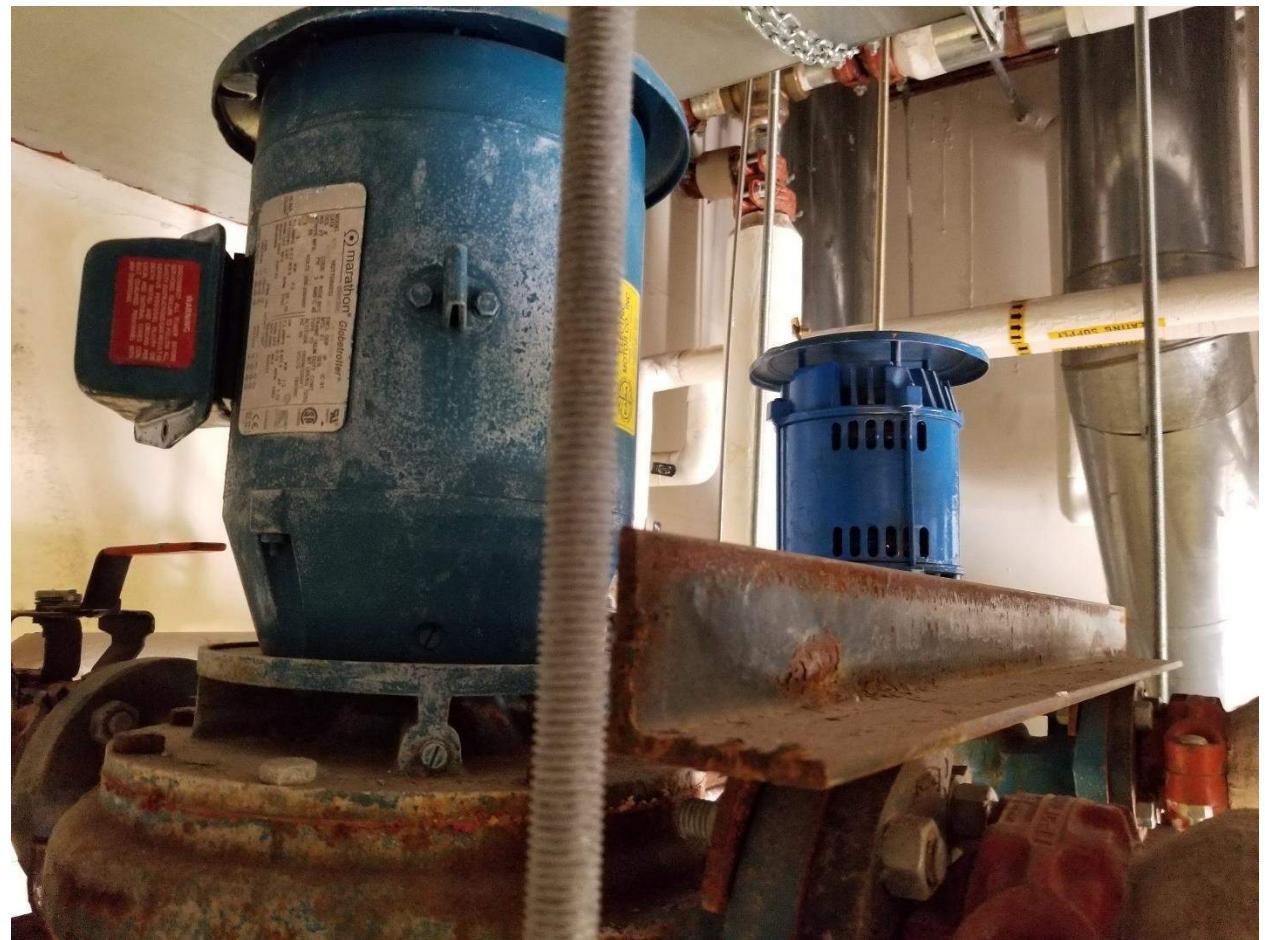
Figure 5 - Marion Boiler Pumps

b. Pumps/Hydronic Operation: The two (2) existing hot water circulation pumps are vertical inline centrifugal pumps sized at 2 HP. The motors were manufactured by Marathon Electric, it could not be verified who manufactured the pump.

(1) Age: These are also from the original construction installation and are approximately 25 years old. According to *ASHRAE*, the maximum serviceable lifespan of hydronic pumps is 20 years.

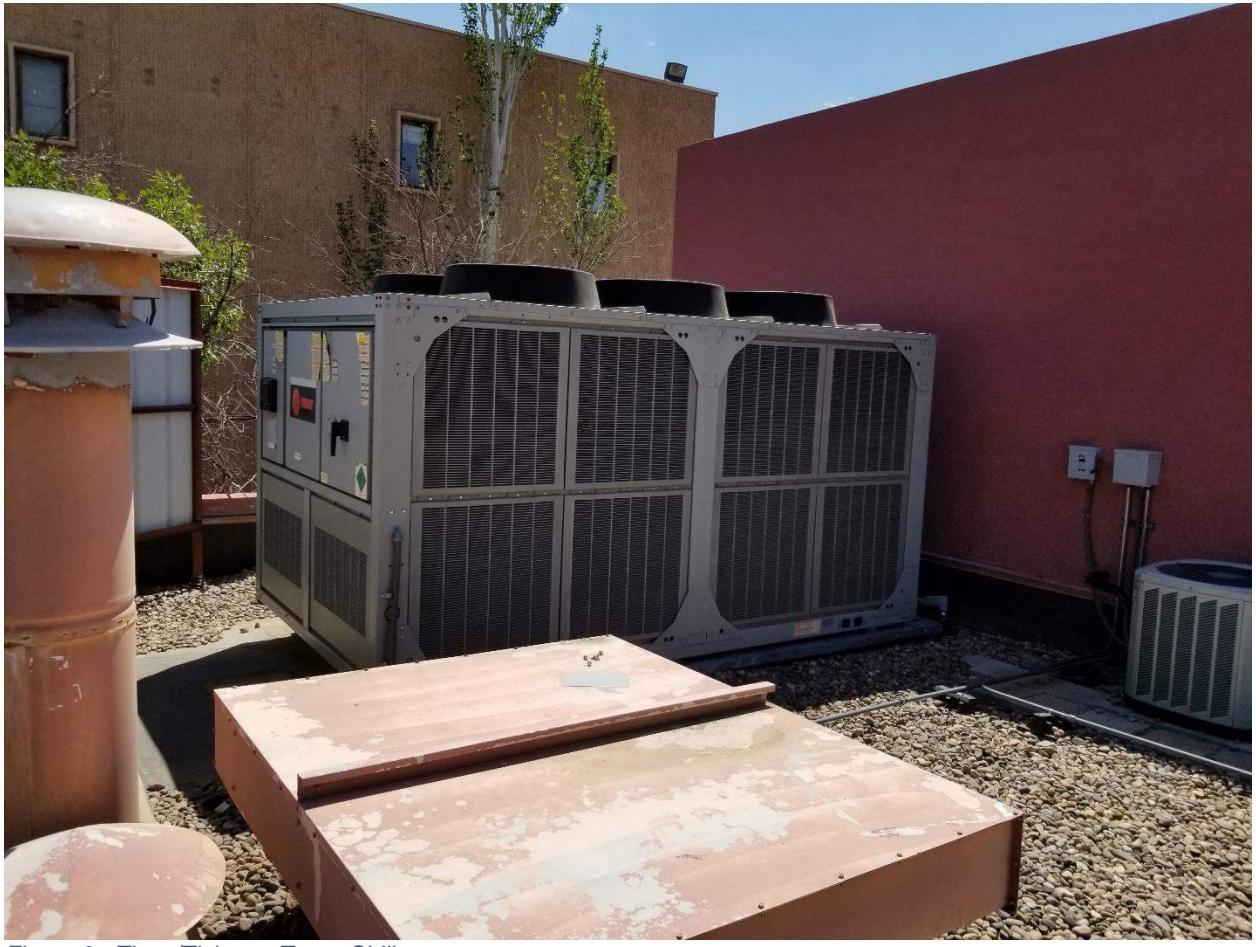
Figure 6 - Thaw/Tishman Trane Chiller

- a. Chiller: The existing chiller currently resides just north of the south mechanical penthouse on the roof. The chiller currently serves AHU-2 but likely served a previous AHU-1 that was removed and replaced with a DX/refrigerated, smaller AHU. (See AHU-1 for more information). This chiller is a Trane Model CGAM 060F a 60 ton air-cooled scroll chiller with a cooling capacity of approximately 693,000 BTU/h. The chiller has multiple R-410 refrigeration circuits and stages of 25%-50%-75%-100%.

- (1) Age: The existing chiller was not part of the original construction. The age of this chiller is likely somewhere in the range of the other newer equipment which would put the age at 11-13 years old. According to the American Society of Heating, Refrigerating and Air-Conditioning Engineers or ASHRAE, the maximum serviceable lifespan of a chiller ranges between 20-23 years is 35 years. This is provided the chiller has been properly designed, installed and maintained, as well as no damage or unforeseen wear and tear has occurred throughout the chiller's lifespan.

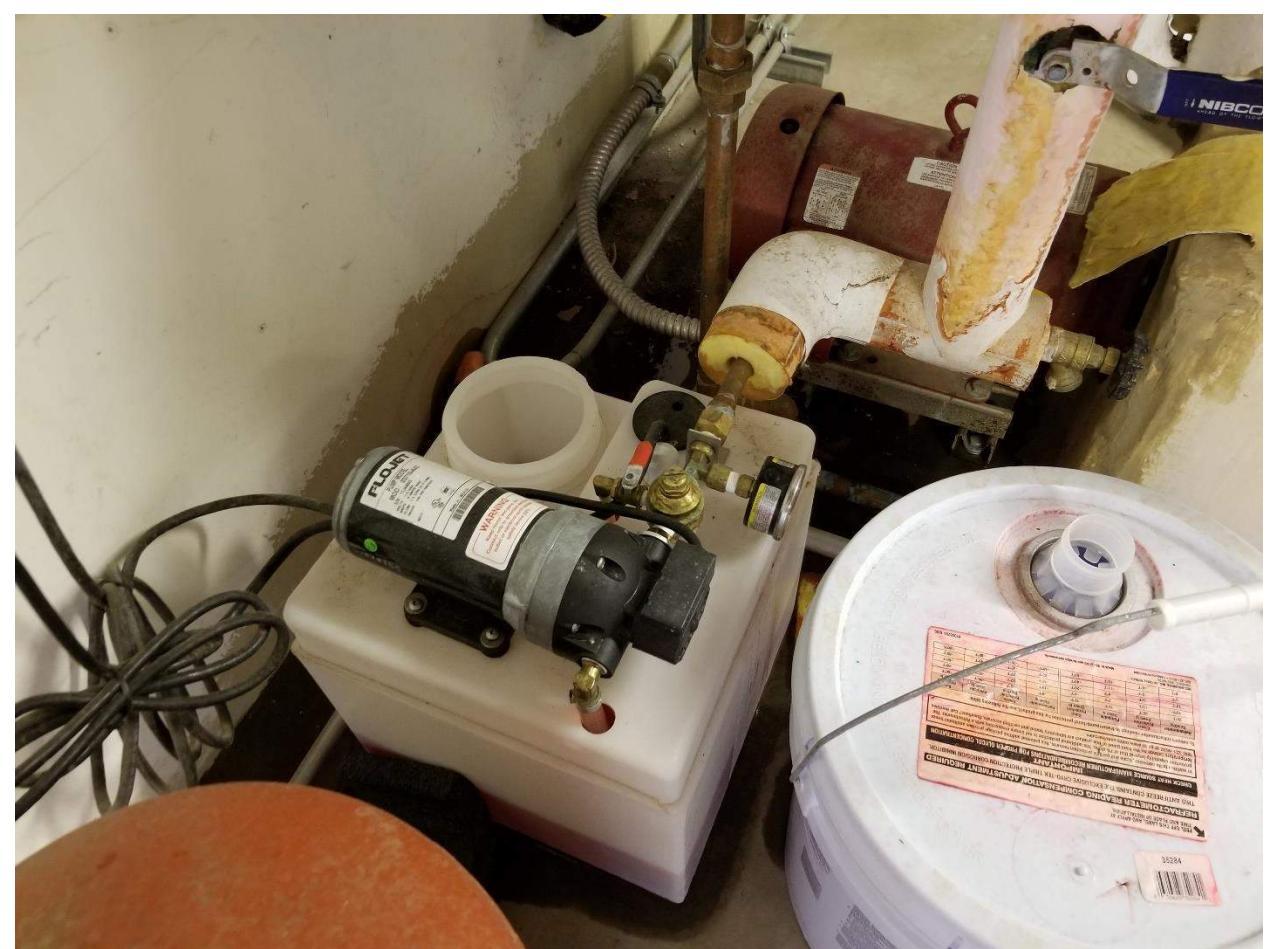
Figure 7 - Thaw/Tishman Chilled Water Pump and Water Treatment Pot Filler

- b. Pumps/Hydronic Operation: The existing chiller water circulation pump is a Bell & Gosset Model 8.75 BF, end suction, centrifugal pumps sized at 5 HP. These pumps were originally sized to provide 141 GPM at 75' of head.
  - Age: These were also installed after the original construction installation and are estimated to be approximately 11-13 years old. According to ASHRAE, the maximum serviceable lifespan of hydronic pumps is 20 years.

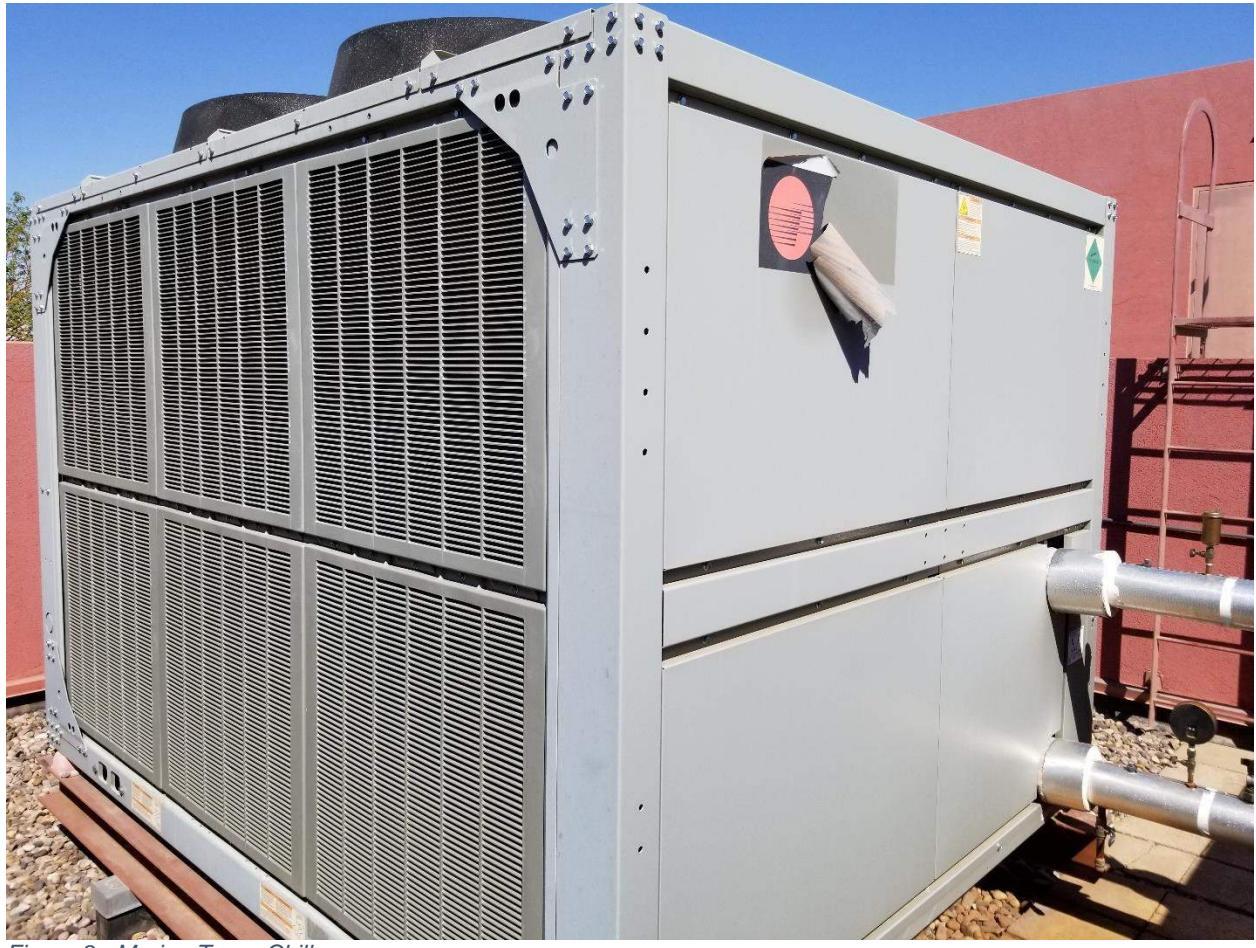
Figure 8 - Marion Trane Chiller

- (1) Age: The existing chiller was not part of the original construction. The original chiller from 1998 was an R-22, 30-ton chiller that was designed for only AHU-7. It is hard to determine the exact date of manufacturing, but the newer RTUs were manufactured in 2011 and the AHU-1 vertical air handler in Thaw/Tishman was manufactured in 2013. The age of this chiller is likely somewhere in that range which would put the age at 11-13 years old. According to the *American Society of Heating, Refrigerating and Air-Conditioning Engineers* or ASHRAE, the maximum serviceable lifespan of a chiller ranges between 20-23 years is 35 years. This is provided the chiller has been properly designed, installed and maintained, as well as no damage or unforeseen wear and tear has occurred throughout the chiller's lifespan.

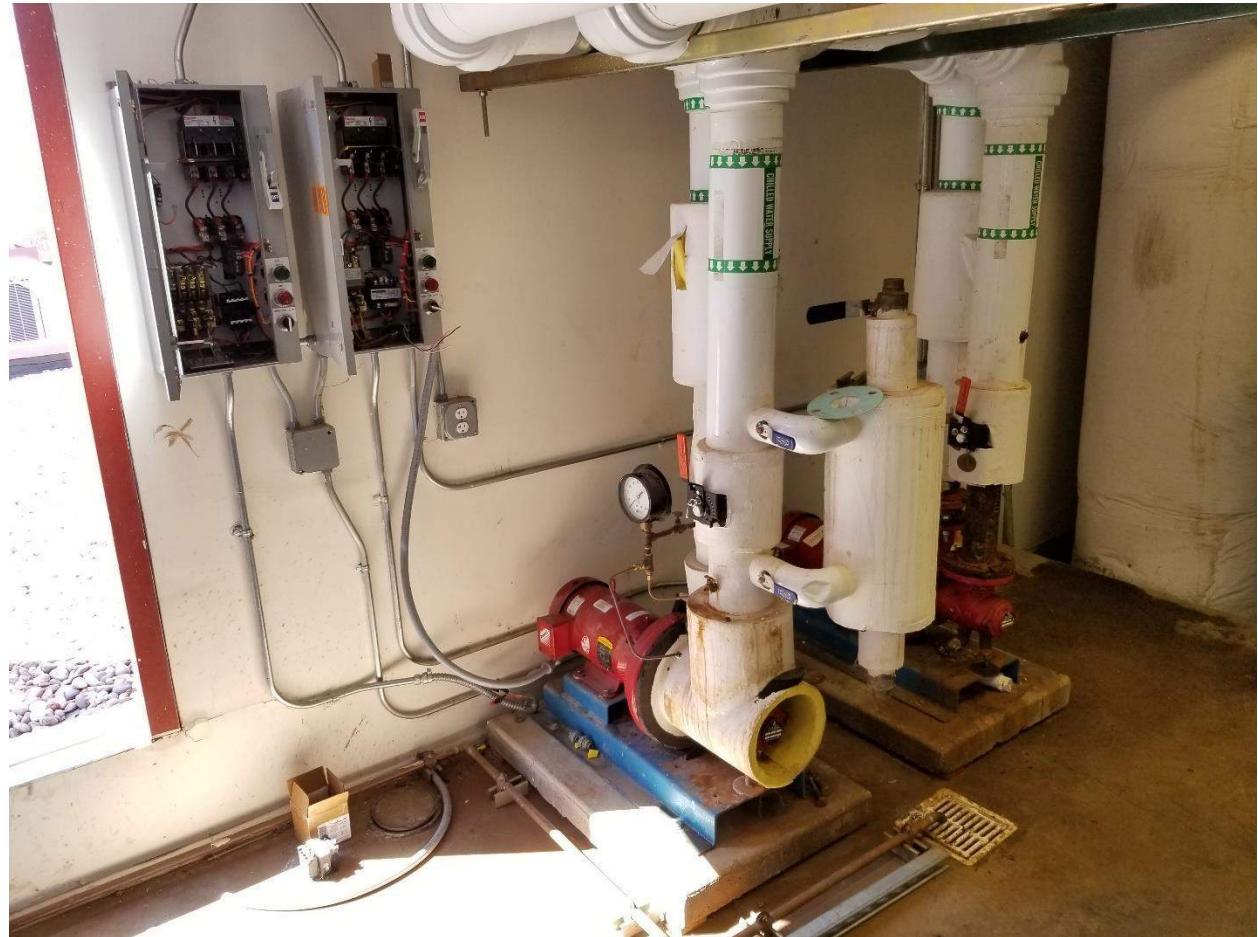
- Pumps/Hydronic Operation: The two (2) existing chiller water circulation pumps are Bell & Gosset Model 5.375 BF, end suction, centrifugal pumps sized at 5 HP. These pumps were originally sized to provide 121 GPM at 50' of head.
  - Age: These were also installed after the original construction installation and are estimated to be approximately 11-13 years old. According to ASHRAE, the maximum serviceable lifespan of hydronic pumps is 20 years.

Figure 9 - Marion Chilled Water Pumps and Open Disconnects/Starters

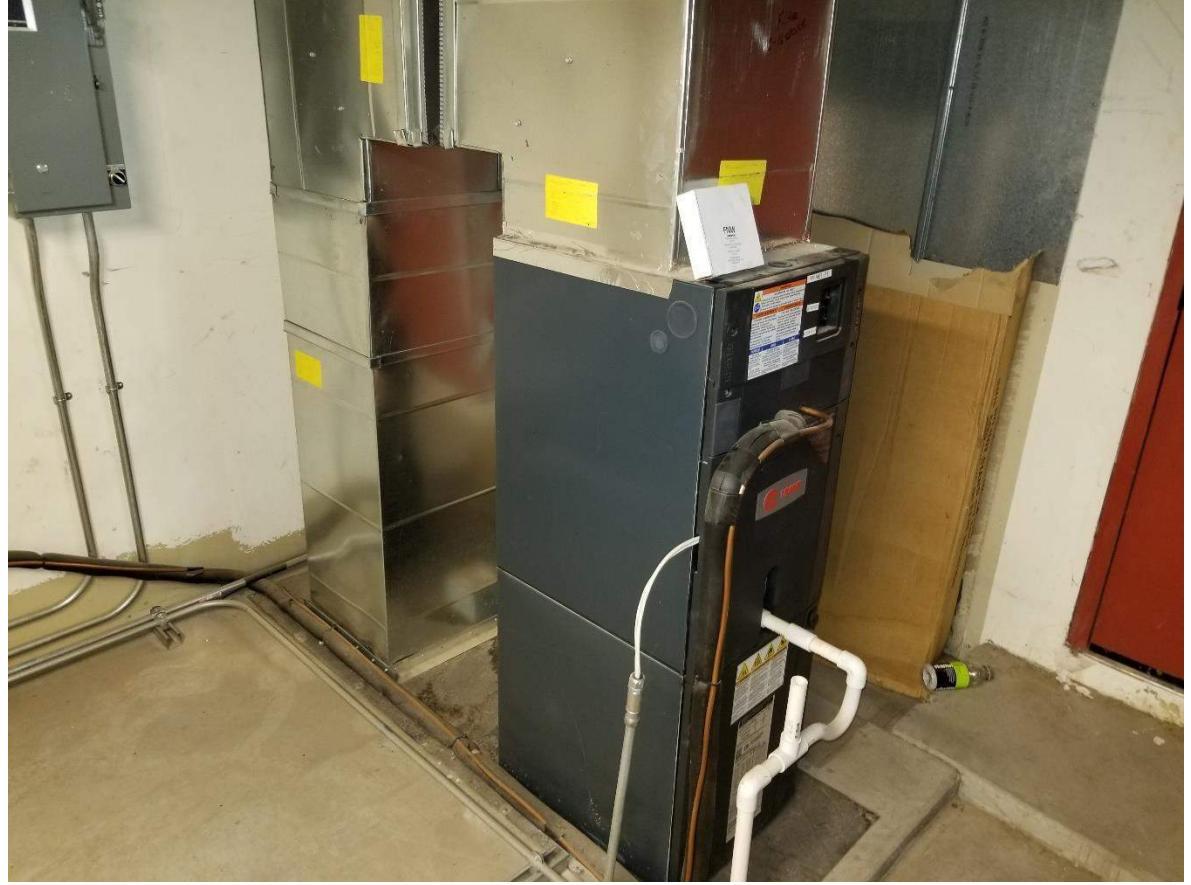
Figure 11 - AHU-1 Replacement Fan Coil

- b. This is no longer the case, as it appears AHU-1 was removed some time ago and replaced with a DX, refrigerated air, vertical modular fan coil with electric heat manufactured by Trane – Model# TAM4A0A36. This unit does not appear to incorporate outside air and serves areas previously identified as A.V. Equipment 115, Copy Stand 114, Visual Resource Library 116 and the central courtyard building previously identified as the Art History Research Library 111. These areas also include CAVs with reheat coils for heating.

- (2) Age:
  - (a.) This particular unit has been manufactured since 2016 and is relatively new putting it at approximately 6 years old.
     According to ASHRAE, the maximum serviceable lifespan of a DX cooling coil is 20 years and the maximum serviceable lifespan of a centrifugal fan is 25 years.
- (3) Condition/History:
  - (a.) The unit appears to be in good condition. It is unknown how well it has been maintained. The liquid piping is uninsulated.

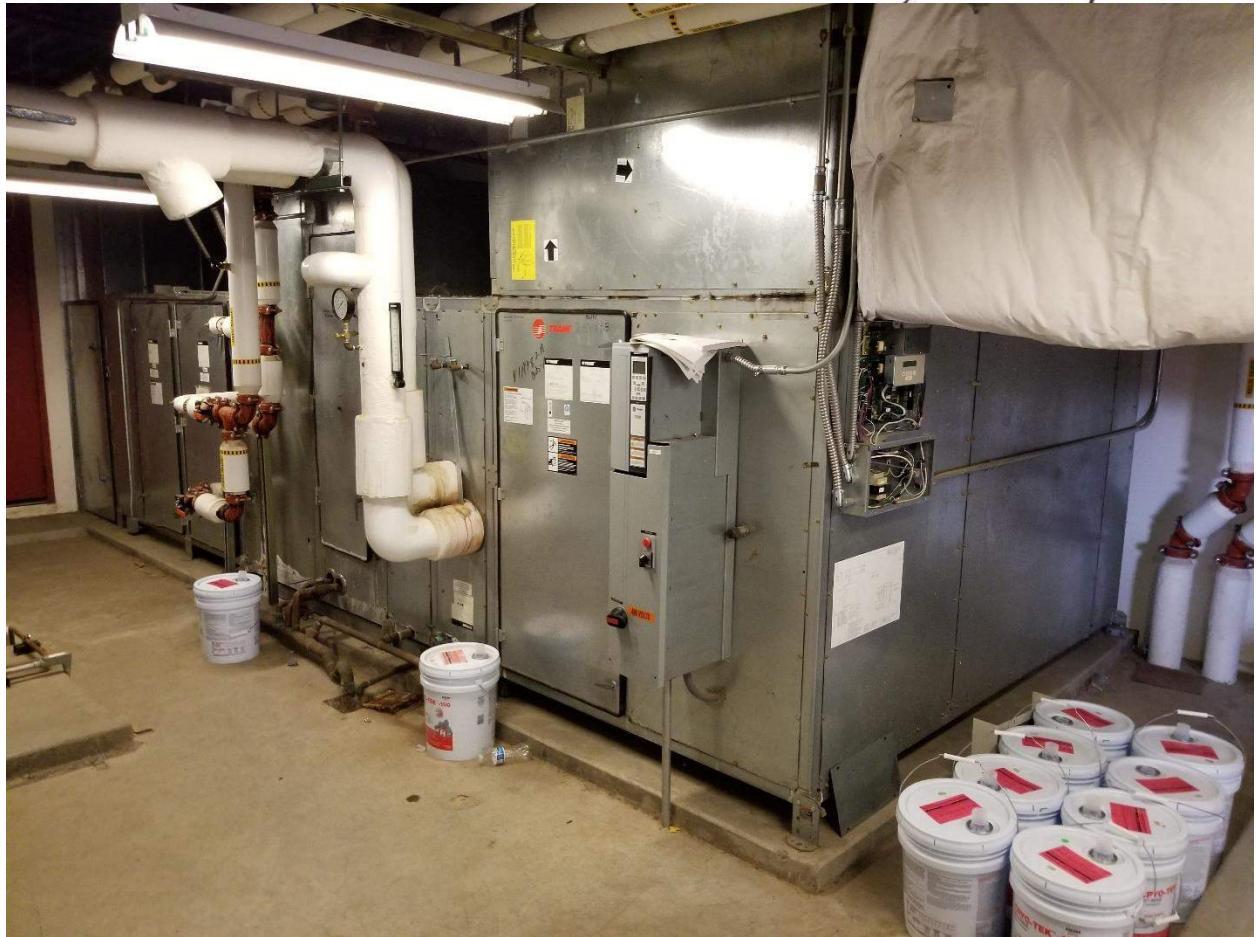
Figure 12 - AHU-2

- (1) Age:
  - (a.) The existing AHU is from the original construction, which would make it approximately 25 years old. According to ASHRAE, the maximum serviceable lifespan of a built-up air handler varies, as there are many components. The coils are typically good if well maintained up to 20 years, while the centrifugal fans typically have a maximum serviceable life of 25 years. This is provided the AHU has been properly installed and maintained, as well as no damage or unforeseen wear and tear has occurred throughout the AHU's lifespan.

- (2) Condition/History:
  - (a.) AHU-2 appears to be well maintained, given that it is 25 years old. The old air washer section shows some water damage and rust, but this can be easily repaired. The heating coil is original and has some corrosion issues near the bottom of the coil, likely from being exposed to the excess moisture from the old air washer. The cooling coil appears to be in great condition, likely because it is much newer than the heating coil. The unit was not running at the time of observation, so it is unknown if the supply fan is in good working condition, but upon visual inspection it appeared to be in moderate condition, while the motor looked to be in good condition and more recently replaced (+/- 5-10 years). The size of the currently installed motor (20 HP) is less than what was originally designed: 20 HP. See more on this in the recommendations section of the report.

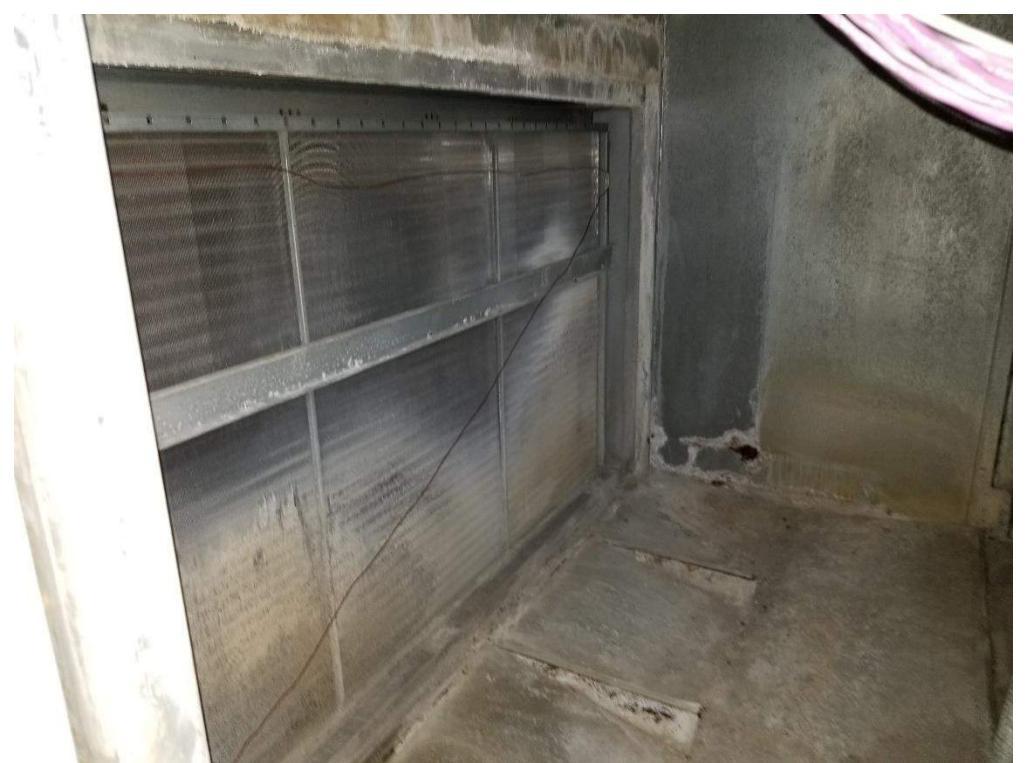
Figure 15 - AHU-2 Heating Coil and Air Washer Damage to Pan and Coil

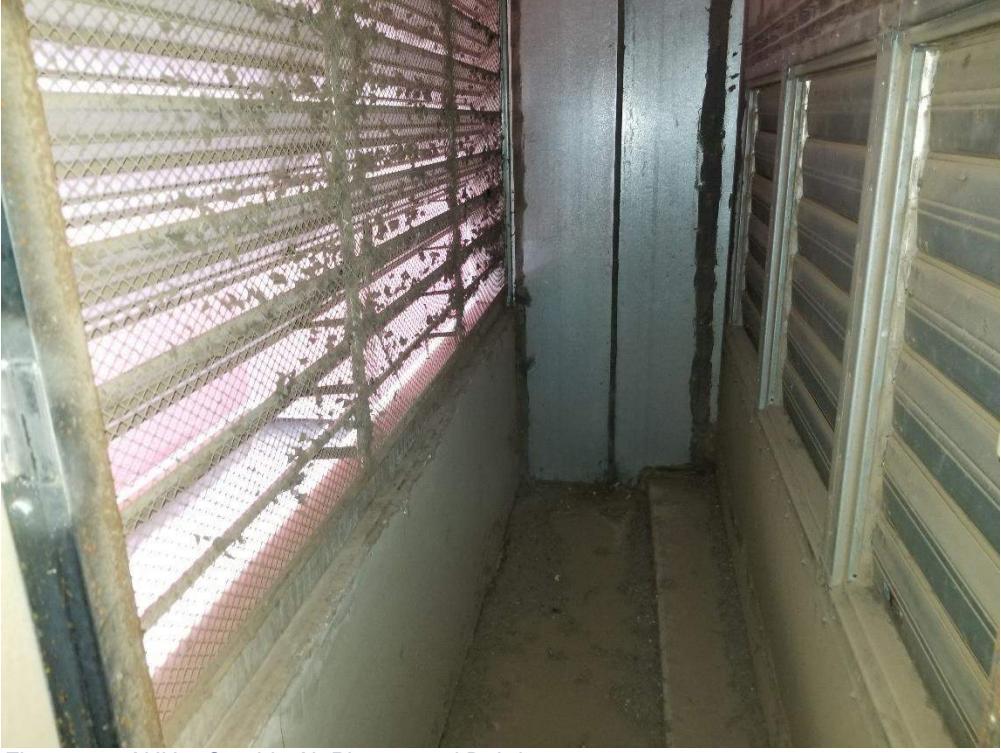
Figure 19 - AHU-2 Outside Air Plenum and Debris

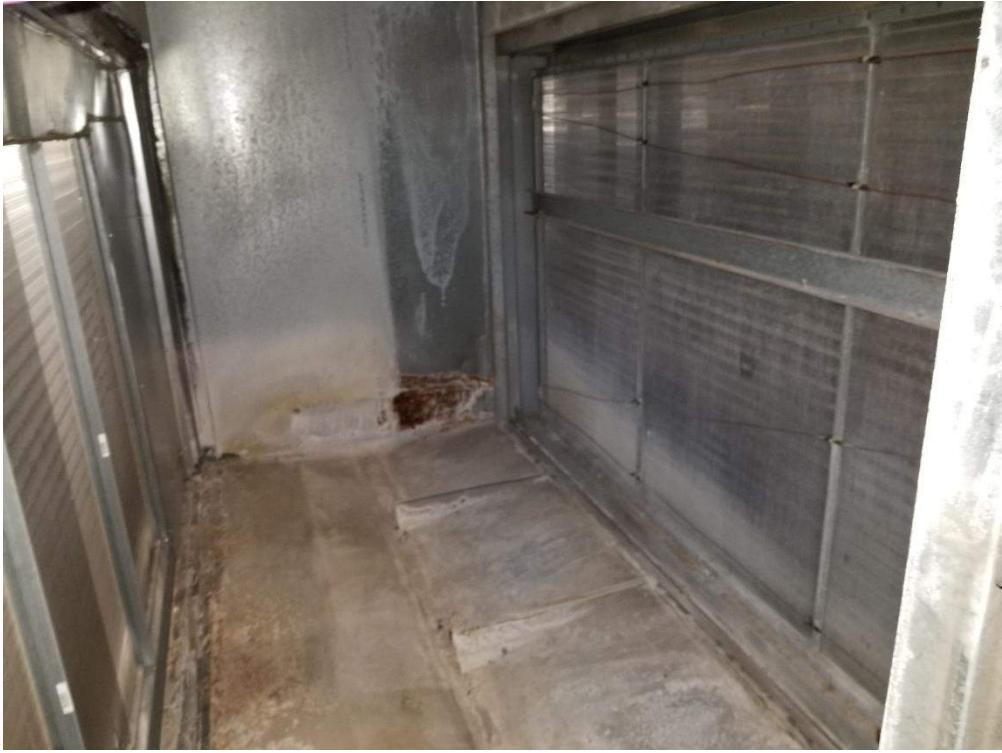
Figure 23 - AHU-3 Air Washer Water Damage

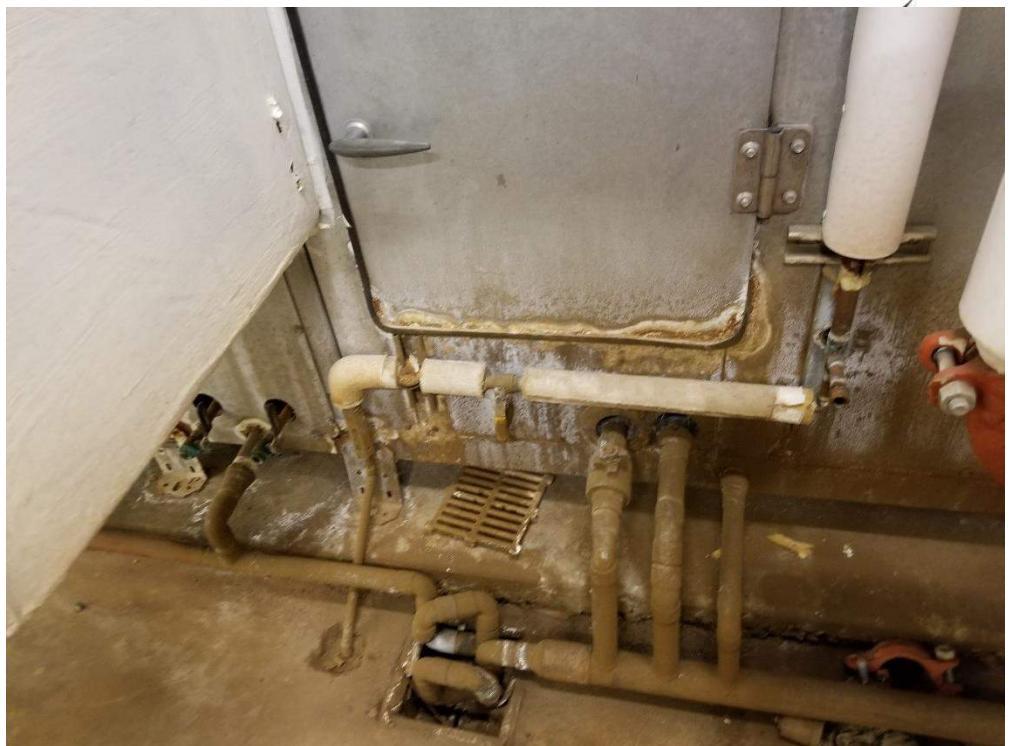
Figure 24 - AHU-3 Cabinet and Door Corrosion

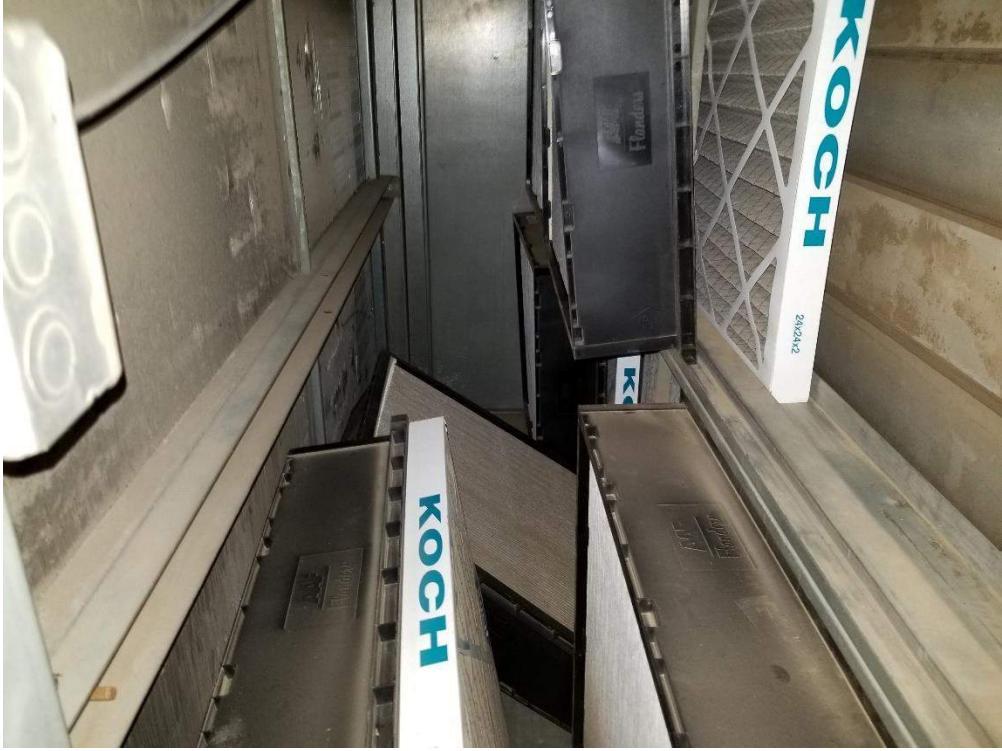
Figure 28 – AHU-6 Filter Section and Dirty Backside of Heating Coil

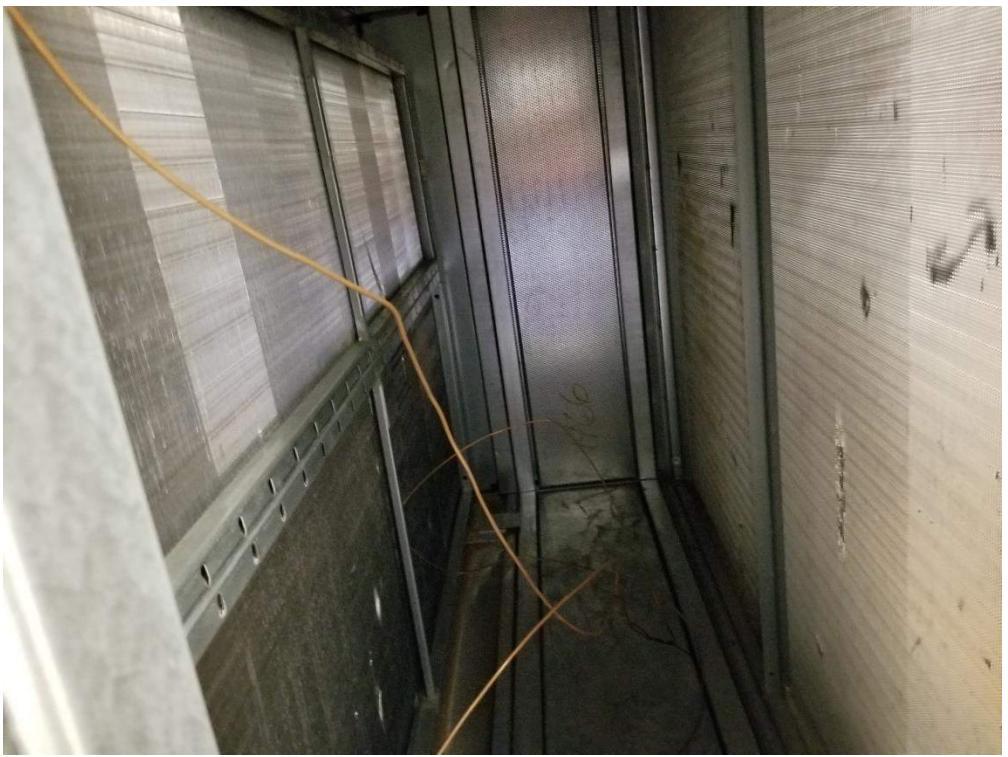
Figure 32 - AHU-7 Coils with Loose Sensor Wiring
