# FACILITY ASSESSMENT REPORT

**Visual Arts Center**

January 4, 2023

January 4, 2023 WCI Project #: 21-600-030-10

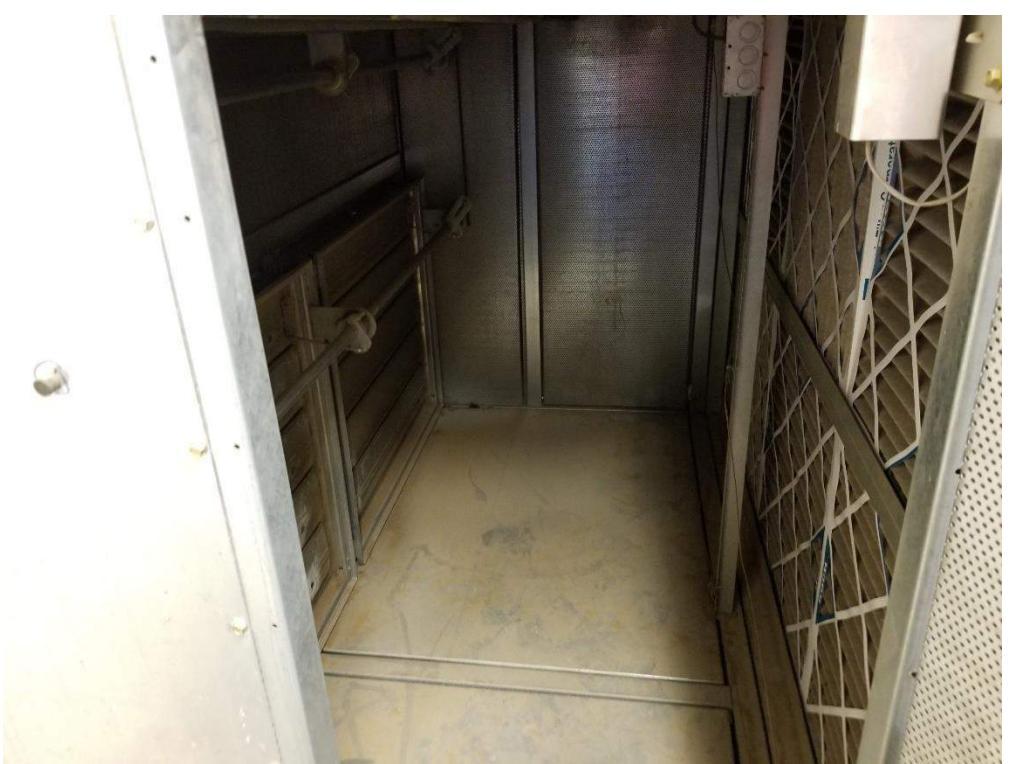
- (2) Condition/History:
  - (a.) AHU-7 appears to be in good condition. The heating coil is original appears to be in good condition but needs to be cleaned as it appears the unit was in operation with dirty or compromised filters. The cooling coil appears to be in great condition but also needs to be cleaned due to dust/dirt carry-over. Temperature sensors and freeze stat wiring was compromised and needs to be replaced. The mixed air/outside air dampers have an actuator with exposed wiring and likely a faulty actuator. An electrical junction box on the exterior of the unit was open with wires exposed. The unit was not running at the time of observation, so it is unknown if the supply fan is in good working condition. The motor looked to be in good condition and replaced in the past 5-10 years. The filters were dirty and in need of replacement.

Figure 33 - AHU-7 Dirty Filters

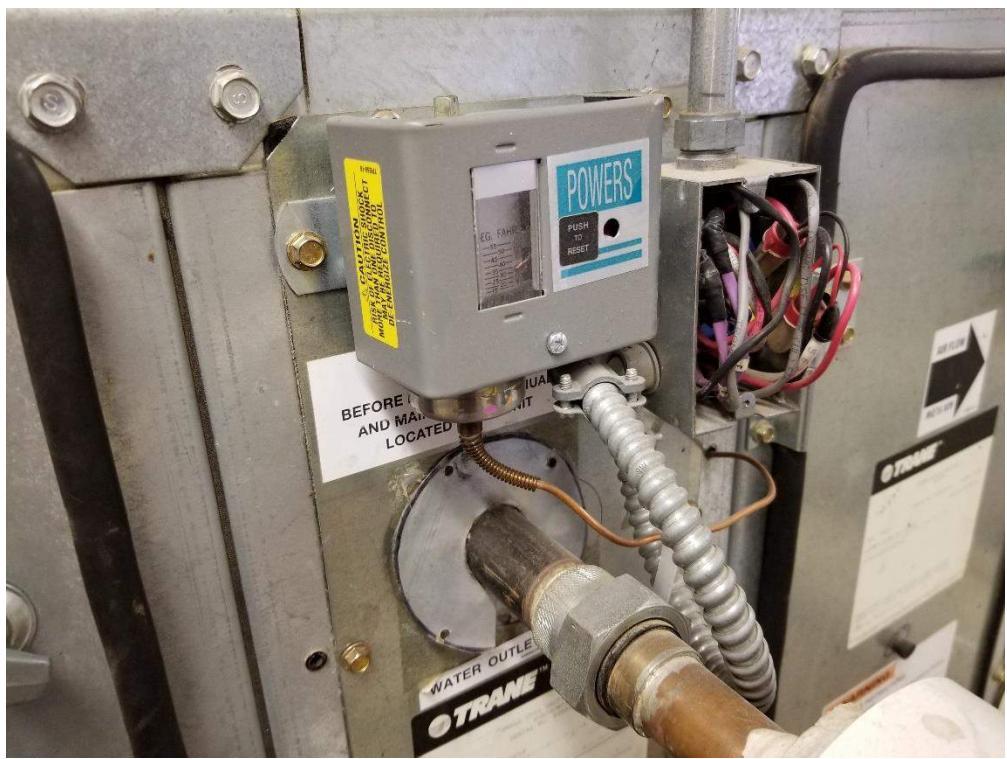
Figure 35- AHU-7 Open J-Box

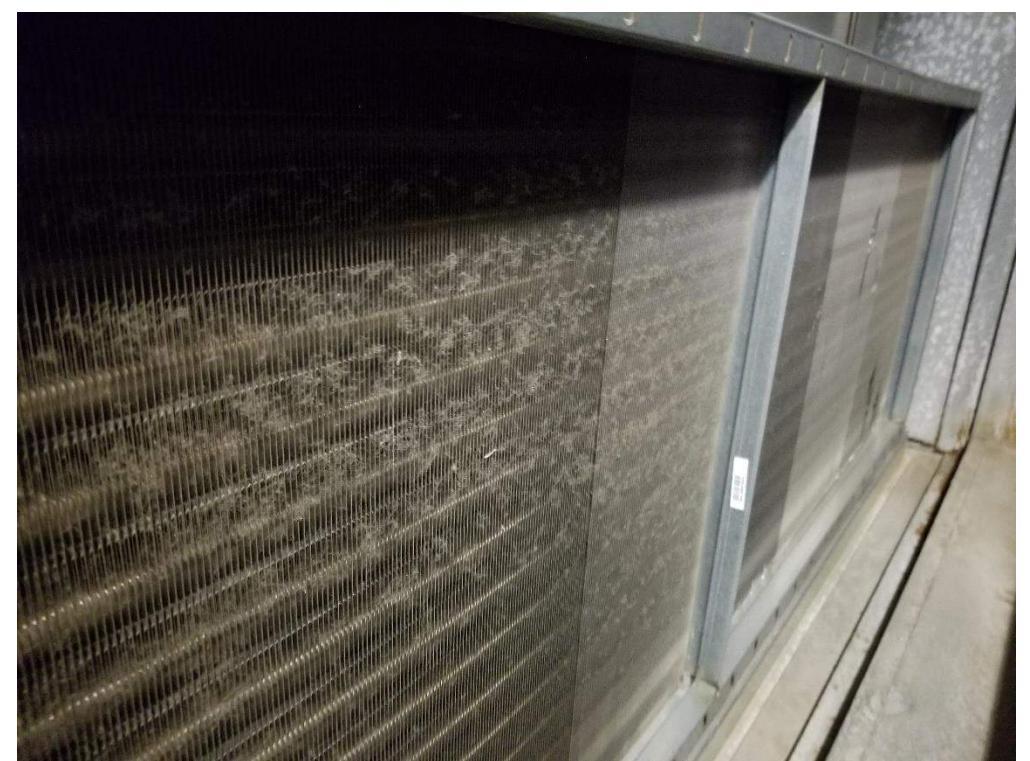
Figure 36 - AHU-7 Dirty Coil
