# FACILITY ASSESSMENT REPORT

**Benildus Hall**

# FACILITY ASSESSMENT REPORT BENILDUS HALL

January 11, 2023 WCI Project #: 21-600-030-10

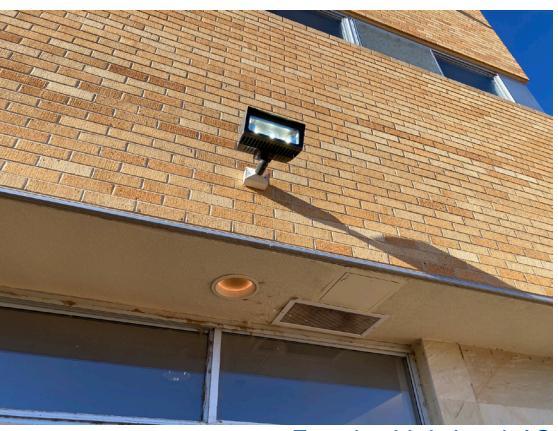
Exterior Lighting | A3

Site lighting is poor and consists of few pole-mounted downlights near the paths around the building, and exterior building sconces and canlights under soffits (A3).

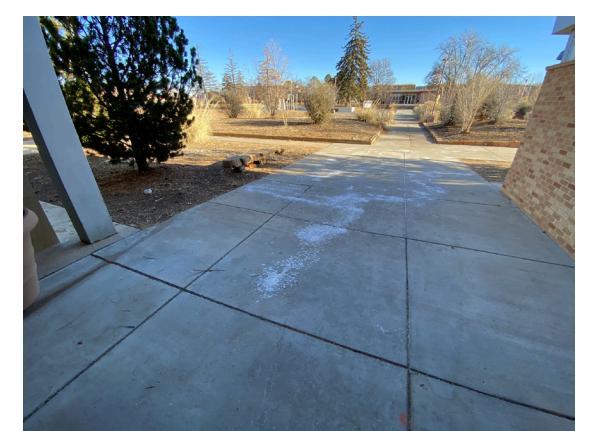
Concrete sidewalks, ramps and stairs around the site range from acceptable to poor condition (A4). The concrete at the main entrance has some grading issues that cause pooling of water which freezes. This is a safety concern.

Exterior grading at main entrance | A4

- Repair/replace the grading in front of the main entrance.
- Landscaping should be addressed by a professional landscaper.

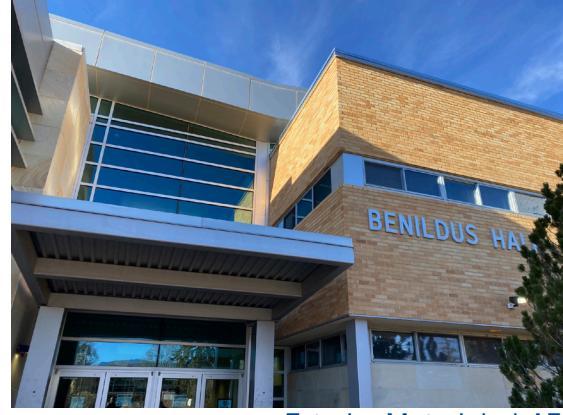
The exterior walls are metal studs with concrete, brick and metal panel cladding on a slab-on-grade foundation. The walls are in good condition, but may have inadequate insulation. (A5)

Exterior Materials | A5

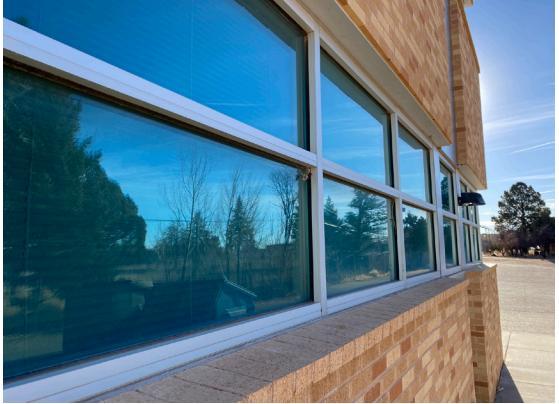
The windows need to be cleaned. There is no visual evidence of window flashing to prevent water from getting inside the building. The original construction documents show the windows as 1" insulated glazing, however proper flashing could not be determined (A6).

Exterior Windows | A6

- Replace missing splash blocks.
- A full roof inspection by a licensed roofing contractor is recommended to verify the estimated life left in the current roofing system. Inspect all flashings and sealants on the roof and repair as necessary.
- Add sealant to all pipe openings
- Inspect and repair sealants at exterior openings and glazing.

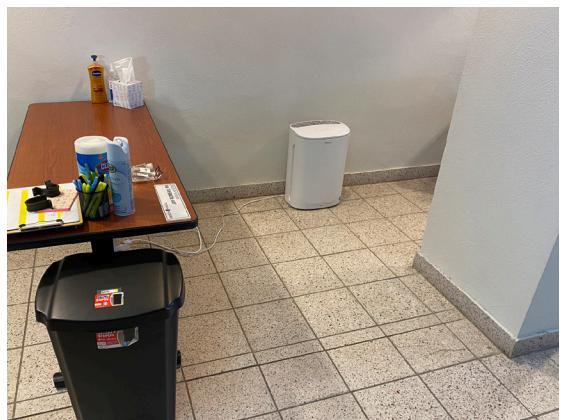
**Ceramic Tile:** Located at the main floor lobbies, atrium, restrooms and the middle of the second floor corridor. The tile is 1'x1' and is in acceptable condition, with the exception of tiles near expansion joints. (A9 & A10)

Ceramic tile damage at expansion joint | A9

- Patch/repair or replace broken ceramic floor tiles at expansion joints. Consider using a different floor material to allow for expansion and contraction
- Replace stained acoustic tiles after inspecting the fire suppression system for leaks and evaluate it for code compliance.
- Move the large/high value items (i.e. pianos and sound systems) to a proper storage facility.

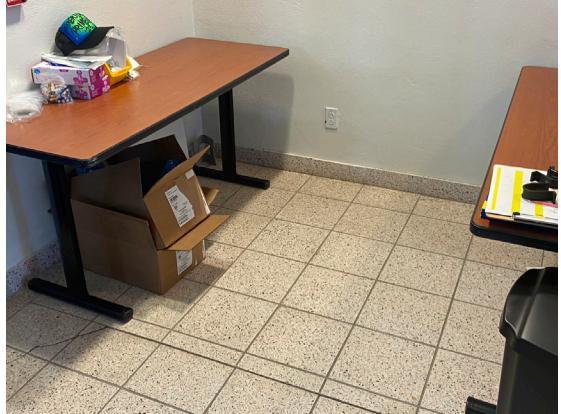
Ceramic tile damage at expansion joint | A10

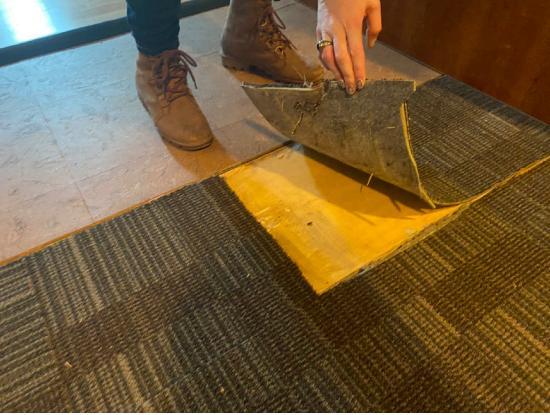
**Carpet Tile:** Located in classroom spaces & offices. Overall, the carpet is in acceptable condition. The carpet tile used in the recording studio is not properly attached to the plywood. (A11)

Carpet tile over plywood not secure | A11

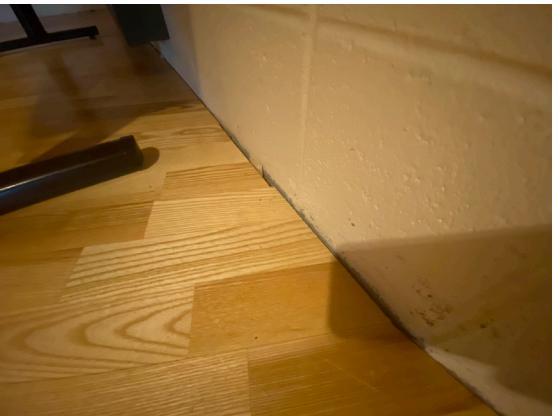
**Wood planks over plywood:** Located in the recording studio and although it is in good condition, the flooring transitions are done poorly, and need wall trim at the perimeter. (A12)

Wood flooring without baseboard | A12

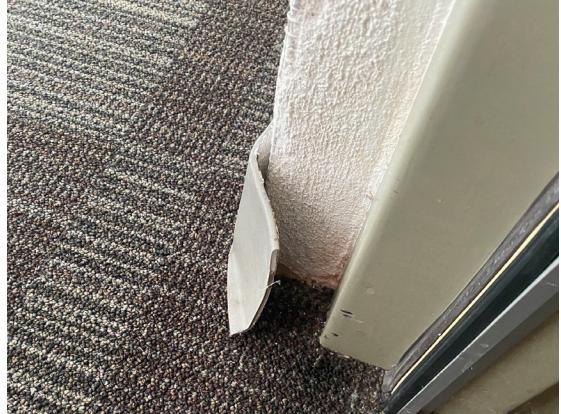
The majority of the first floor partitions are a combination of CMU and/or textured/painted gypsum board. While the majority of second floor is also textured/painted gypsum. Overall, the interior partition walls are in good to acceptable condition. Some vinyl base is not secure. (A13)

Detached vinyl base | A13

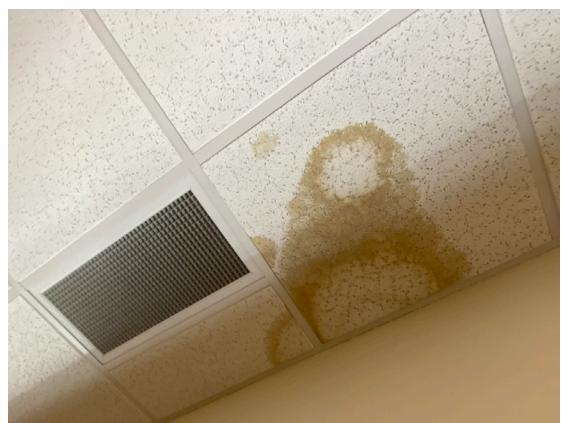
Acoustic Ceiling Tiles Both decorative wood and typical ceiling tiles are used through the majority of the facility. The decorative wood ACT is being used in the garage/bump out and the lobby. There are many instances of the typical ACT that is damaged, most likely from a mechanical, plumbing, or roof system leak. (A14) Otherwise, these ceilings appear to be in acceptable to good condition.

Acoustic ceiling tile stainaige | A14

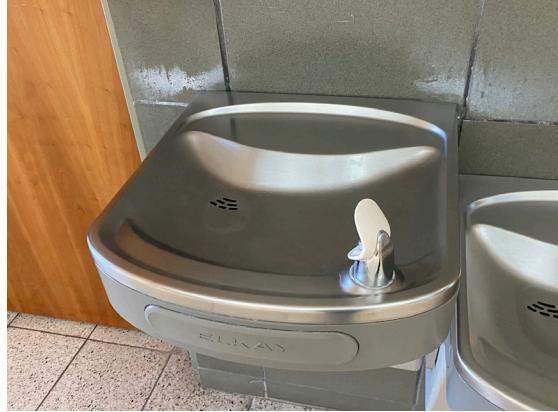
Two water fountains are present in the main atrium on both the 1st and second floor. They appear to be ADA compliant, wheelchair height fixture with a manual front button. They have poor finishes on the wall to prevent efflorescence. (A18)

Efluenscense behind drinking fountain | A18

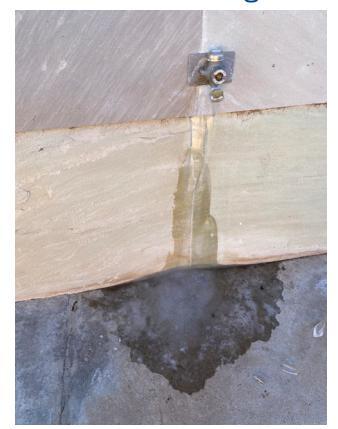
One water connection located in the exterior wall on the Northwest side of the facility shows some evidence of leaking (A24).

Exterior leaking Spiggot | A19

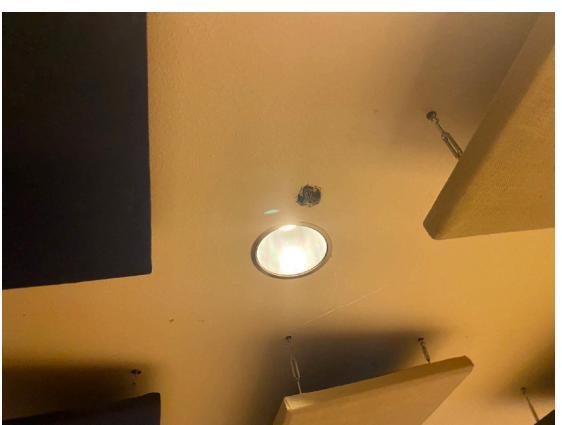
There is a fire suppression sprinkler system installed in the building, and it's likely to be a dry-pipe system. The staining to some of the acoustic ceiling tiles may be evidence of leaking. There are some missing escutcheon covers. (A22)

Missing eschutcheon cover | A20

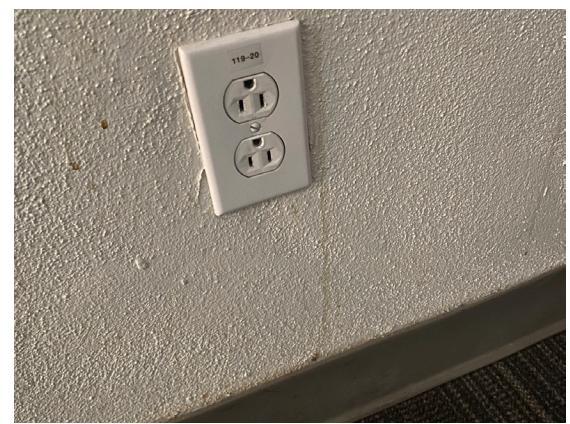
Many outlets did not have proper covers to hide the wall finish and junction box. On the first floor corridor there appears to be a water stain dripping from the outlet. This can be an indication of water in

the wall. It may be worth looking into it's cause. (A25) A majority of the classrooms and offices had wiring extending from holes and broken ceiling tiles to utilizing the old clock outlets. (A26 & A27)

Water stain near outlet | A25

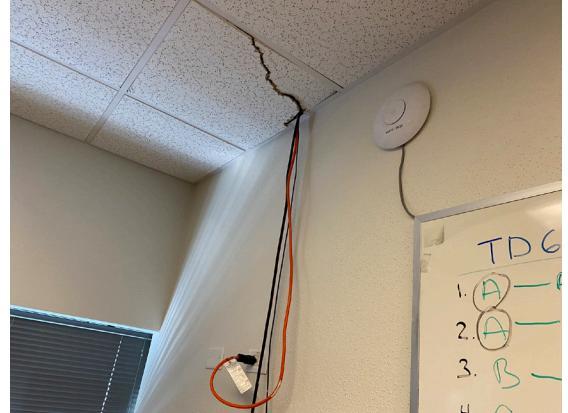
Chords through cracked ACT tile | A26

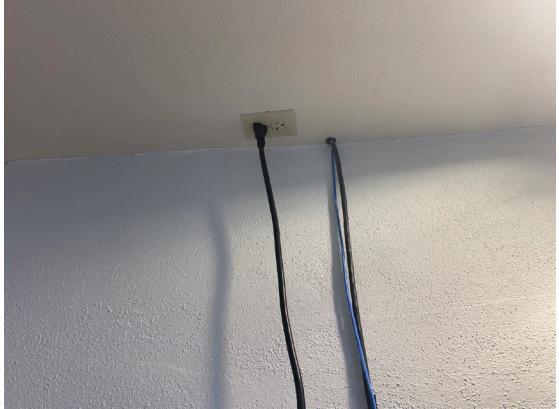
Chord hole in gypsum ceiling | A27

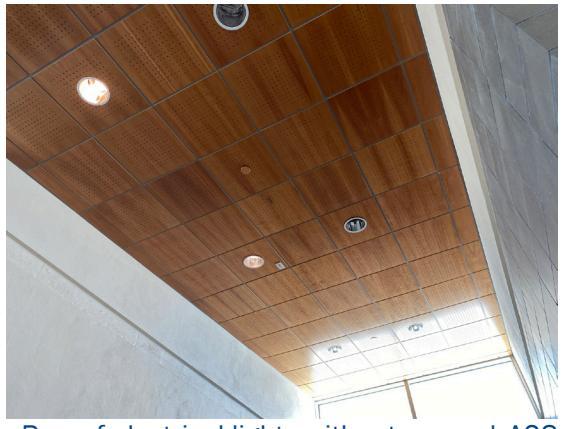
The facility is illuminated with a mixture of lighting technologies, though fluorescent is most common. The fixtures appear to be in acceptable condition overall. There was one row of lights without power at the second floor of the atrium. (A28) The fixture types are as follows:

Row of electrical lights without power | A28

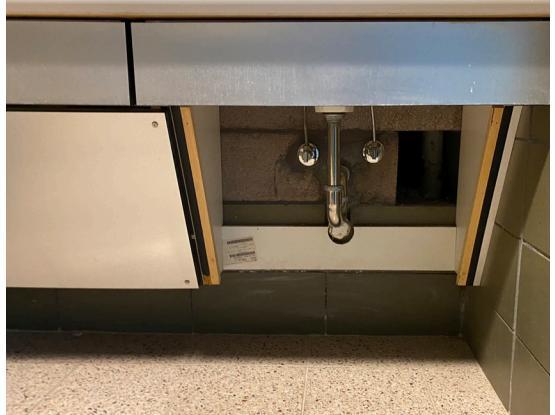
Missing ADA Apron | A30

- Consider adding an additional handrail to the Accessible ramp (A29)
- All hot and cold water pipes need to be insulated or covered with an appropriately angled ADA apron. (A30)
- Continuous cane detection is needed under the stairs. (A31)
- Move accessible hold-open door hardware to a safer more and more convenient location. (A32)

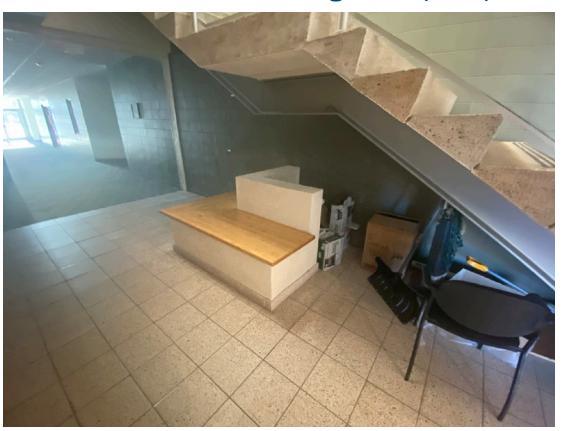
Cane Detection | A31

There are four stairwells leading from the first floor up to the second floor and include a landing. These stairs are concrete and in good condition. The main lobby stair appears to have a bench as cane detection, but was not built to be continuous.

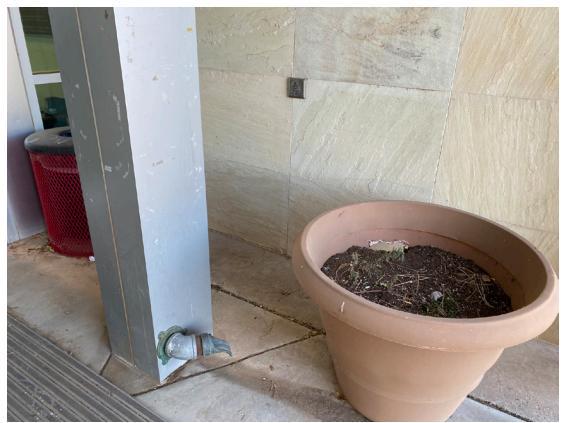
ADA door hold-open hardware | A32

There are a few external drain spouts around the building, many of which do not have a splash block present, and potentially others that are terminating underground. It is advised to be cautious about sink holes if the pipes break. An external drain at the main entrances is running through a column and allowing water to drain in front of the hold-open accessible door hardware.
