## INTERSECTION EVALUATION AND METHODOLOGY

## Intersection Rating

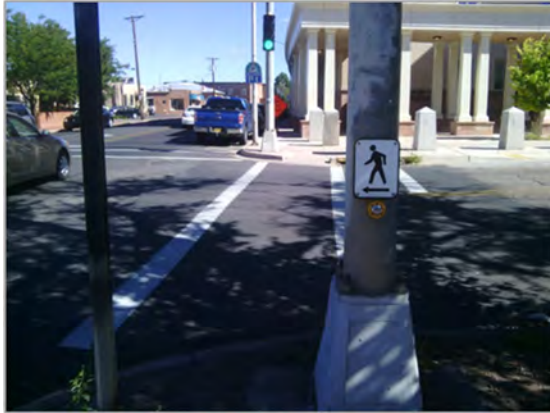
**Figure 2-22: Missing Curb Ramp**

An intersection segment that lacks one or more curb ramps is non-compliant and non-functional for persons in wheelchairs. The curb acts as both an extreme example of a vertical discontinuity and as an obstruction to a continuous sidewalk. Of the 4,810 intersections surveyed, 1,288 (26.8%) do not have a curb ramp connection. Examples of intersections lacking curb ramp connections are shown in Figures 2-22 and 2-23.

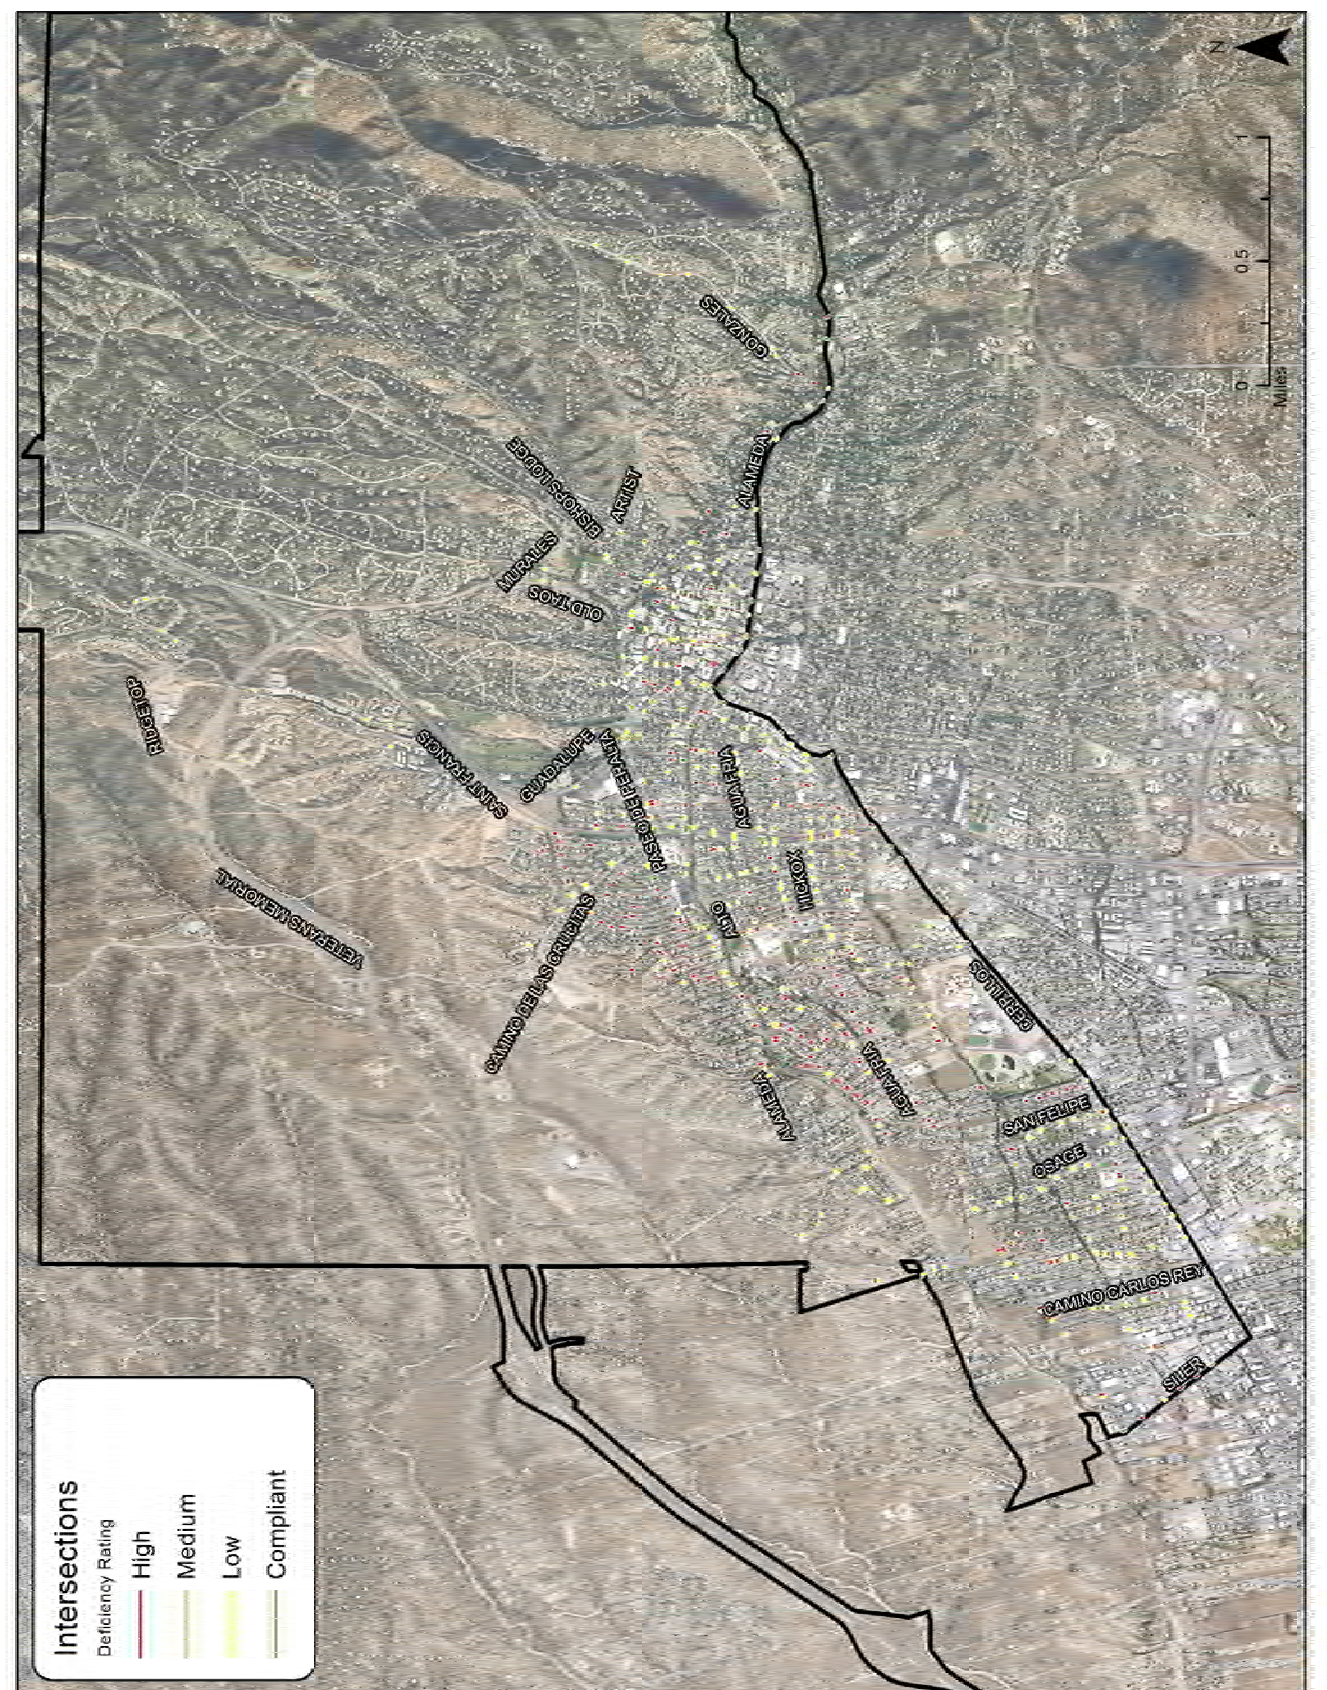
**Figure 2-26: City Council District 1 Intersection Summary Map**

District 1 contains the highest percentage of high priority intersections (32.1%). Many of which are located along Agua Fria Street, Alameda Street, and the neighborhoods to the west of St. Francis Drive and north of Alameda Street. Medium and low priority intersections are fairly dispersed throughout the area. Compliant intersections are primarily found in the downtown area and along St. Francis Drive. As seen in Figure 2-24, the overall condition of intersections in District 1 is varied with a large percentage falling into the high and medium

priority categories. Figure 2-26 displays the location of intersections within District 1 and their priority level.
