#### PEDESTRIAN WALK QUALITY

# GREEN INFRASTRUCTURE (GI) OPPORTUNITIES

## PEDESTRIAN CROSSING OPPORTUNITIES

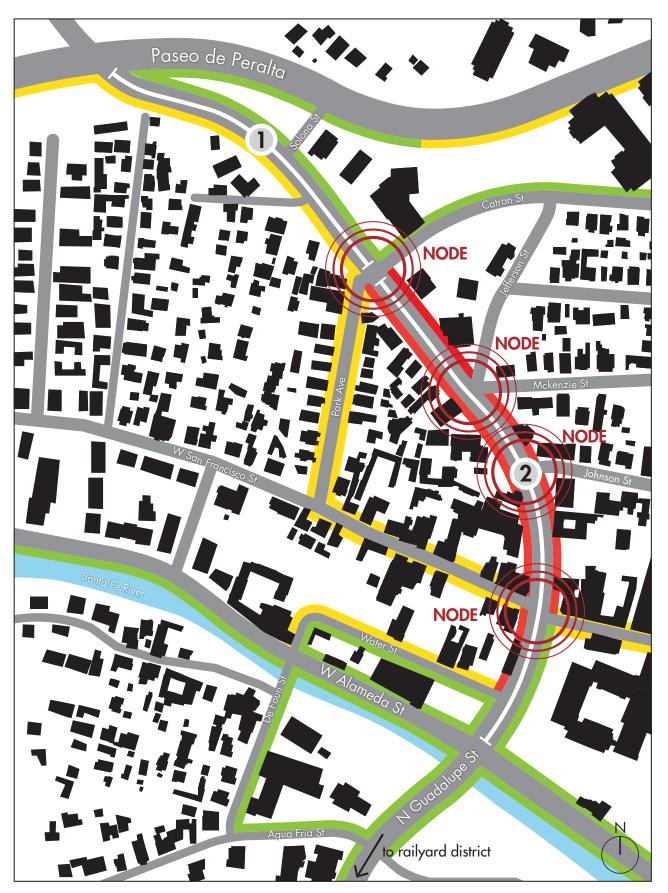
- Good | Wide sidewalk, buffer from vehicular traffic, no impediments
- **Fair** | Moderate width, average surface quality, infrequent impediments. Meets but does not exceed ADA requirements.
- **Poor** I Narrow sidewalk, frequent impediments (poles, signs, cables), uneven walking surface, no buffer from vehicular traffic. Does not meet ADA requirements.

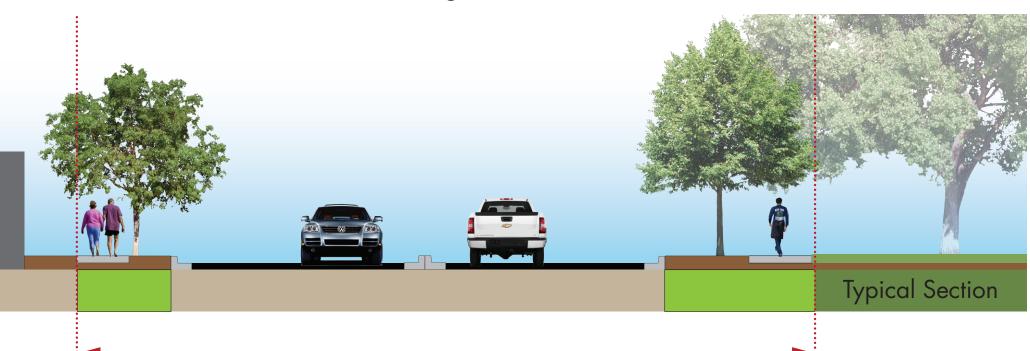
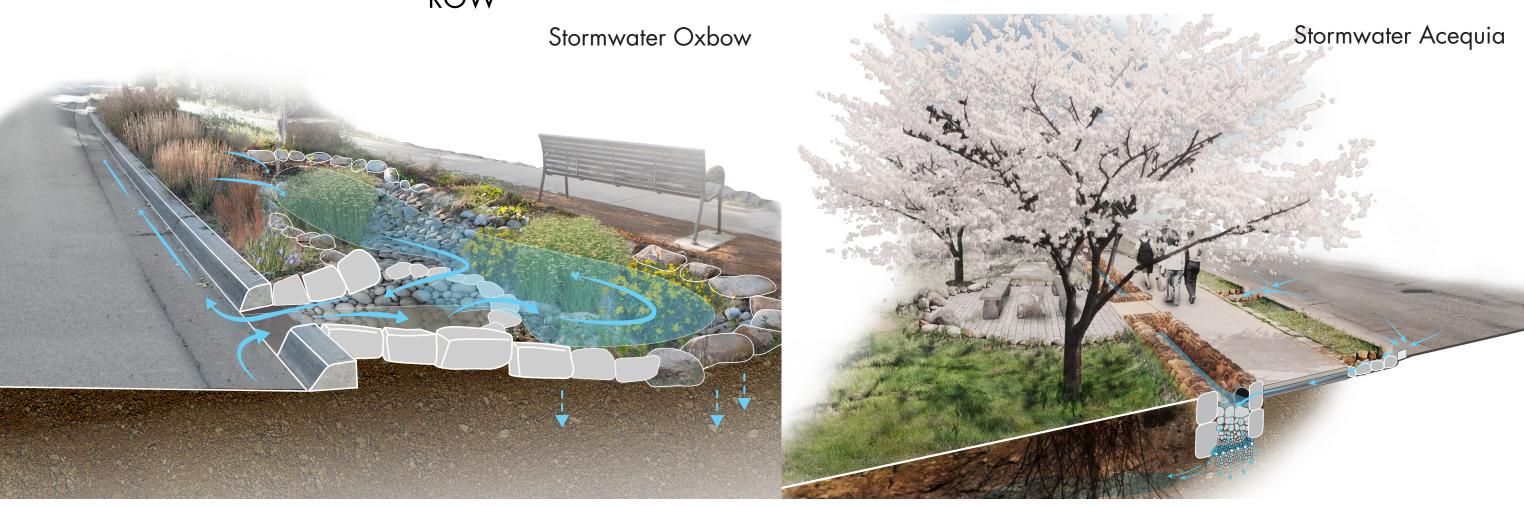
#### Agua Fria to W San Francisco

The narrow right-of-way (ROW) but ample space along the edges of the street create opportunities for Green Infrastructure such as Stormwater Oxbow infiltration basins and Stormwater Acequias.

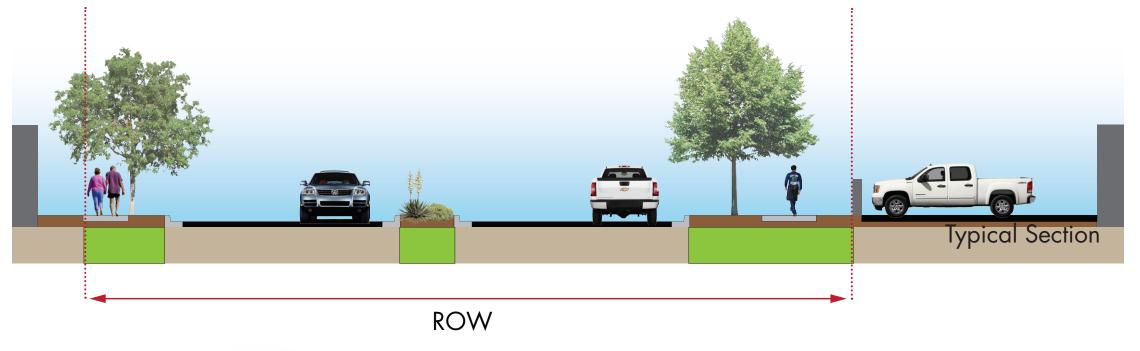
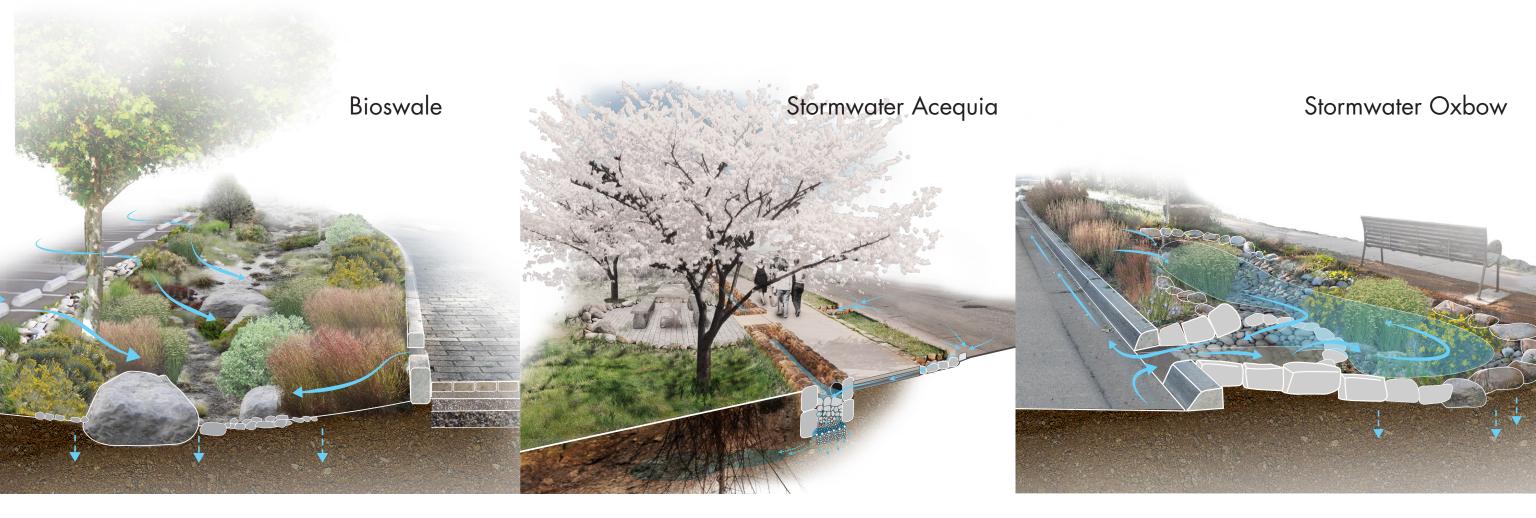
#### Catron St to Paseo de Peralta

The relatively broad ROW with ample space at the median and along the edges allows for a mix of potential Green Infrastructure. Opportunities include Bio-Retention Swales, Stormwater Acequias, and Oxbow infiltration basins.

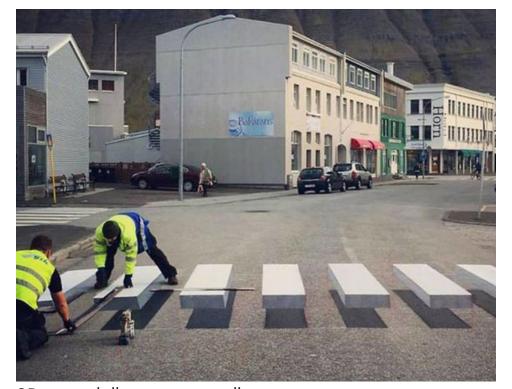
3D optical illusion crosswalk

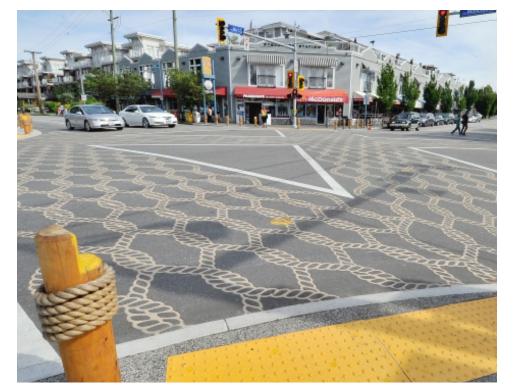
Imprinted asphalt pattern crosswalk

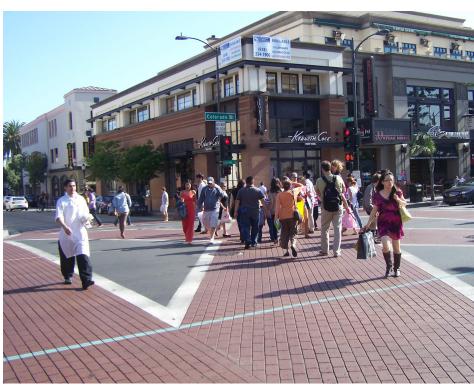
Brick crosswalk

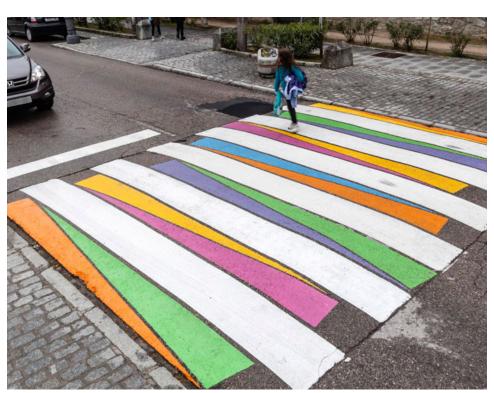
Vibrant, graphic crosswalk

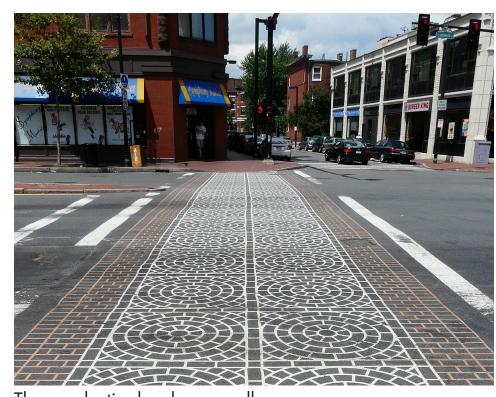
Thermoplastic decal crosswalk

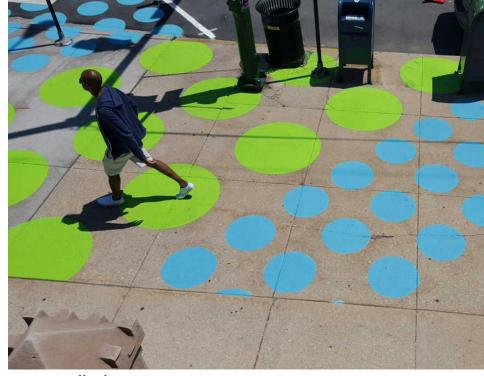
Crosswalk dots

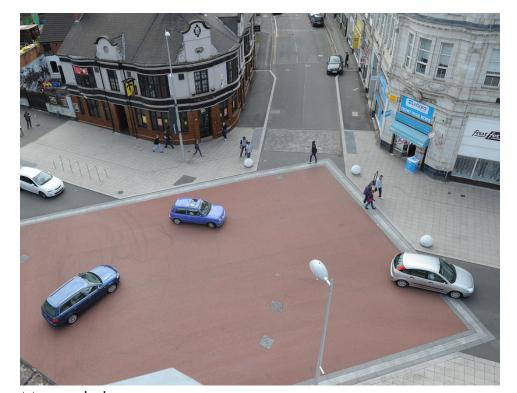
Material change at intersection

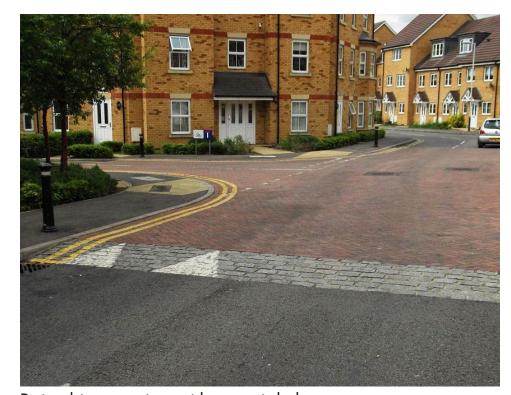
Raised intersection with material change

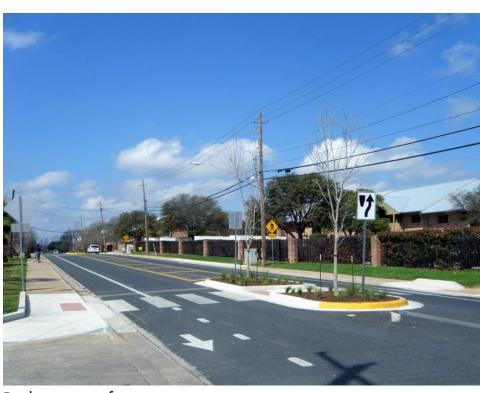
Pedestrian refuge at crossing

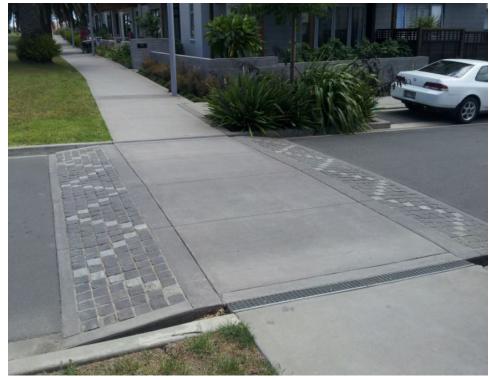
Raised pedestrian walk

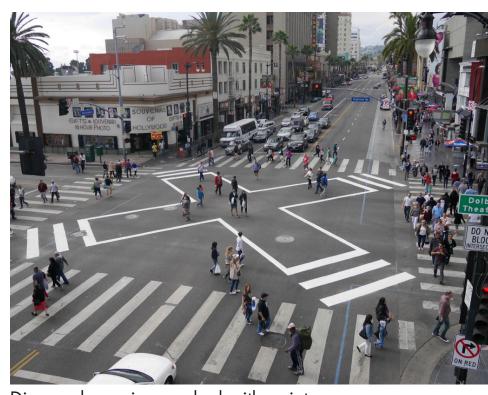
Diagonal crossing marked with paint

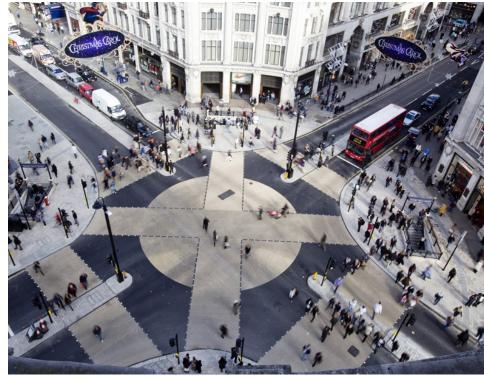
Diagonal crossing with material changes
