**St. Michael's Drive (NM 466) &
NM Rail Runner Crossing (NMRX) / Santa Fe Rail Trail Crossing
Roadside Safety Audit (RSA)
FINAL REPORT**

September 2014

Souder, Miller & Associates
Engineering • Environmental • Surveying

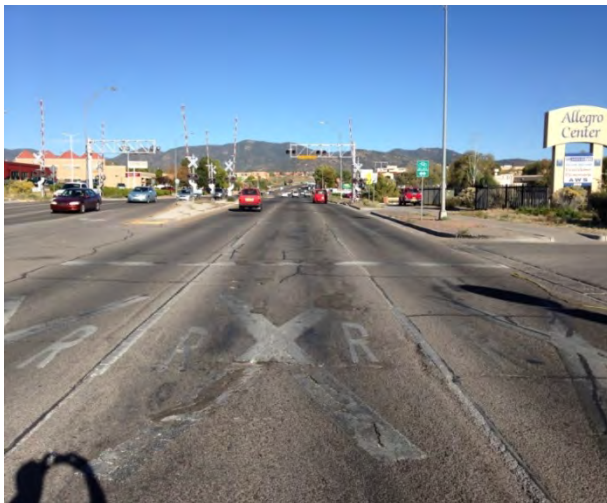
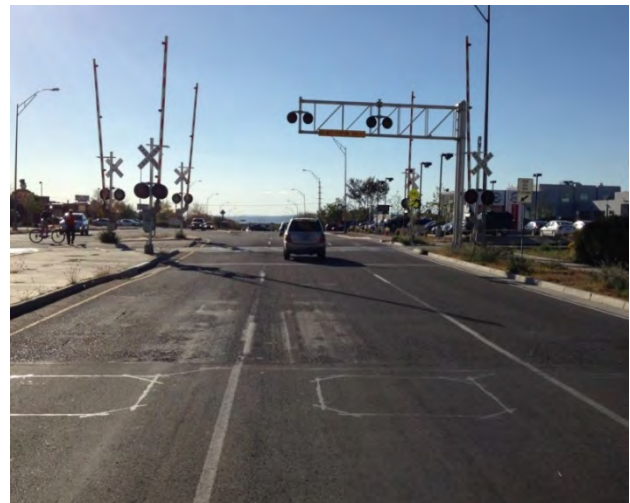
**Figure 2.1
St. Michael's Drive Existing Typical Sections**

Within the study area, St. Michael's Drive is a six-lane facility and approximately 130' in width (back of sidewalk to back of sidewalk based on field measurements) consisting of 6-12' driving lanes (3 lanes in each direction), 24' raised median separating east/west bound lanes, 24" curb/gutter, 8' landscaped area (8') and 6' sidewalks. Posted speed limit is 40 mph within the project area.

**Eastbound St. Michael's Drive
Approaching NMRX Crossing**

**Westbound St. Michael's Drive
Approaching NMRX Crossing**

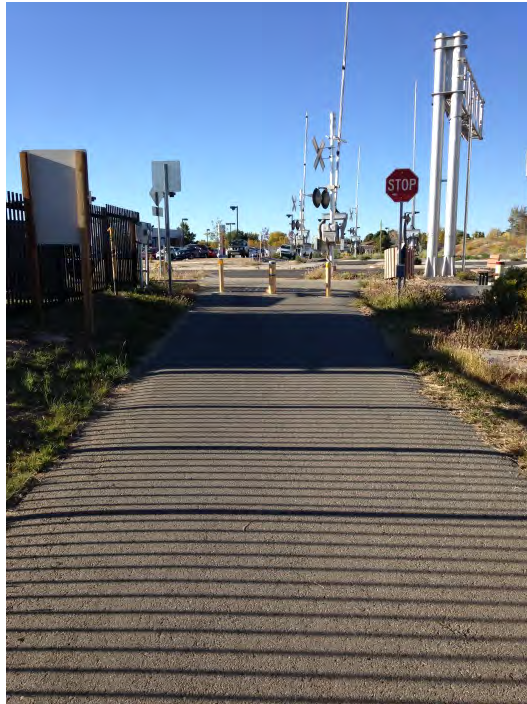
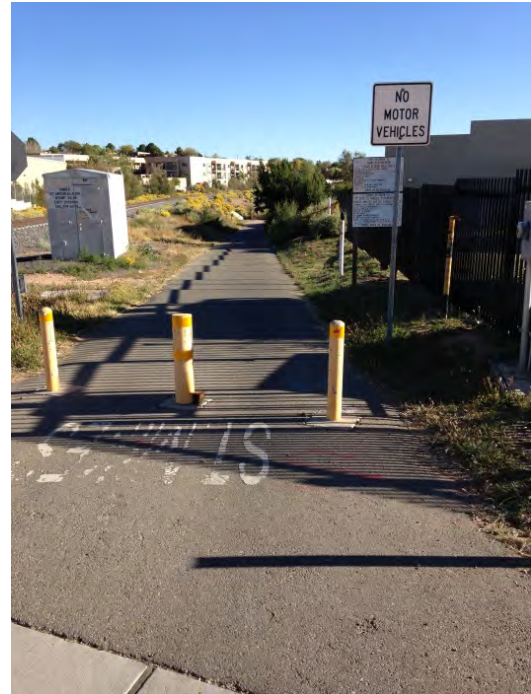
Within the project study area, SFRT is approximately 12' in width on both sides of the St. Michael's Drive crossing. Figures 2.2, 2.3 and 2.4 below represent photos of the trail south and north of St. Michael's Drive.

Figure 2.2
Santa Fe Rail Trail south of St. Michael's Drive

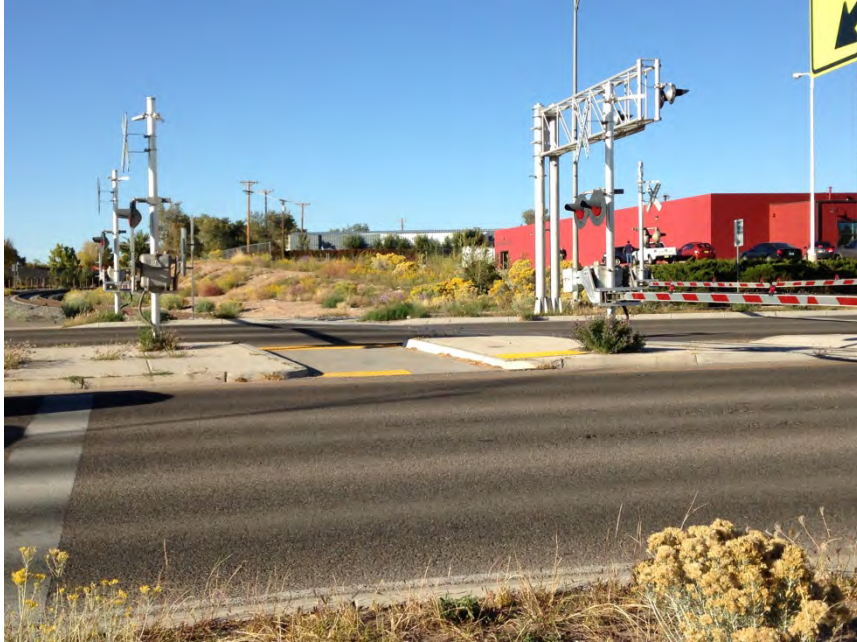
Figure 2.3
Santa Fe Rail Trail Median Refuge on St. Michael's Drive

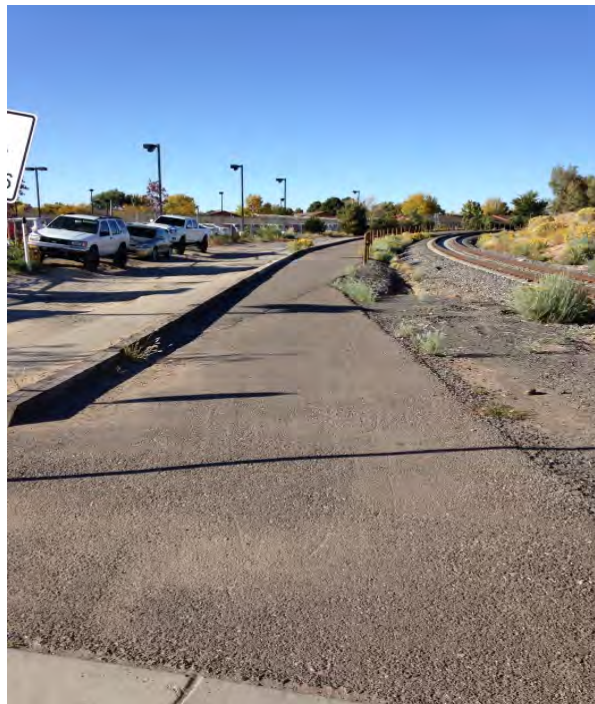
Figure 2.4
Santa Fe Rail Trail north of St. Michael's Drive

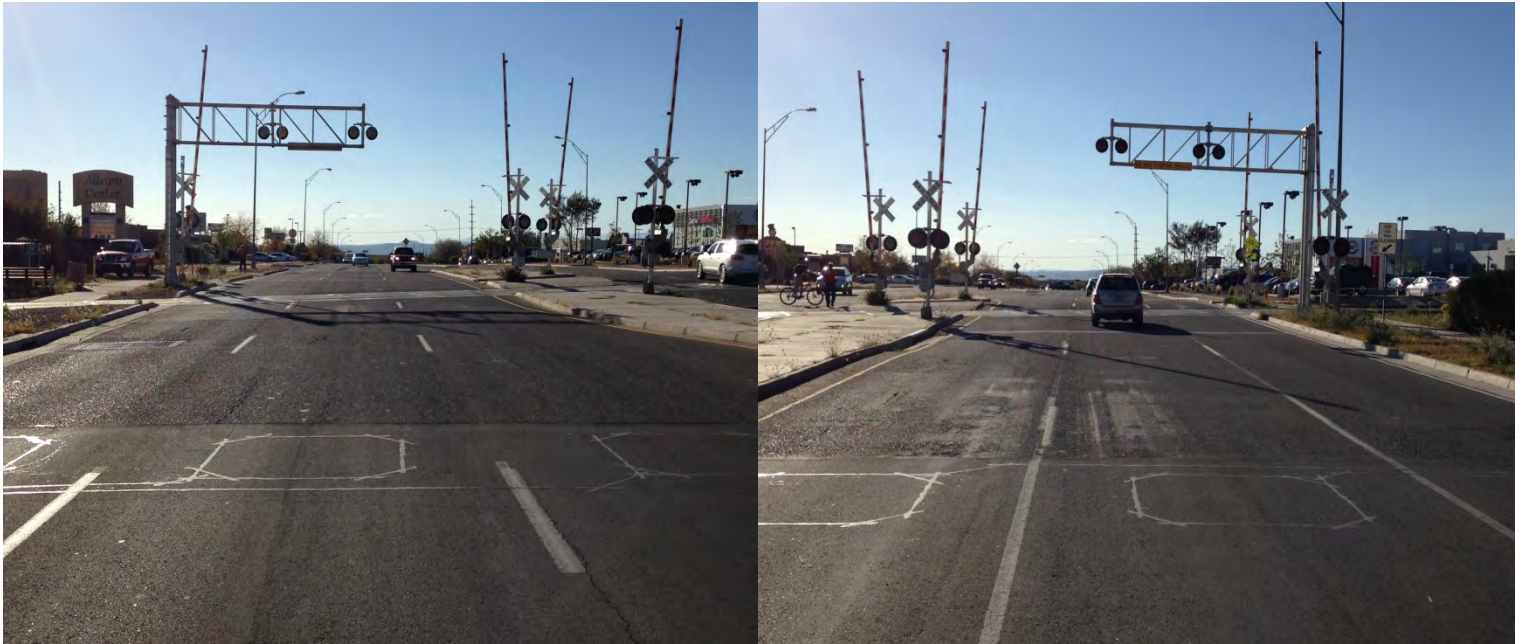
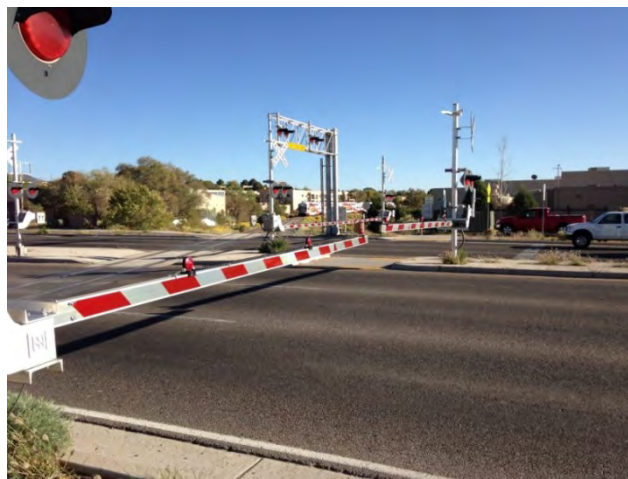
**Figure 2.5
St. Michael's Drive Rail Crossing Traffic Control**

St. Michael's Drive and NMRX / SFRT crossing is currently controlled by a railroad crossing. Figure 2.5 below shows three (3) photos identifying the rail crossing traffic control for both eastbound and westbound St. Michael's Drive. This crossing has a railroad signal mastarm with two (2) signal heads and six (6) crossing gates, four (4) crossing gates are for westbound traffic and two (2) crossing gates are for eastbound traffic. This crossing is considered a quiet zone crossing meaning that approaching trains do not sound the horn. There are no crossing gates to stop pedestrian/bicyclist traffic traveling along the sidewalks on St. Michael's Drive from crossing NMRX tracks.

**Eastbound St. Michael's Drive
Approaching NMRX Crossing**

**Westbound St. Michael's Drive
Approaching NMRX Crossing**

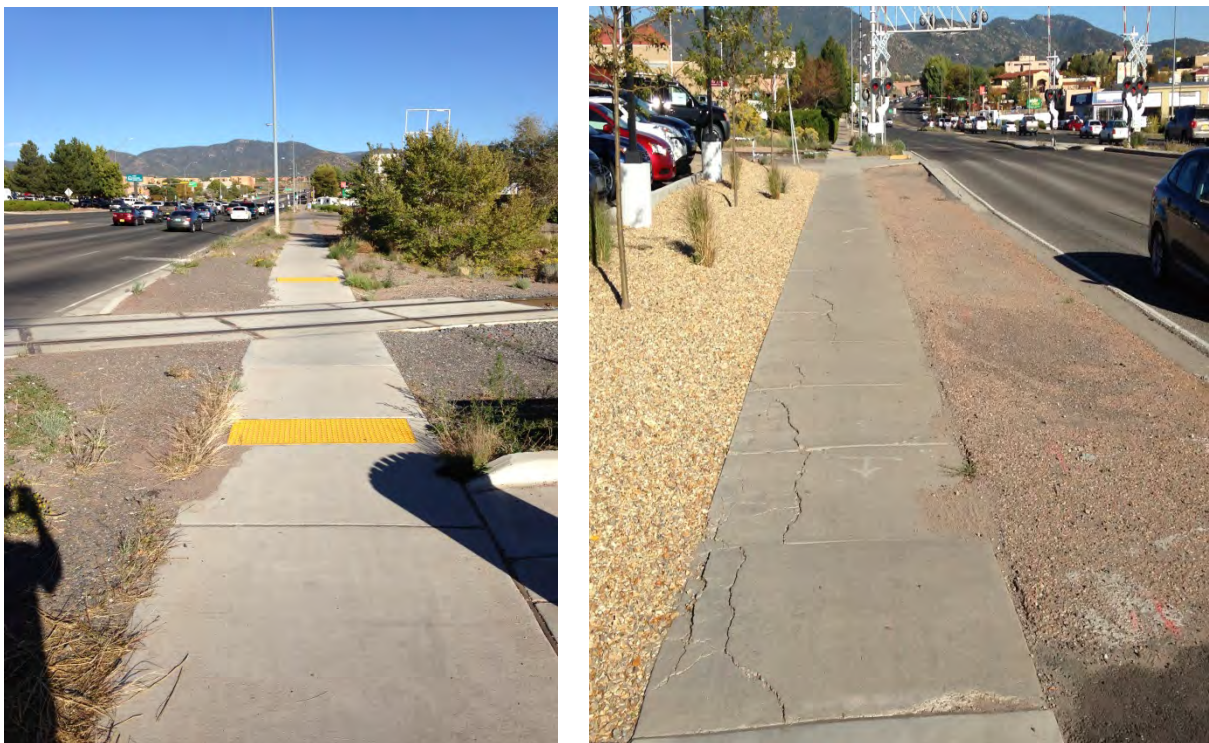
Pedestrian facilities within the project area are 6' sidewalks located on both the north and south sides of St. Michael's Drive.

Figure 2.6
Pedestrian Facilities along St. Michael's Drive at Santa Fe Rail Trail

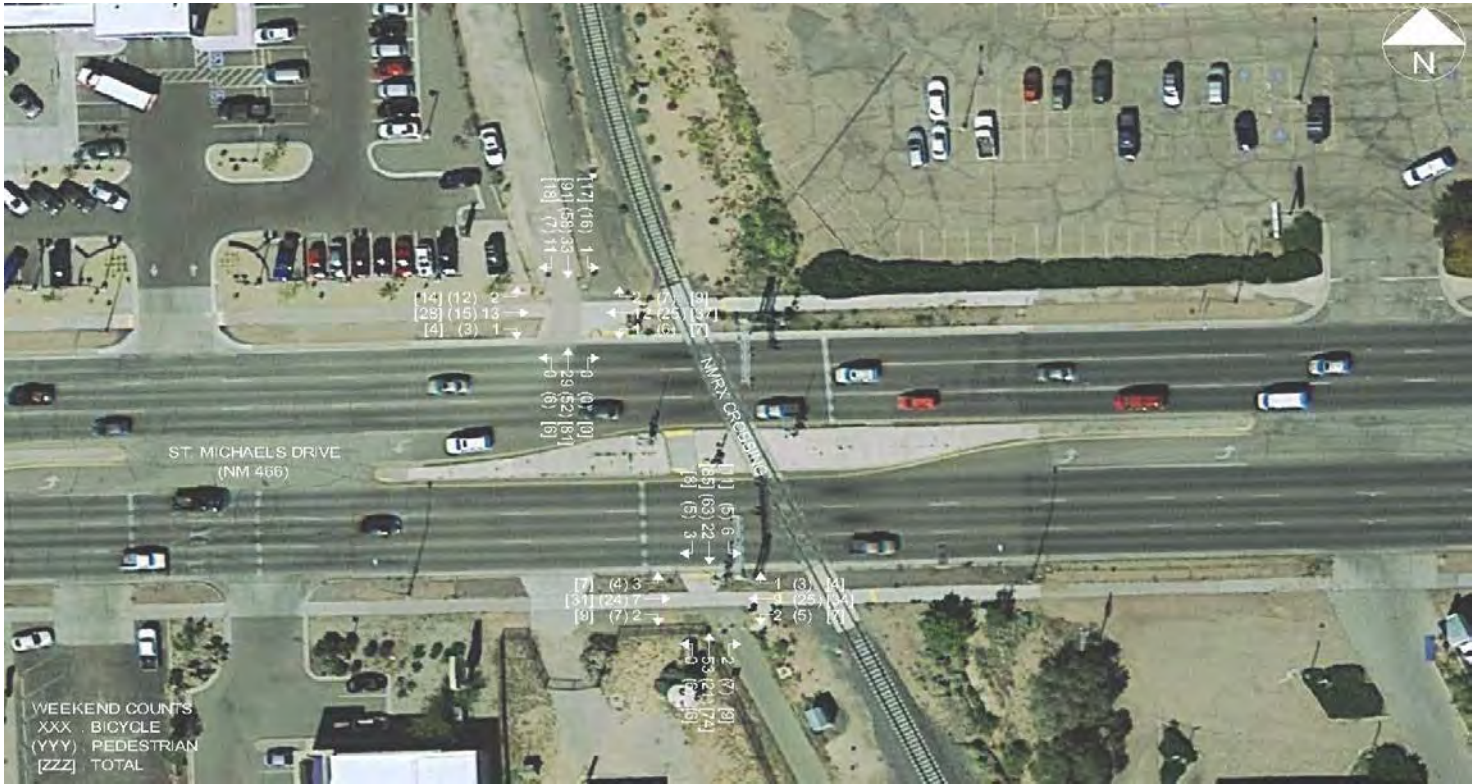
Turning movement counts (bicycles and pedestrians) were taken on both the north and south of St. Michael's Drive at the NMRX/SFRT crossing. Figures 3.1 and 3.2 on Page 10 identify the locations of weekday and weekend turning movement counts. All approaches of the trail at the crossing were counted.

Figure 3.1
Weekday Pedestrian / Bicycle Turning Movement Counts

For both the AM and PM peak hours, pedestrian/bicycle use along the SFRT is predominantly in a north/south direction.

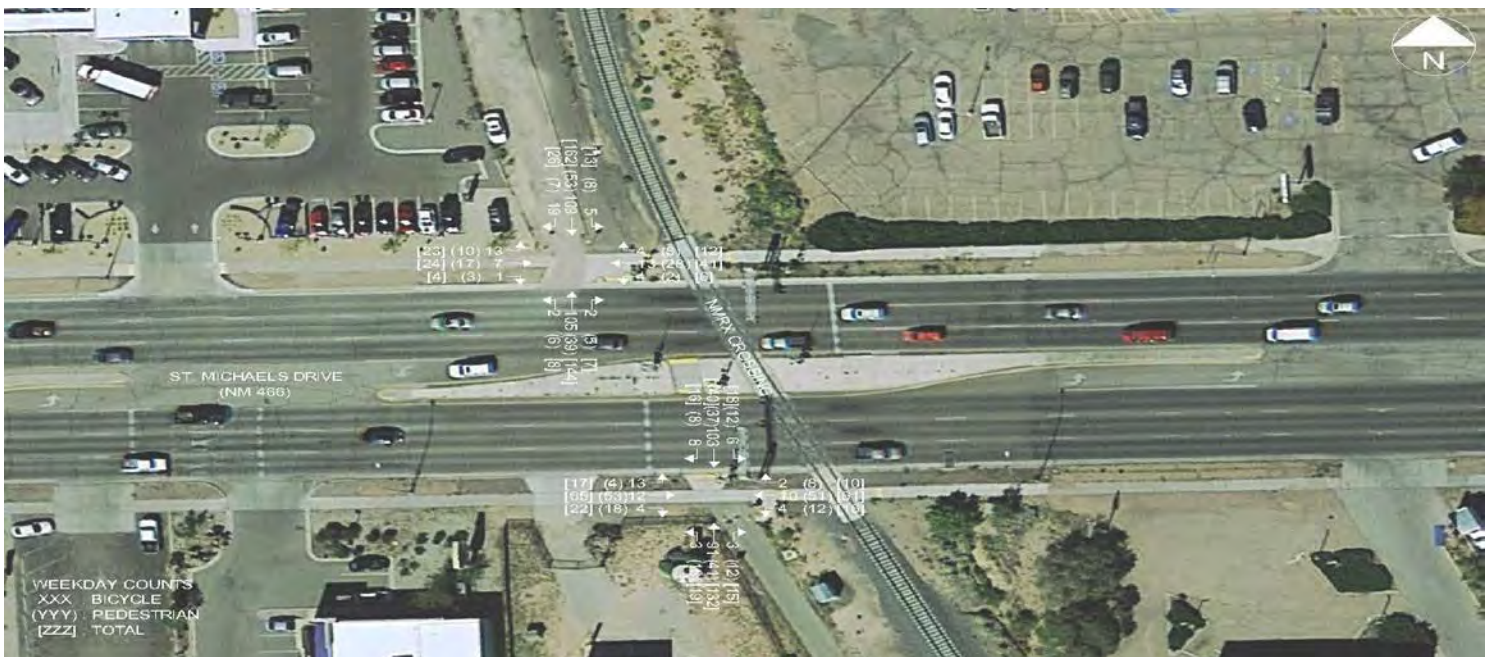
Figure 3.2
Weekend Pedestrian / Bicycle Turning Movement Counts

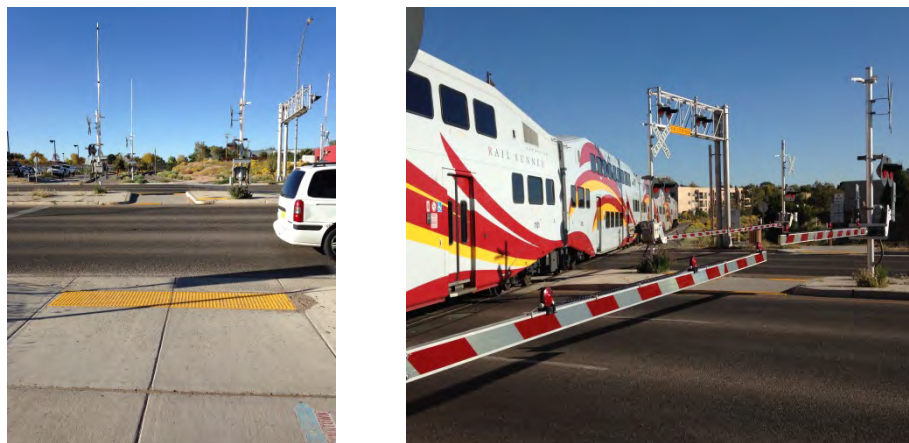
One concern that has been voiced by the general public to NMDOT, City and MPO staff pertains to the median refuge for this crossing is located behind the crossing gate on the west side of the NMRX crossing. As stated previously in the report, this rail crossing was upgraded as a part of the New Mexico Rail Runner – Phase II project back in 2009. The location of the median refuge behind the crossing gates creates a safety hazard for both pedestrians and bicyclists. When a train approaches the crossing, the gates are lowered and pedestrians/bicyclists traveling northbound on the SFRT are caught in between the gates and the train and are not able to continue north until after the train has cleared the crossing and the gates are in the upright position.

Please see Figure 4.1 below showing the median refuge behind the crossing gates along the west side of the crossing.

**Figure 4.1
Median Refuge**

A solution to this condition would be to construct a new median refuge approximately 25' west of its current location. By relocating the median refuge outside of the crossing gates will allow pedestrians/bicyclists to cross St. Michael's Drive unobstructed in both directions while the train crosses the St. Michael's Drive and vehicle traffic is stopped. Also by relocating this median refuge from its current location will significantly reduce any chances of a train versus pedestrian/bicyclists incident.

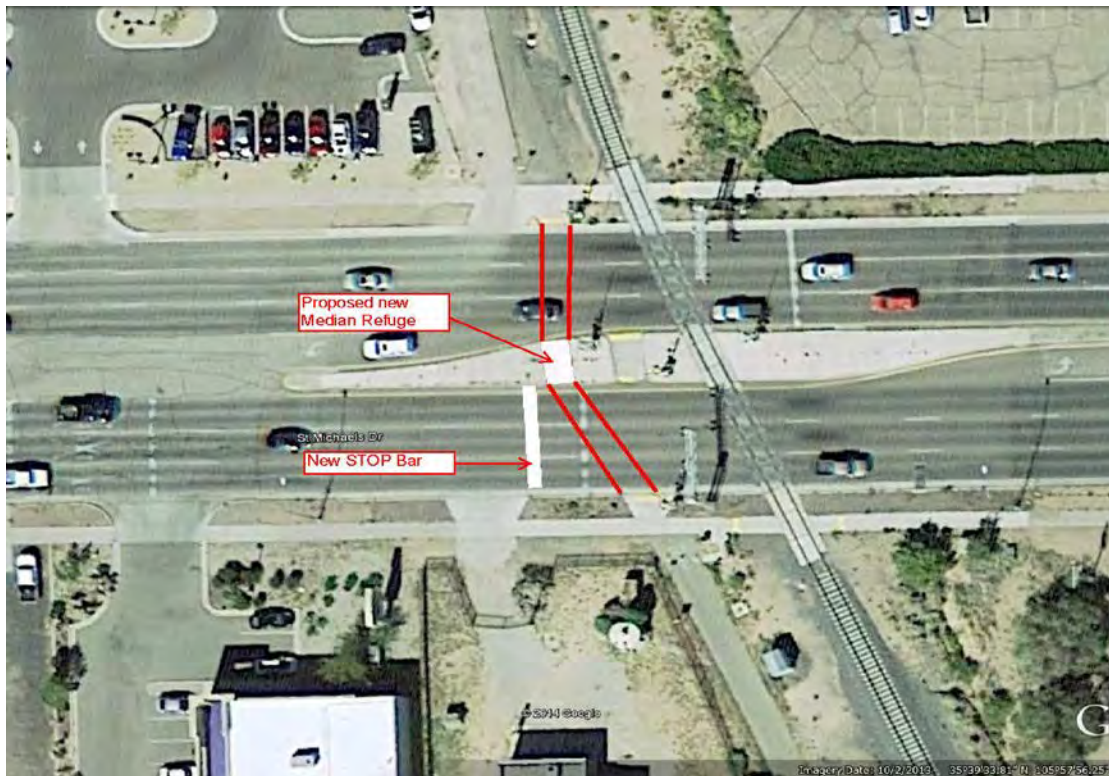
Figure 4.2
Alternative #1

Please refer to Figure 4.2 on Page 13 for a schematic drawing showing the proposed new median refuge location.

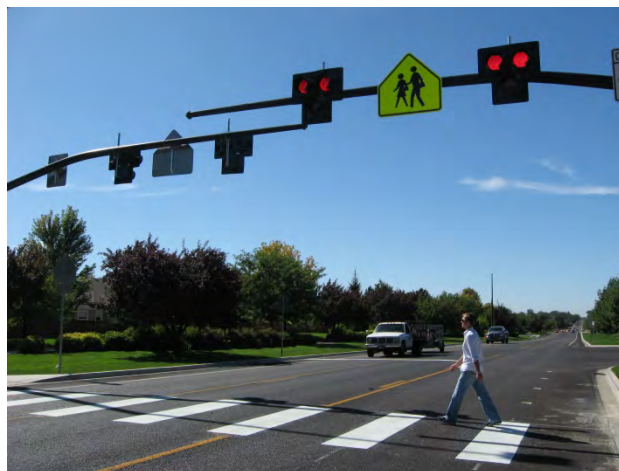
A **Pedestrian Hybrid Beacon – PHB** (formerly known as **High-Intensity Activated CrossWalk – HAWK Signal**) is a special type of hybrid beacon used to warn and control traffic at an unsignalized location to assist pedestrians crossing a street or highway at a marked crosswalk. When activated, the PHB uses a red indication to inform drivers to stop, thereby creating a time period for pedestrians to cross the major roadway. Chapter 4F of the MUTCD Criteria for PHB's are Figure 4.3 shows an example of the current head configuration for the PHB.

Figure 4.3
PHB Signal Head and Sign Configuration

The PHB beacon is not illuminated until it is activated by a pedestrian, triggering the warning flashing yellow lens on the major street. After a set amount of time, the indication changes to a solid yellow light to inform drivers to prepare to stop. The beacon then displays a dual solid red light to drivers on the major street and a walking person symbol to pedestrians. At the conclusion of the walk phase, the beacon displays an alternating flashing red light, and pedestrians are shown an upraised hand symbol with a countdown display informing them of the time left to cross. During the alternating flashing red lights, drivers can proceed after coming to a full stop and checking that pedestrians have already crossed their lane of travel. Each successive driver is legally required to come to a full stop before proceeding during the alternating flashing red phase.

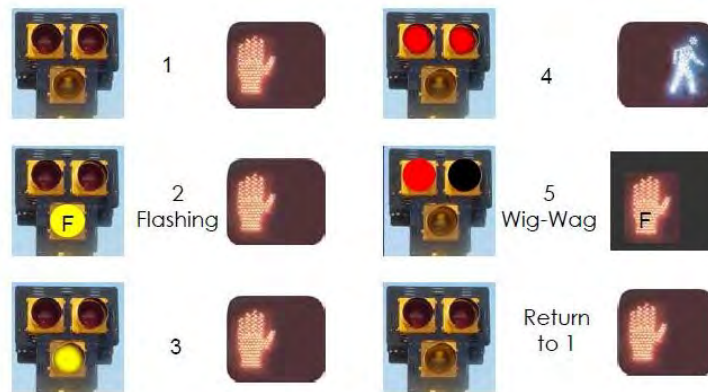
The alternating flashing red phase allows the driver delay to match the actual crossing needs of the pedestrian. Drivers can proceed with a stop-and-go operation during the flashing red phase if a pedestrian walks faster than the assumed walking speed and clears the lanes or roadway, as appropriate. If pedestrians need more time, then the drivers remain stopped until they finish crossing. The ability to balance the needs of the pedestrians with driver delay is a valuable component of the PHB treatment. Concerns have been expressed regarding driver behavior and understanding of the dark phase (not illuminated) and the flashing red phase. Figure 4.4 on Page 15 shows a PHB Beacon and Pedestrian Signal Indication.

Figure 4.4
PHB Beacon and Pedestrian Signal Indications

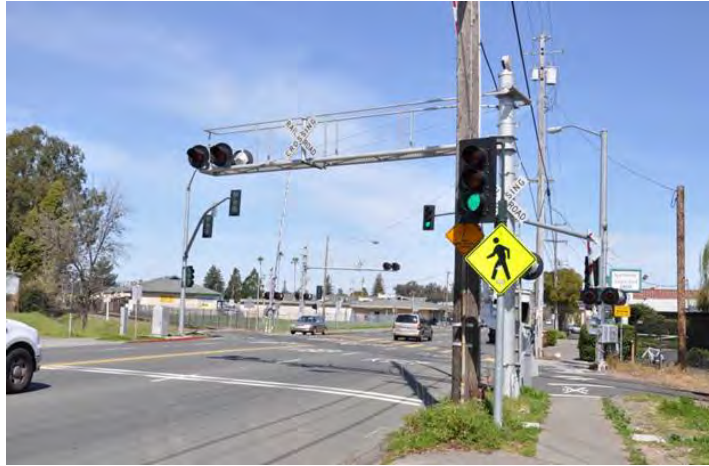
United States where a PHB has been installed in the same location. One location where there is full pedestrian traffic signal in conjunction with a railroad crossing is in Napa, California. The location is along Jefferson Street in Napa, California. Please refer to Figure 4.5 below showing this crossing.

North Bound Jefferson Street approaching Napa Wine Train Crossing

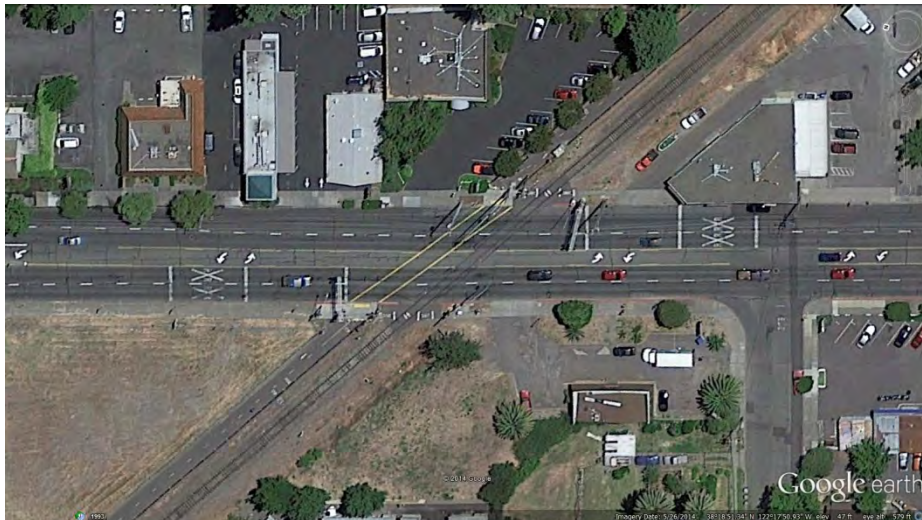
Figure 4.6

The Napa Valley Wine Train provides a three-hour, thirty-six mile round-trip journey from the historic town of Napa, through one of the world's most known wine valleys to the quaint village of St. Helena, and back. This crossing has a full traffic signal and not a PHB signal. In Figures 4.5, 4.6 and 4.7, the rail signal mastarms are placed in advance of the traffic signal mastarms at the rail/trail crossing. The traffic signals are placed on the opposite side of the rail crossing as to not to interfere with the rail signal mastarm and indications. When activated (with rail signal or traffic signal), traffic is stopped in advance of the rail crossing.

Aerial Image of Jefferson Street/Napa Wine Train Crossing

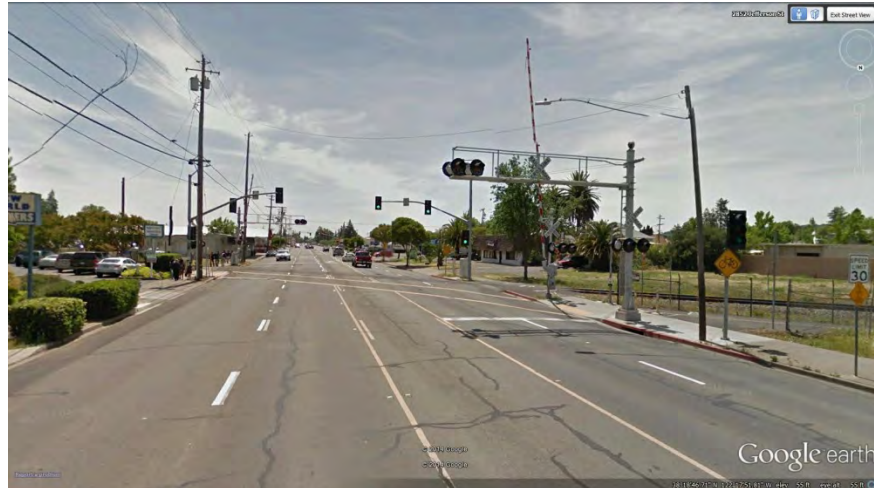
Figure 4.7
Southbound Jefferson Street approaching Napa Wine Train Crossing

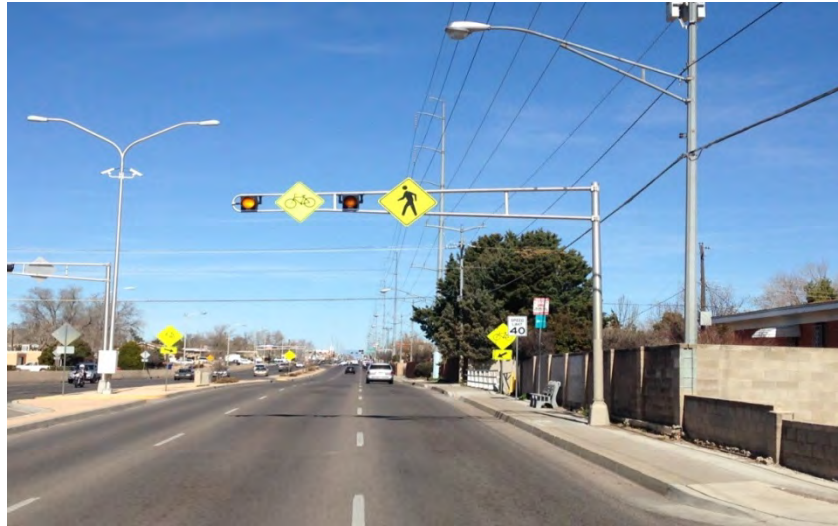
Figure 4.8 on Page 21 shows the advanced flasher with appropriate MUTCD signing on Wyoming Boulevard just south of Indian School Road.

Figure 4.8
Type II Mastarm with Flashers and Pedestrian/Bicycle Signage

Location of the Type II mastarms would be approximately 300' away from the crossings with additional W11-15 and W16-7PL/W16-7PR signs mounted at the locations of the crosswalks.
