Chapter 2

Existing Conditions

Chapter 2 presents the existing conditions of the City of Santa Fe's pedestrian network. This chapter provides a brief overview of the methodology used during the ADA accessibility field survey, equipment used during the survey, and the database analysis that was conducted as part of the quality assurance and quality control portion of the survey. This chapter also details the existing conditions in the order of curb ramps, intersections, and sidewalks. The associated analysis begins with an overview of the categorical documentation of each element, followed by a categorized break-down of the accessibility condition ranking and a side-by-side comparison of each City Council District.

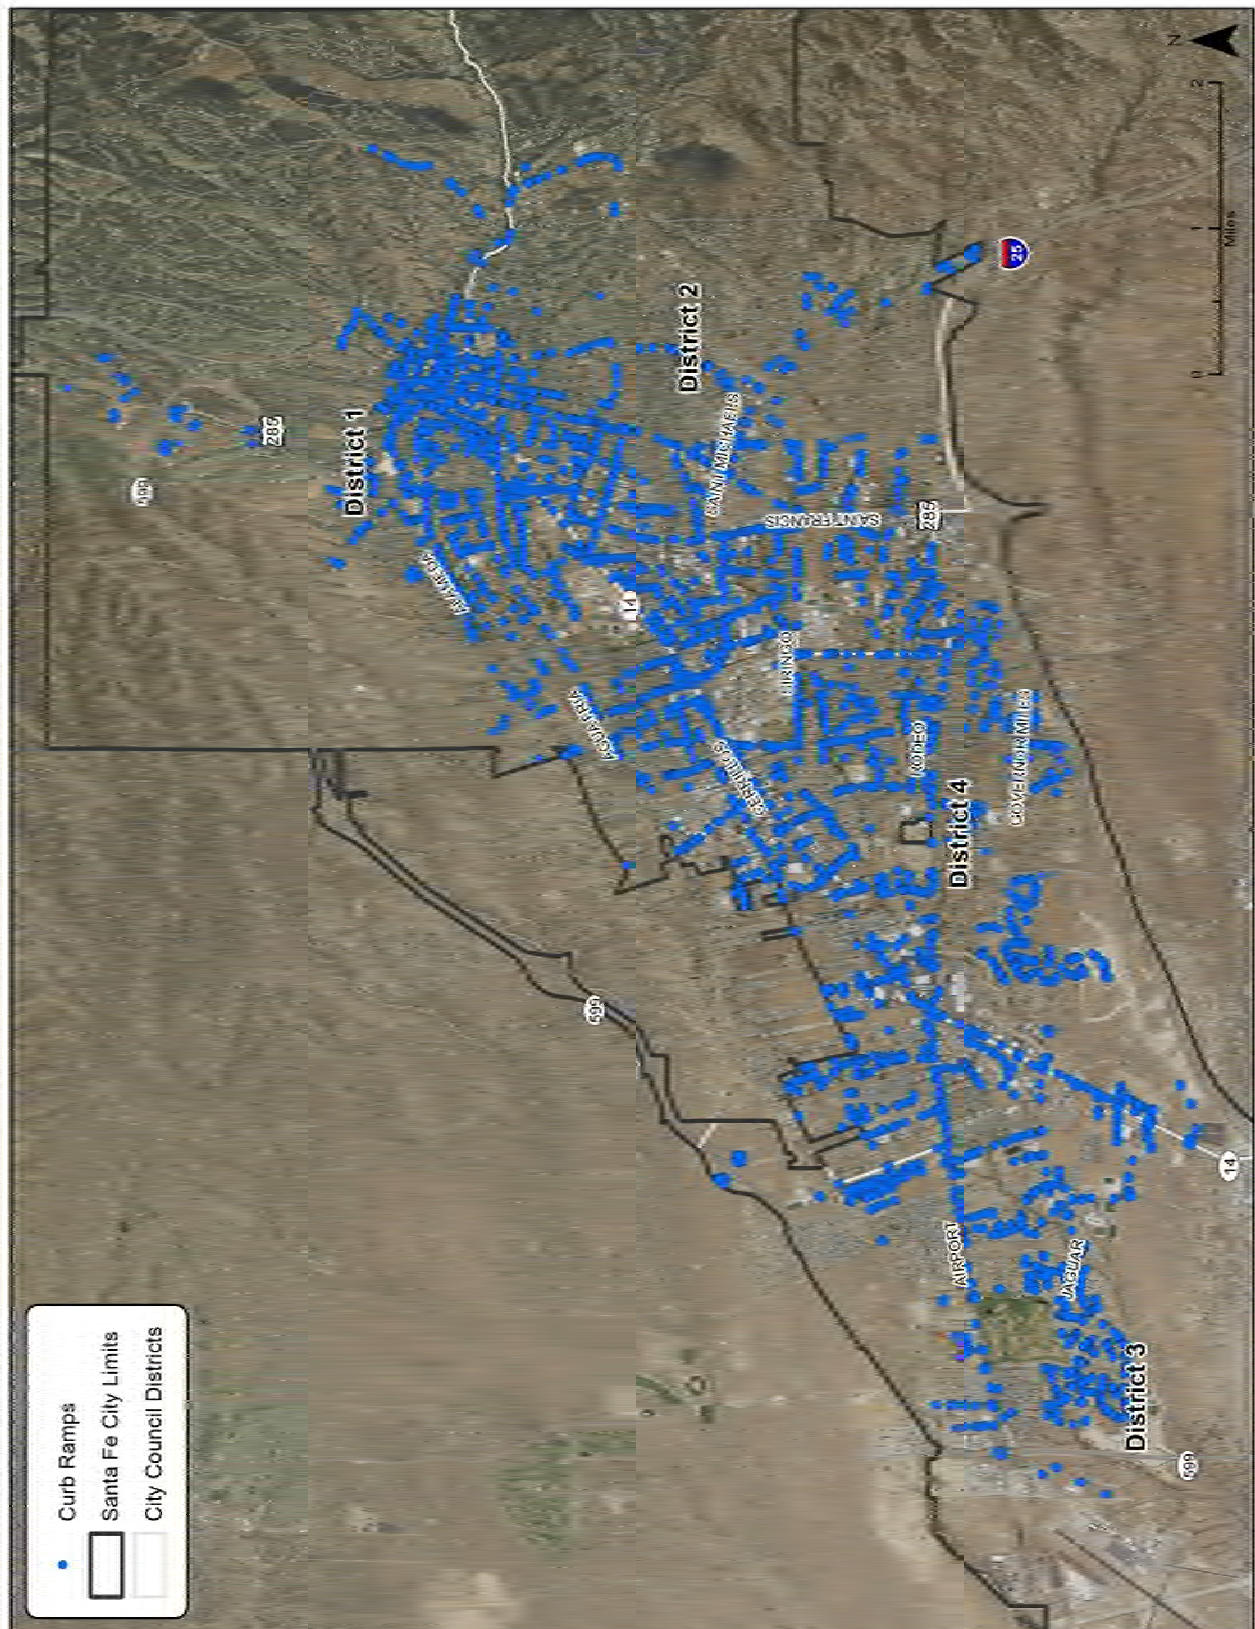
Figure 2-2: Curb Ramp Assessment Summary

To aide in the analysis, categories were developed for each element in accordance with ADA Guidelines. While precise measurements were taken for every curb ramp; these measurements were grouped categorically by best practices, compliance, non-compliance, or severe non-compliance. The curb ramp elements with their associated categories are shown in Table 2-1.

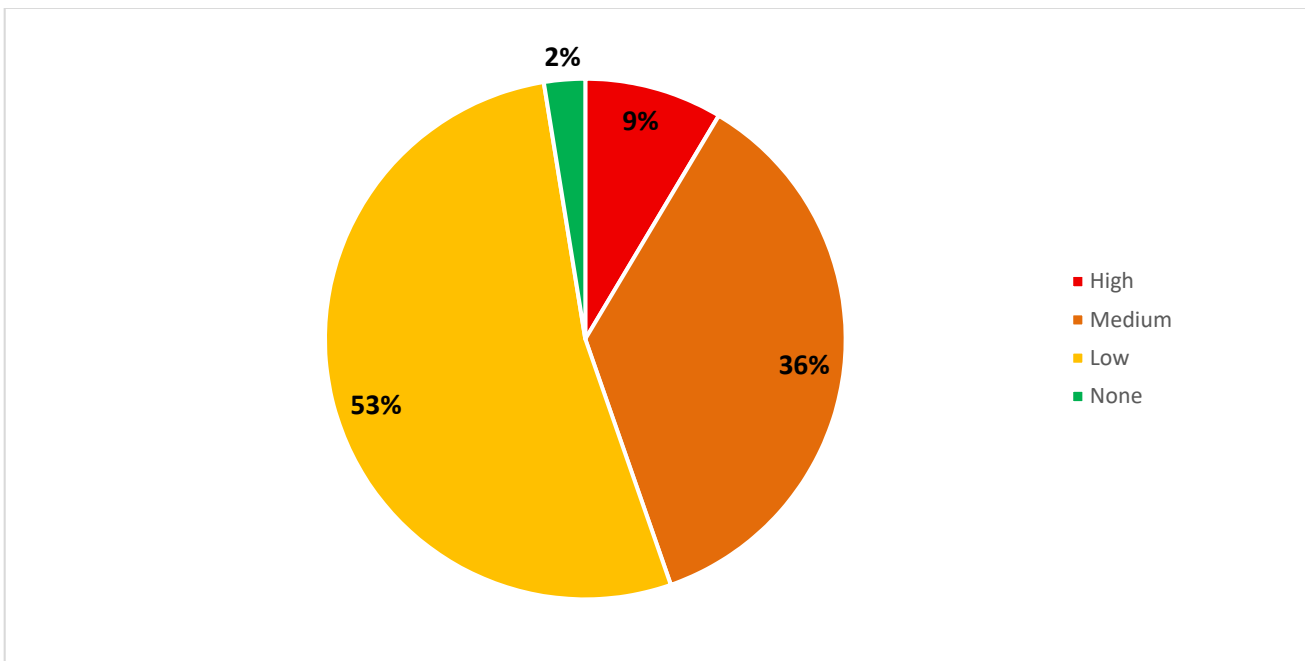
Figure 2-3: Curb Ramp Deficiency Rating

For the purposes of this report, the study team developed a three-tier rating system for curb ramps in need of repair or modification to meet ADA guidelines. Curb ramps found not to be compliant were designated as either “High,” “Medium,” or “Low.” Figure 2-3 shows the overall results of the curb ramp rating process. This tiered system is meant to demonstrate the level of non-compliance for each curb ramp. More information on the rating system can be found in Appendix C.

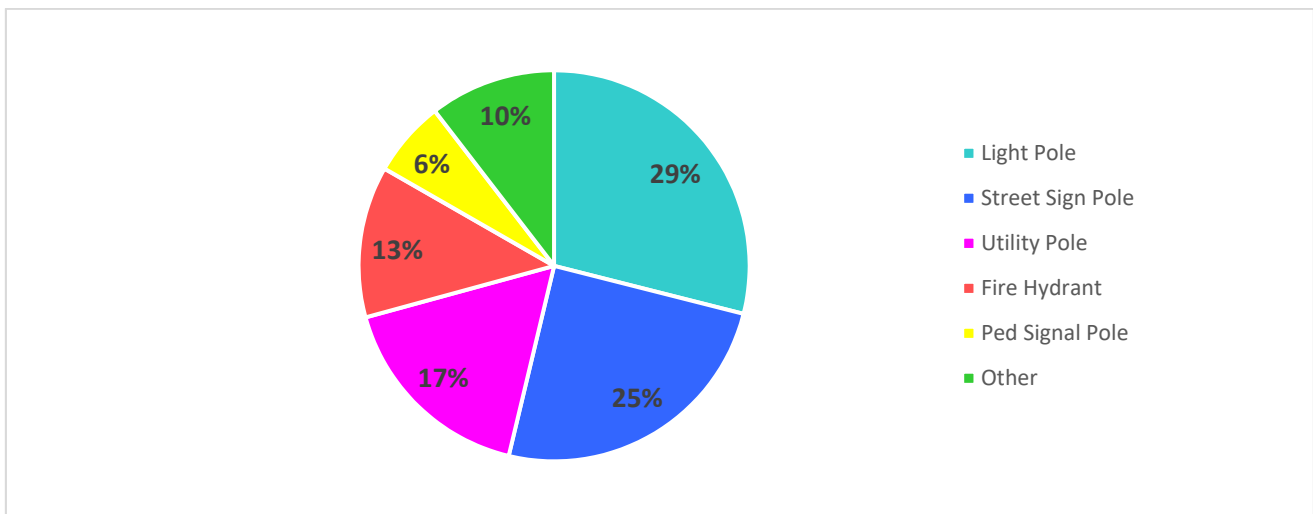
Figure 2-4: Curb Ramp Obstruction Type

Curb ramp obstructions largely consist of light poles, street sign poles, utility poles, and fire hydrants. The category “other” mostly represents fences, walls, and traffic bollards. Figure 2-4 illustrates the most common curb ramp obstruction types. As the chart shows, light poles make up the largest share of curb ramp obstructions (29%) and street sign poles were the second most common (25%) obstruction. Figure 2-5 provides examples of common curb ramp obstructions.

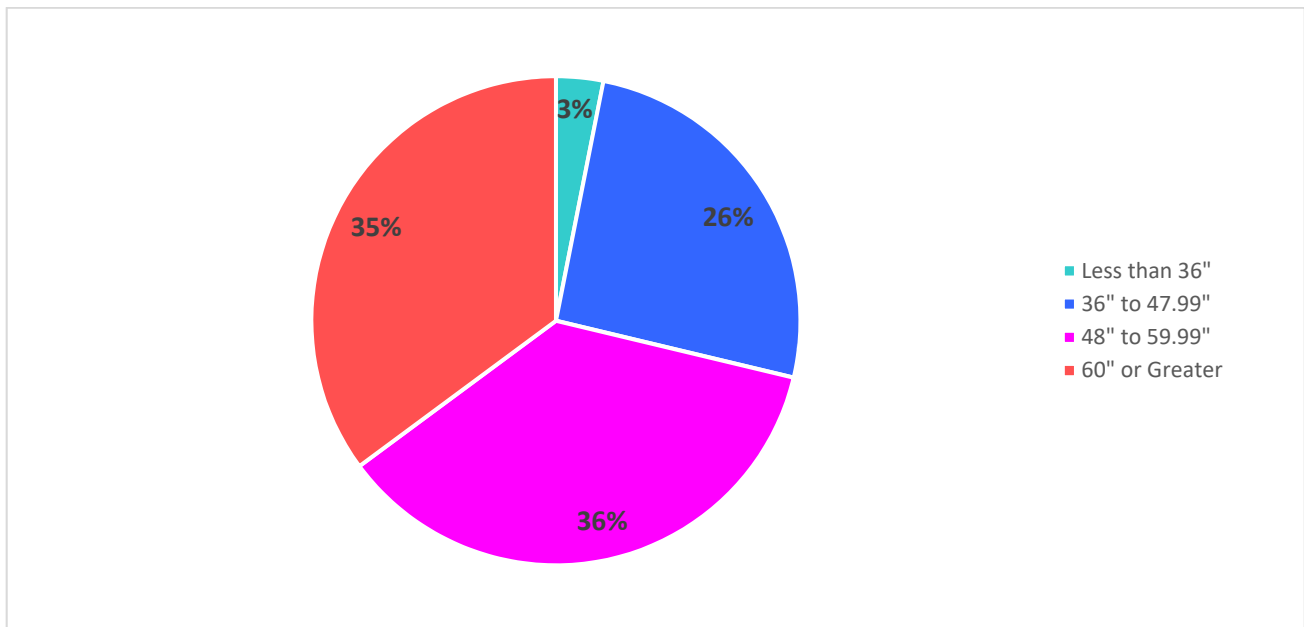
Figure 2-6: Curb Ramp Width

A curb ramp with a width of less than 36 inches is non-compliant under ADA guidelines (ADA requires a width of no less than 48 inches), and inaccessible for a wheelchair user. As seen in Figure 2-6, only 3% of curb ramps surveyed are less than 36 inches wide. Figure 2-7 shows curb ramps with a ramp width below 36 inches.

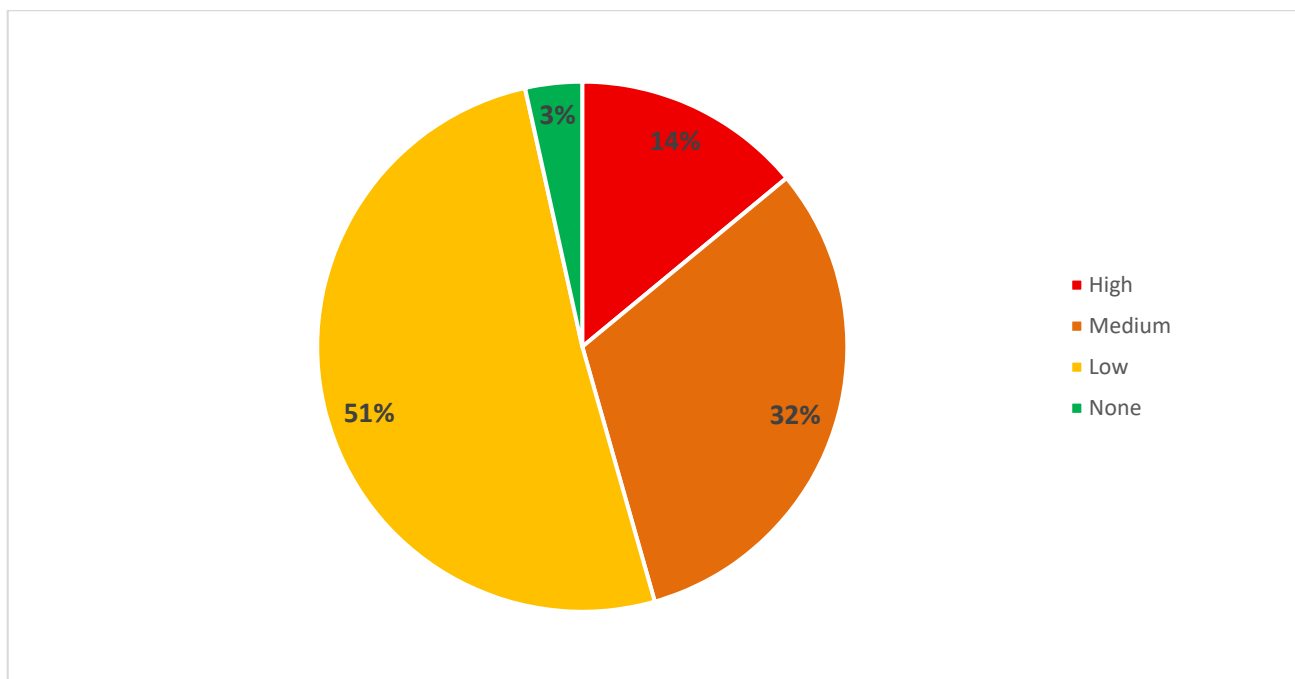
Figure 2-10: District 1 Curb Ramp Deficiency Rating

District 1 is located in the northern most region of the City of Santa Fe. District 1 is home to the downtown plaza area and the neighborhoods along Alameda and Agua Fria to the intersections of Siler Road. As seen in Figure 2-10, the overall condition of curb ramps in District 1 is good. Figure 2-11 displays the location of curb ramps in District 1 and their priority level.

District 1 has the largest percentage of high priority curb ramps when compared to the other districts (14.0%). High priority curb ramps are fairly dispersed throughout the downtown area and northern residential areas; however, some concentrations exist along Agua Fria Street, W. Alameda Street, and Paseo de Peralta.

Medium priority curb ramps are also dispersed throughout the district. Areas of heavy concentration include the northwestern neighborhoods along Agua Fria Street, Camino Sierra Vista, and Rosina Street.

Low priority curb ramps make up the majority of ramps in District 1 at 50.9%. These curb ramps are heavily dispersed with relative concentrations through the downtown areas.

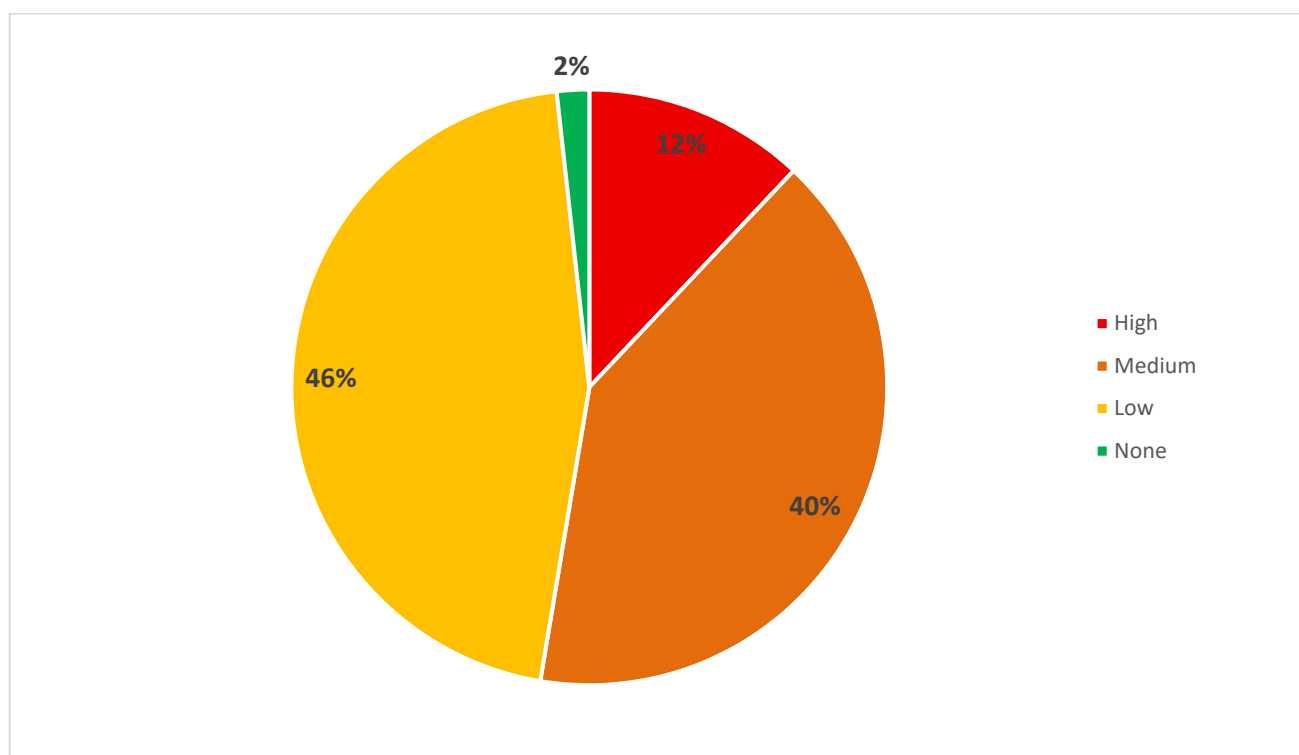
Figure 2-12: District 2 Curb Ramp Deficiency Rating

City Council District 2 is located in the eastern portion of the city. District 2 includes the downtown area south of Alameda Street which includes state government offices, including the capital building. Other noteworthy areas include St. Vincent Medical Center and surrounding medical offices, cultural attractions of Museum Hill, and St. John's College. As seen in Figure 2-12, the overall condition of curb ramps in District 2 is average. Figure 2-13 displays the location of curb ramps with District 2 and priority level.

District 2 has the second highest concentration of high priority curb ramps, after District 1. This designation is largely due to curb ramps downtown and in the neighborhood bound by Cerrillos Road to the west, Saint Michael's Drive to the south, and the Rail Runner tracks to the east.

District 2 has the highest concentration of medium priority curb ramps with 40.6%. While these curb ramps are located throughout the district, concentrations exist along Calle Espejo, Galisteo Street, and Pacheco Street.

Low priority ramps make up 45.6% of District 2's curb ramps. Low priority ramps are evenly distributed across the district.

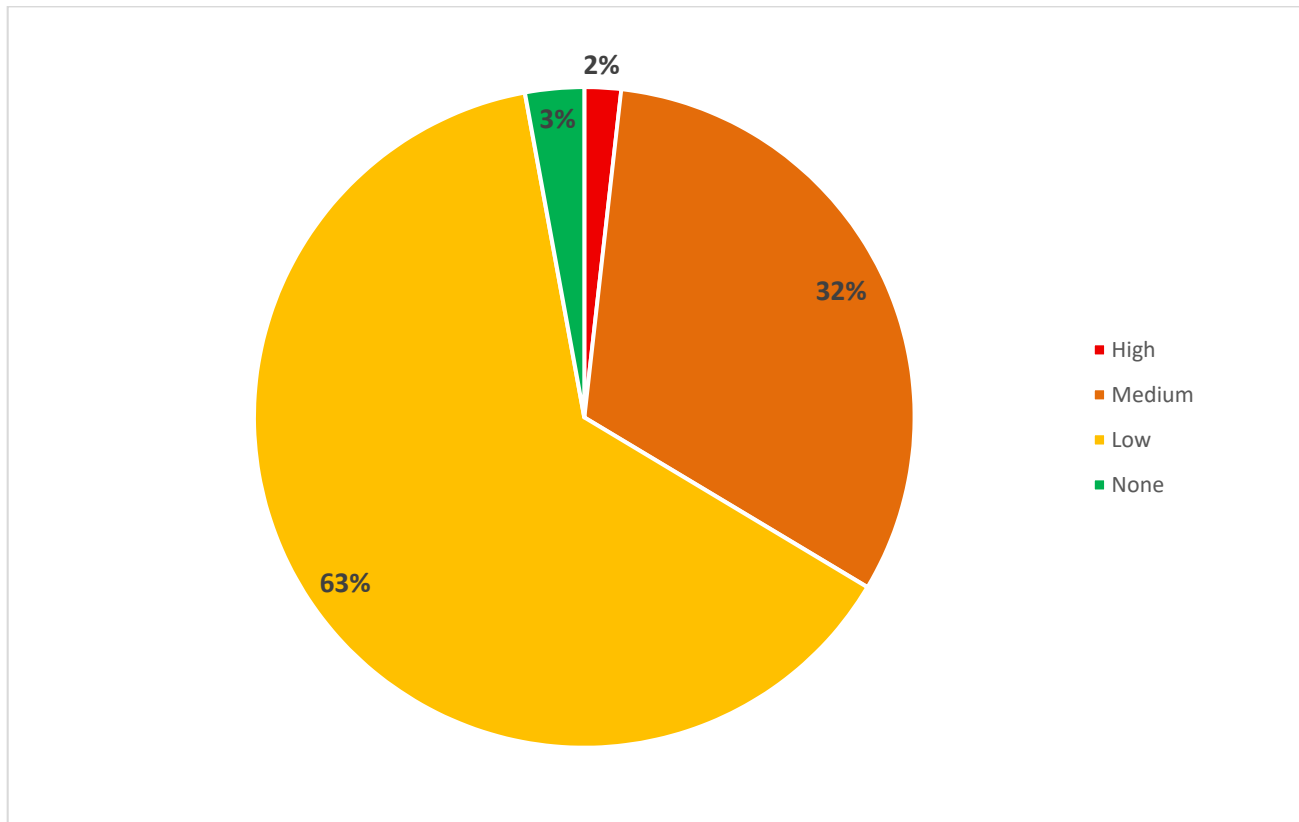
Figure 2-14: District 3 Curb Ramp Deficiency Rating

District 3 is located in the southwest area of the city. The district is home to the Santa Fe Airport, city government offices, major retail destinations, and a number of residential areas. As seen in Figure 2-14, the overall condition of curb ramps in District 3 is very good with approximately 67% of curb ramps a low priority or ADA compliant. Figure 2-15 displays the location of curb ramps with District 3 and priority level.

District 3 has the lowest concentration of high priority curb ramps with 1.8%. High priority ramps are mostly found along Airport Road with a few others located throughout the surrounding neighborhoods.

Medium priority ramps represent 31.8% of the curb ramps in District 3. While medium priority ramps are spread across the district, relative concentrations exist in the residential neighborhoods along Paseo del Sol and Paseo del Sol West.
