## SIDEWALK EVALUATION AND METHODOLOGY

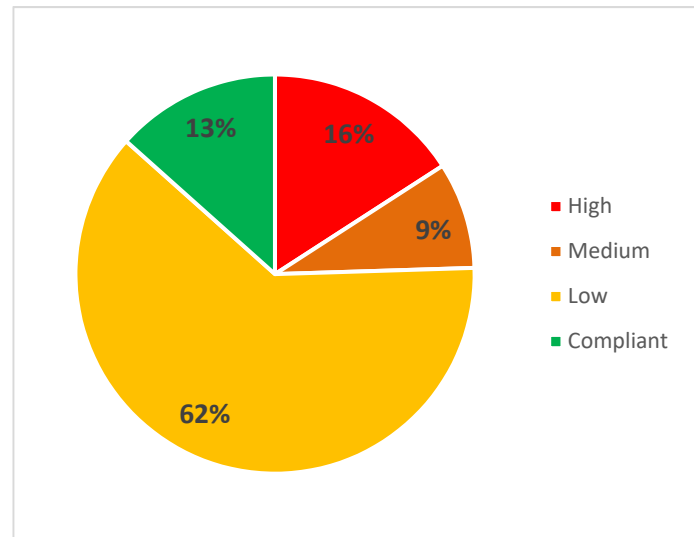
**Figure 2-28: District 3 Intersection Deficiency Rating**

As seen in Figure 2-28, City Council District 3 has the highest percentage of low priority intersections (62.1%) and in turn the lowest percentage of medium and high priority intersections at 8.6% and 15.9% respectively. High priority intersections can be found along South Meadows Road, in the neighborhoods in the vicinity of Paseo del Sol and Paseo del Sol West. Medium and low priority intersections are evenly dispersed around the district while compliant intersections are mostly located along Airport Road, Jaguar Drive, and the northern area of South Meadows Road. Figure 2-30 displays the location of the intersections in District 3 and their priority level.

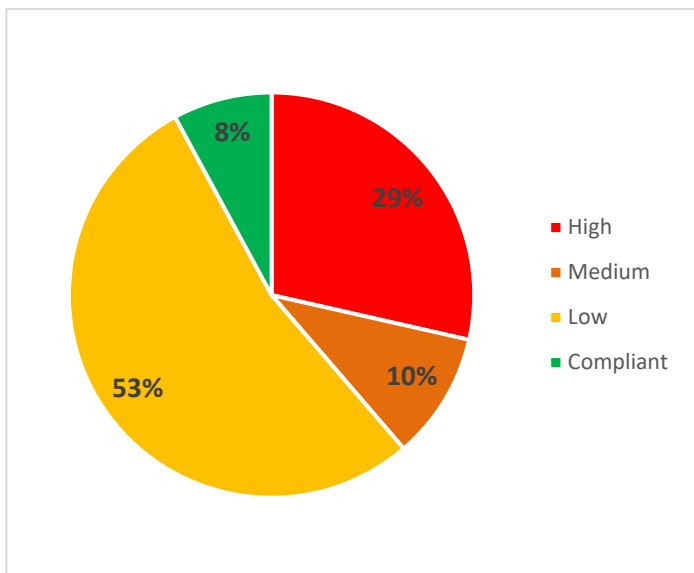
**Figure 2-29: District 4 Intersection Deficiency Rating**

The average conditions of intersections in District 4 fall within the general ranges seen in the other districts. As seen in Figure 2-29, high priority intersections make up 28.5% of the total intersections. High priority intersections are largely found along the corridor roads in District 4 such as Airport Road, Alamosa Road, northern Cerrillos Road, and Siringo Road. Similar to other districts, medium and low priority intersections are spread throughout the district. Compliant intersections are generally found along Cerrillos Road, Rodeo Road, and the newly developed areas in the southern portion of the district. Figure 2-31 displays the location of intersections within District 4 and their priority level.

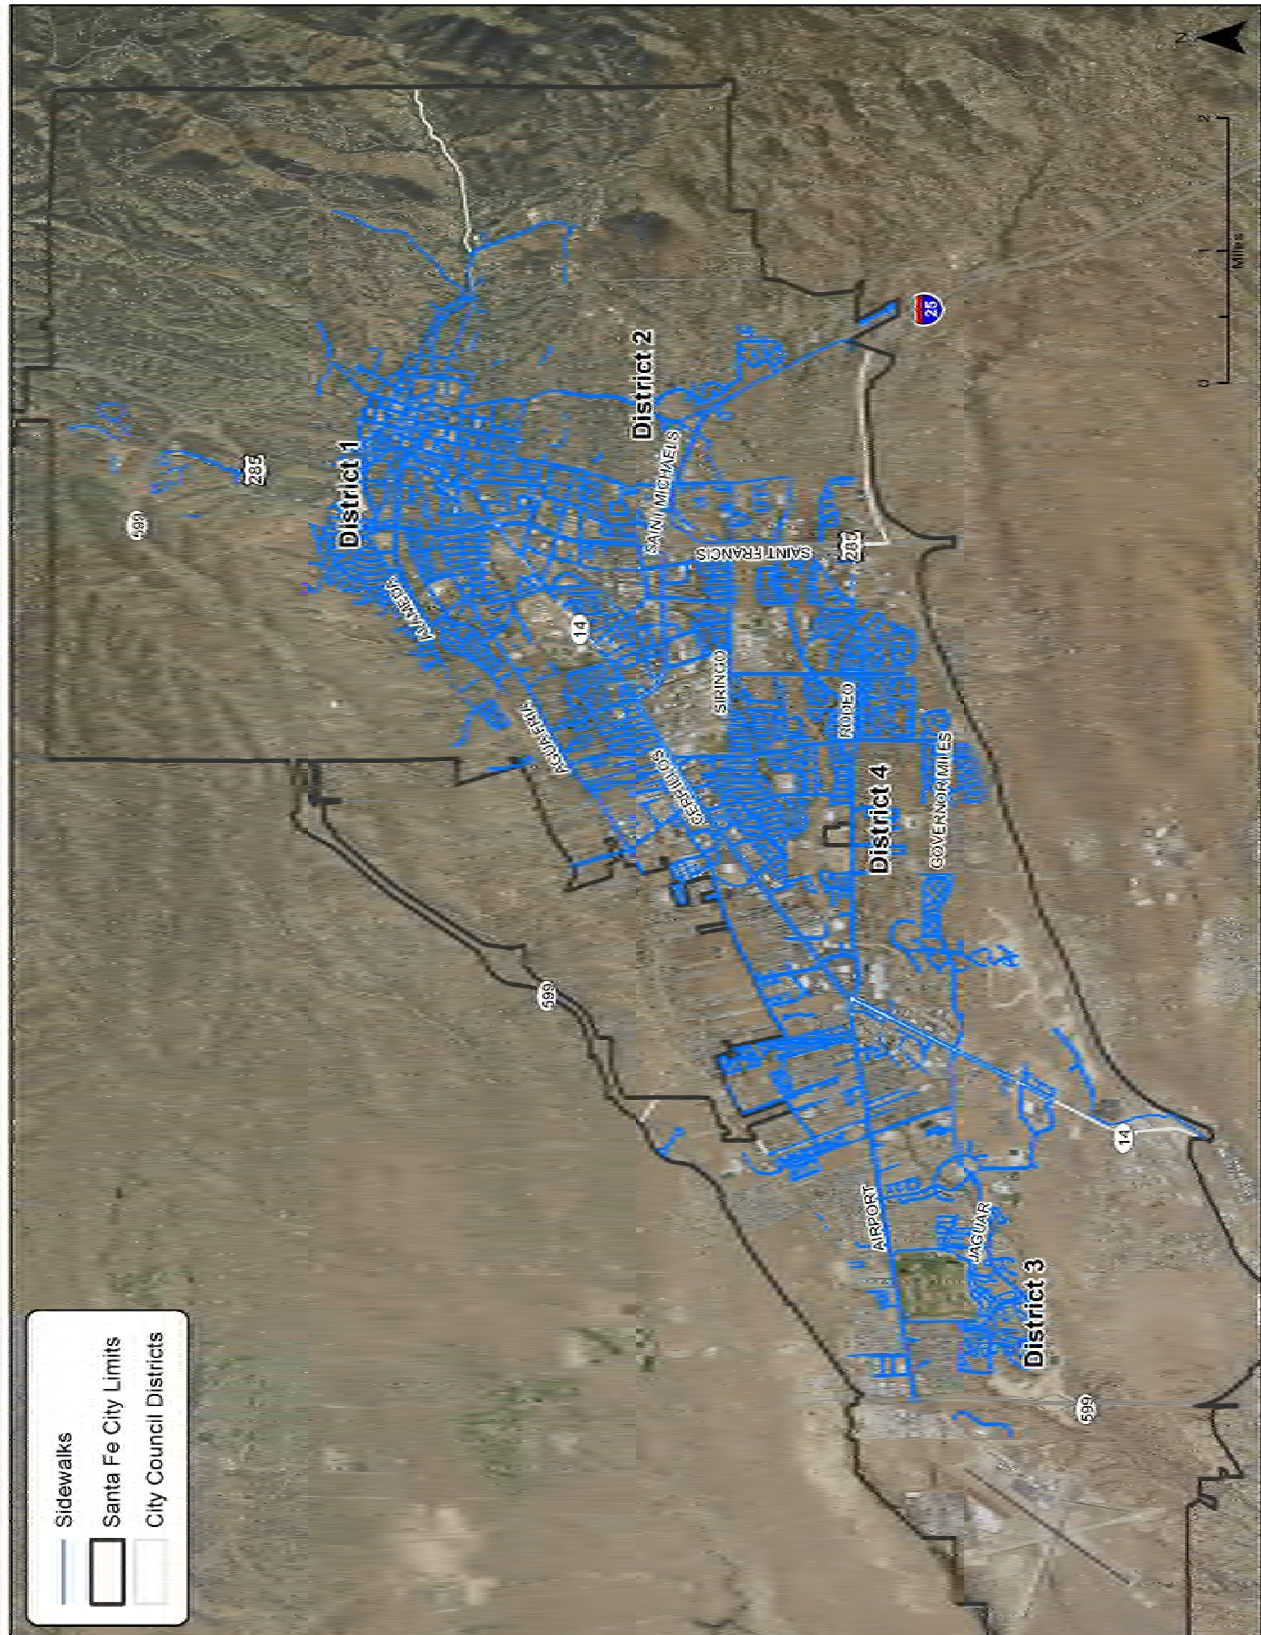
Figure 2-32: Sidewalk Assessment Summary Map

Sidewalks within the study area were broken into segments separated by intersections and occasionally mid-block crossings. A total of 4,686 sidewalk segments were surveyed and evaluated for ADA compliance. Figure 2-32 provides a map of sidewalk segments in the City of Santa Fe. Table 2-9 provides a statistical breakdown for the information collected on the attributes of each sidewalk.
