# FACILITY ASSESSMENT REPORT

**Garson Studios**

January 4, 2023

January 4, 2023  
WCI Project #: 21-600-030-10

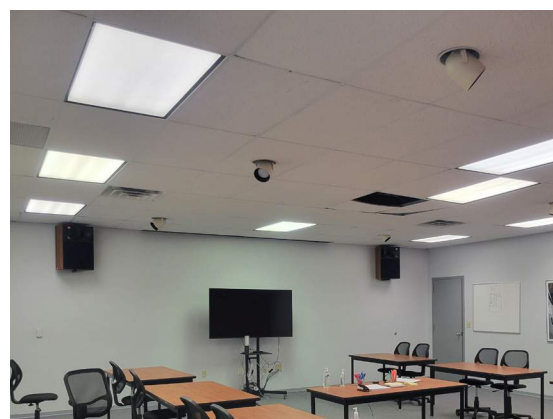
Lighting in room 217 | A27

- Lay-in 2x4 fluorescent fixtures with mirrored waffle diffusers.
- Suspended linear two-lamp fluorescent fixtures.
- Surface-mounted square lights
