# FACILITY ASSESSMENT REPORT

**Visual Arts Center**

January 4, 2023

January 4, 2023 WCI Project #: 21-600-030-10

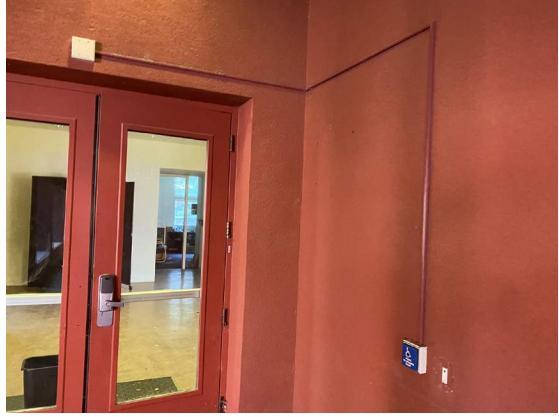
The exterior doors are a mixture of three door types. Hollow metal doors are found at the entrances into Tishman, as well as at externally accessed mechanical spaces. Solid wood doors are found at the front entrance to Tipton Hall and Marion Hall. Hollow metal doors with glazing are found at the main courtyard entrance to Thaw Hall. The hardware is ADA-compliant (A6) and appears to be in good working order with a few exceptions. Multiple exterior automatic doors appear not to function properly and should be updated with new openers and buttons. The overall condition of the exterior doors is acceptable.

Exterior entrance doors to Thaw | A6

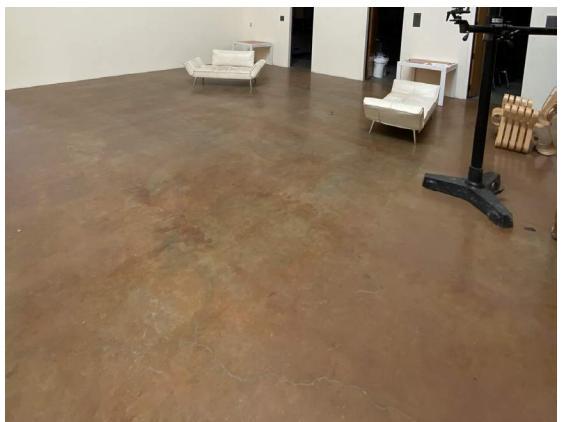
Colored, sealed concrete | A9

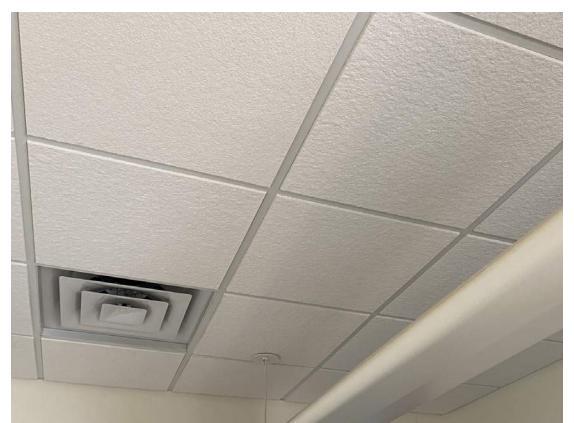
**Lay-in Acoustical Ceilings Tiles (ACT):** The tiles used in the Visual Arts Center are notably of high quality and have a finely textured surface. Areas with ACT are generally in good condition. Some missing tiles will require replacement.

Typical ACT office ceiling | A12

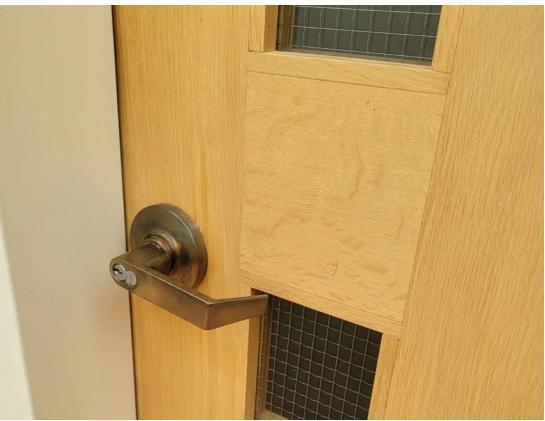
Interior doors include custom solid wood doors (with or without small windows), painted solid wood doors, full glass hollow metal doors, and tempered plate glass doors. They appear to be ADA-compliant in design and hardware (A14). Overall, the interior doors are in good condition.

Typical interior door hardware | A14

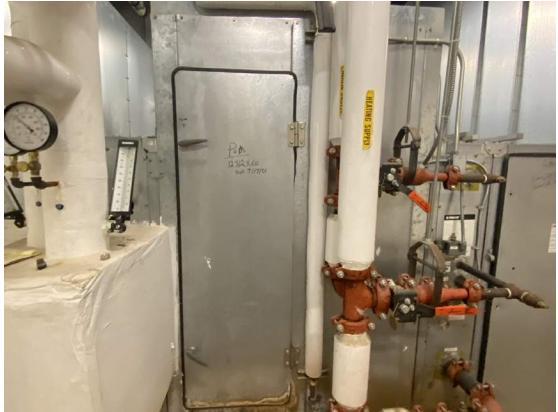
Tishman mechanical penthouse | A15

Mechanical penthouses contain the majority of HVAC equipment (A15), with some equipment located on the roof. The system utilizes a Direct Digital Control (DDC) system, a humidifier, evaporative cooling, and a gas boiler-fed heating coil system. It appears that the system is currently being repaired.

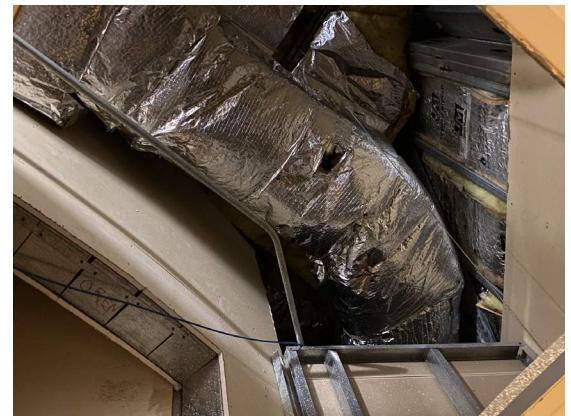
Ducting in Tipton plenum | A16

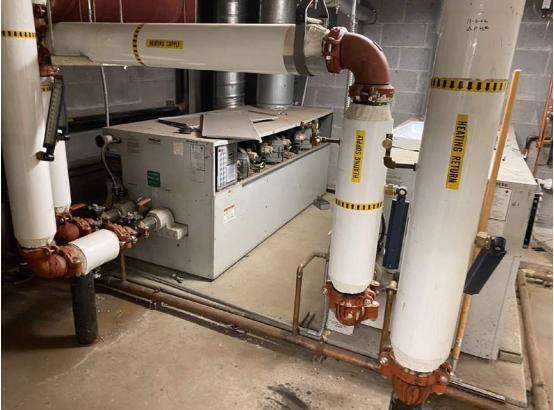
The general condition of the boiler heating system appears good and is comprised of two "Lochinvar" gas-fired boiler units. According to the original drawings, one is primary and the other is backup (A17). A large expansion tank is hung from the ceiling nearby. A "Navien" brand gasfired instant water heater is present in the Thaw basement (A18).

Primary and backup boilers | A17

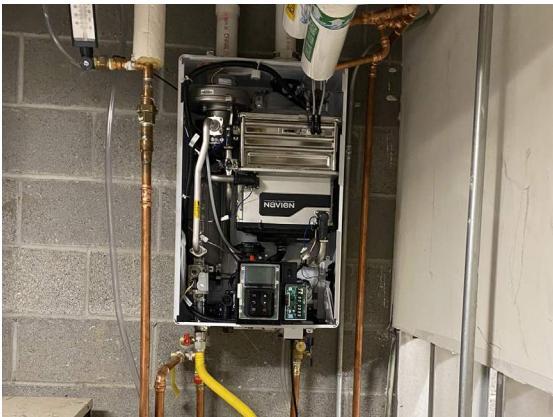
Instant hot water heater | A18

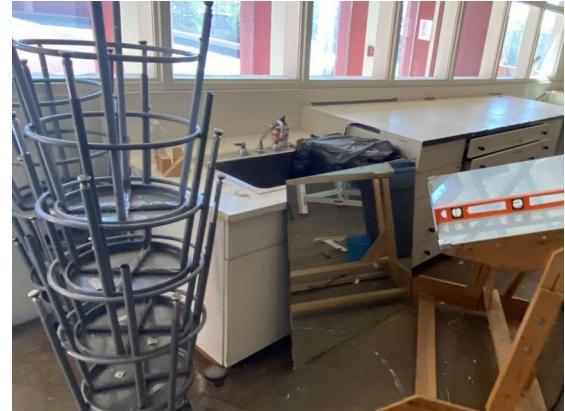
The four large open classrooms in Tishman have two oversized metal sinks with double-handle faucets, with some of the sinks having double basins (A21).

Oversized sink in Tishman | A21

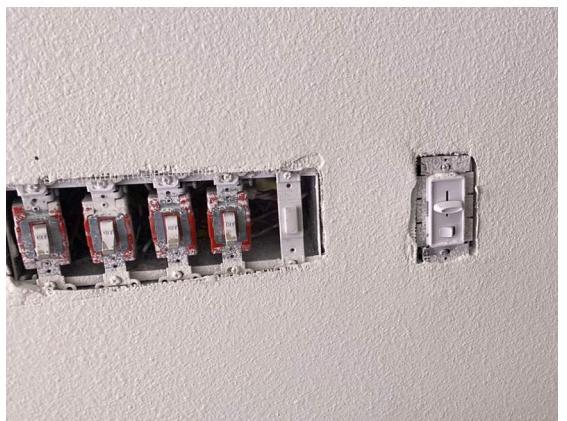
The overall appearance of the wiring devices for the building is good except for a few in Thaw that are missing covers (A23). Some thermostats appear to be mid-replacement.

Wall switches without cover plates | A23

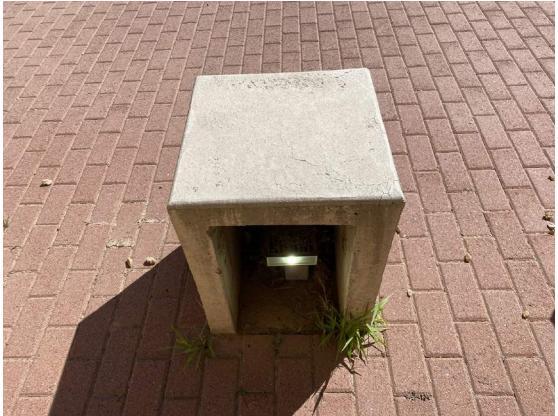
- Large wall packs.
- Small wall packs in wall-matched stucco surrounds.
- Recessed can lights.
- Inset lamps in wall niches.
- In-ground up-lights with grates.
- Wall-wash lights hidden in concrete housings (A25).

Hidden wall-wash lights | A25

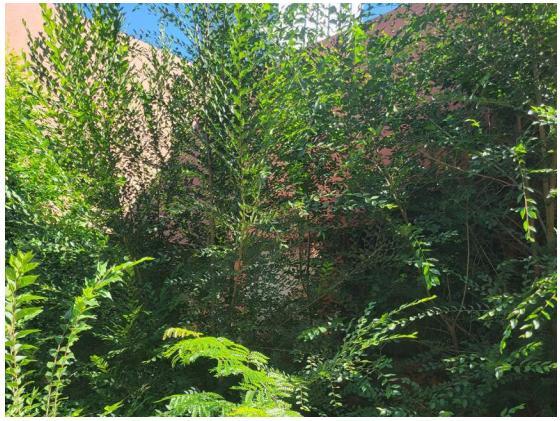
The Visual Arts Center is along the northern edge of campus on a site that generally slopes north to south. Site landscaping has degraded since the building became vacant. Much of what remains is either overgrown or dying. Volunteer plants are growing in the crack between the exterior wall and the sidewalk on the southeast elevation. Site lighting consists of pole-mounted down lights in a few areas along sidewalks and exterior building lighting.

Overgrown area of the site | A28

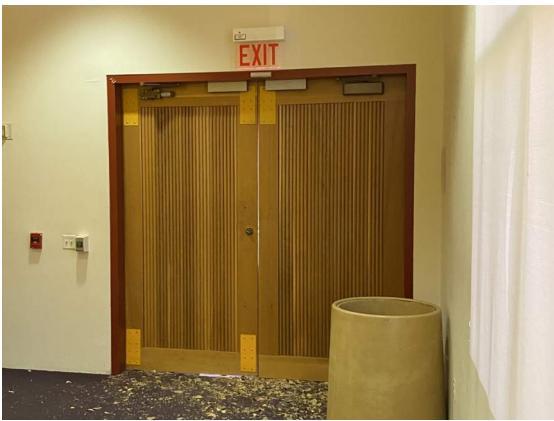
Automatic door to Tipton not working | A31

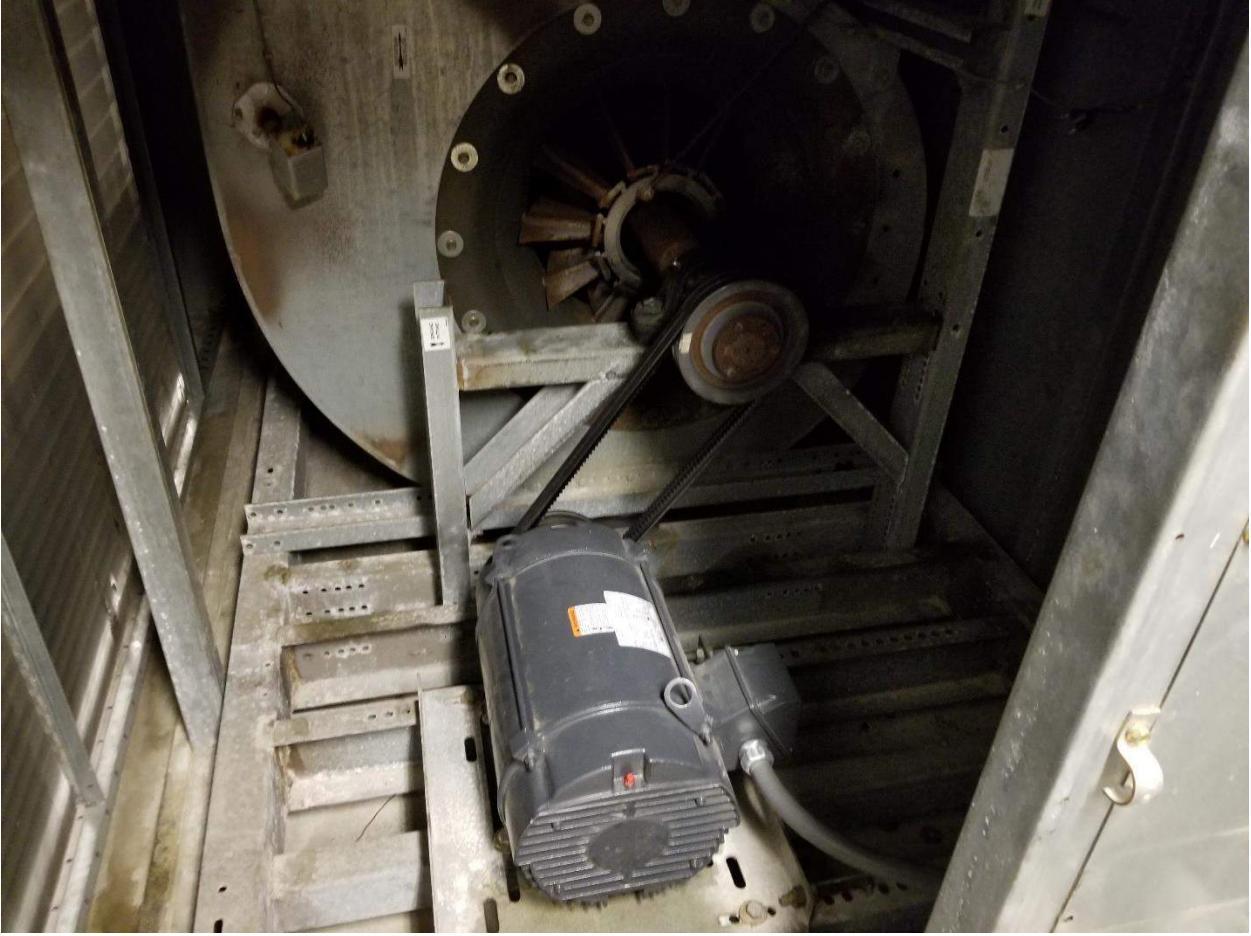
- (2) Condition/History:
  - (a.) AHU-2 appears to be well maintained, given that it is 25 years old. The old air washer section shows some water damage and rust, but this can be easily repaired. The heating coil is original and has some corrosion issues near the bottom of the coil, likely from being exposed to the excess moisture from the old air washer. The cooling coil appears to be in great condition, likely because it is much newer than the heating coil. The unit was not running at the time of observation, so it is unknown if the supply fan is in good working condition, but upon visual inspection it appeared to be in moderate condition, while the motor looked to be in good condition and more recently replaced (+/- 5-10 years). The size of the currently installed motor (20 HP) is less than what was originally designed: 20 HP. See more on this in the recommendations section of the report.

Figure 13 - AHU-2 Supply Fan

- b. The fan and motor should be tested and serviced to ensure good operating condition.
  - c. The mixed air and outside air dampers should also be actuated and tested to ensure they are operational.

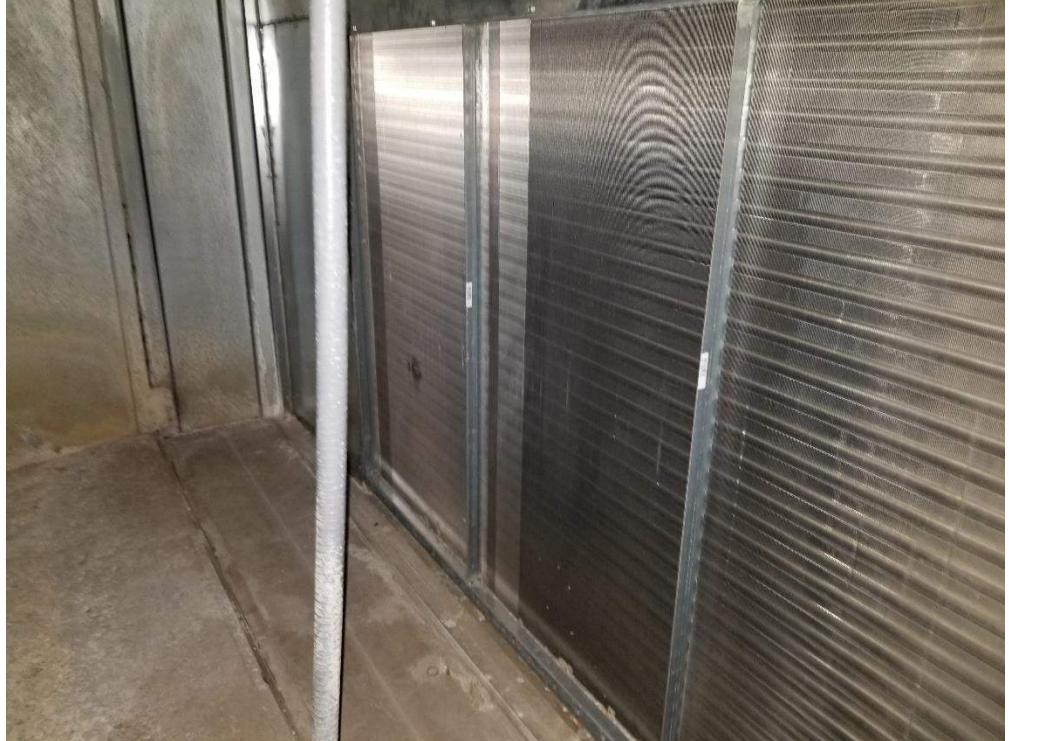
Figure 14 - AHU-2 Cooling Coil

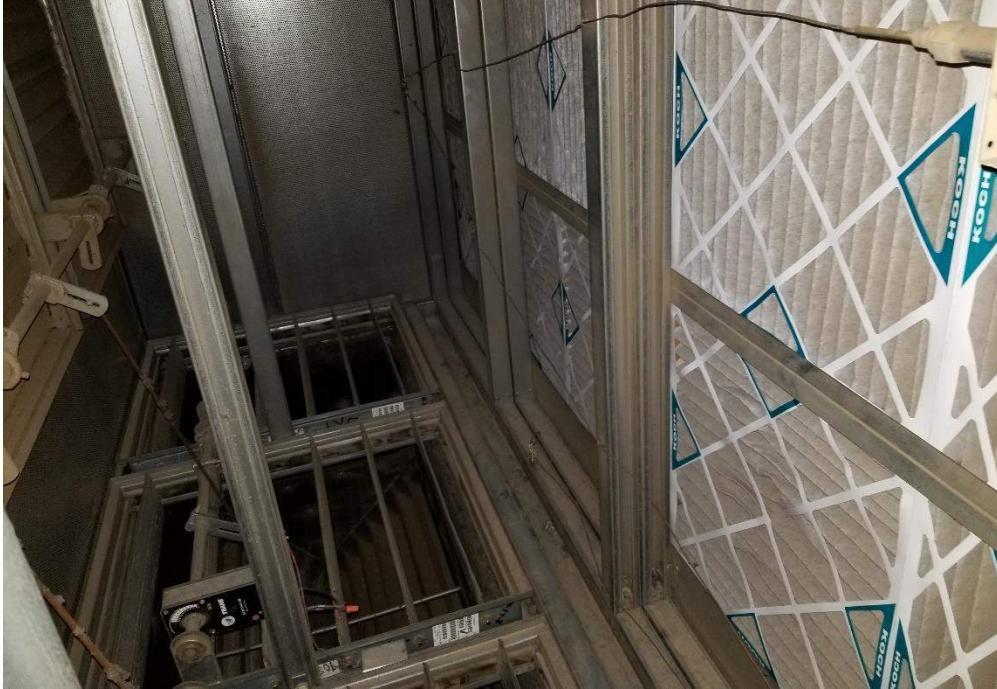
Figure 17 - AHU-2 Pleated Pre-Filters

- d. The filters appear to be slightly dirty and should be changed prior to operation. If the City of Santa Fe wishes to meet ASHRAE's Pandemic Task Force recommendations for airborne pathogen mitigation, the filters should be replaced with MERV13 filters, and the fan/unit should be analyzed to determine if the fan needs to be upsized as a result of the added friction loss. If this is not done, the pre-filters and the cartridge filters should be replaced at a minimum.

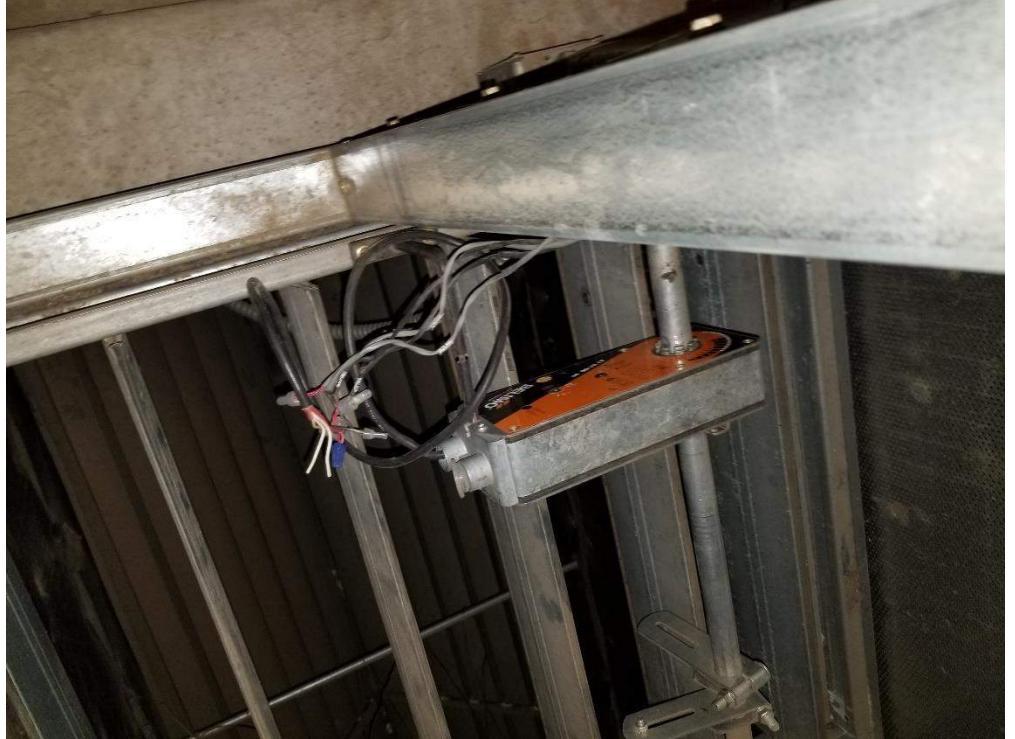
Figure 18 - AHU-2 Existing Damper Actuator

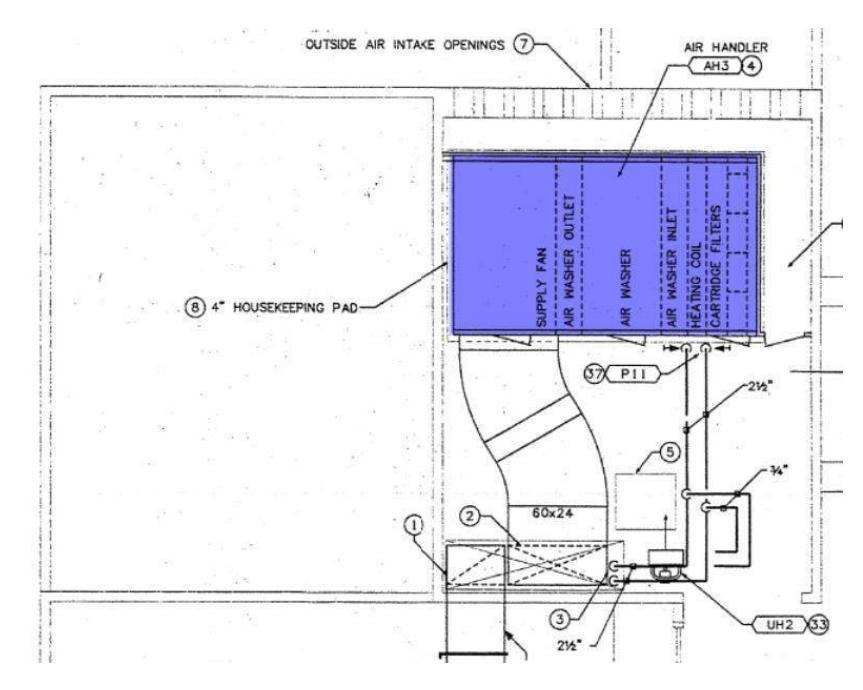
Figure 20 - Tishman Hall AHU-3

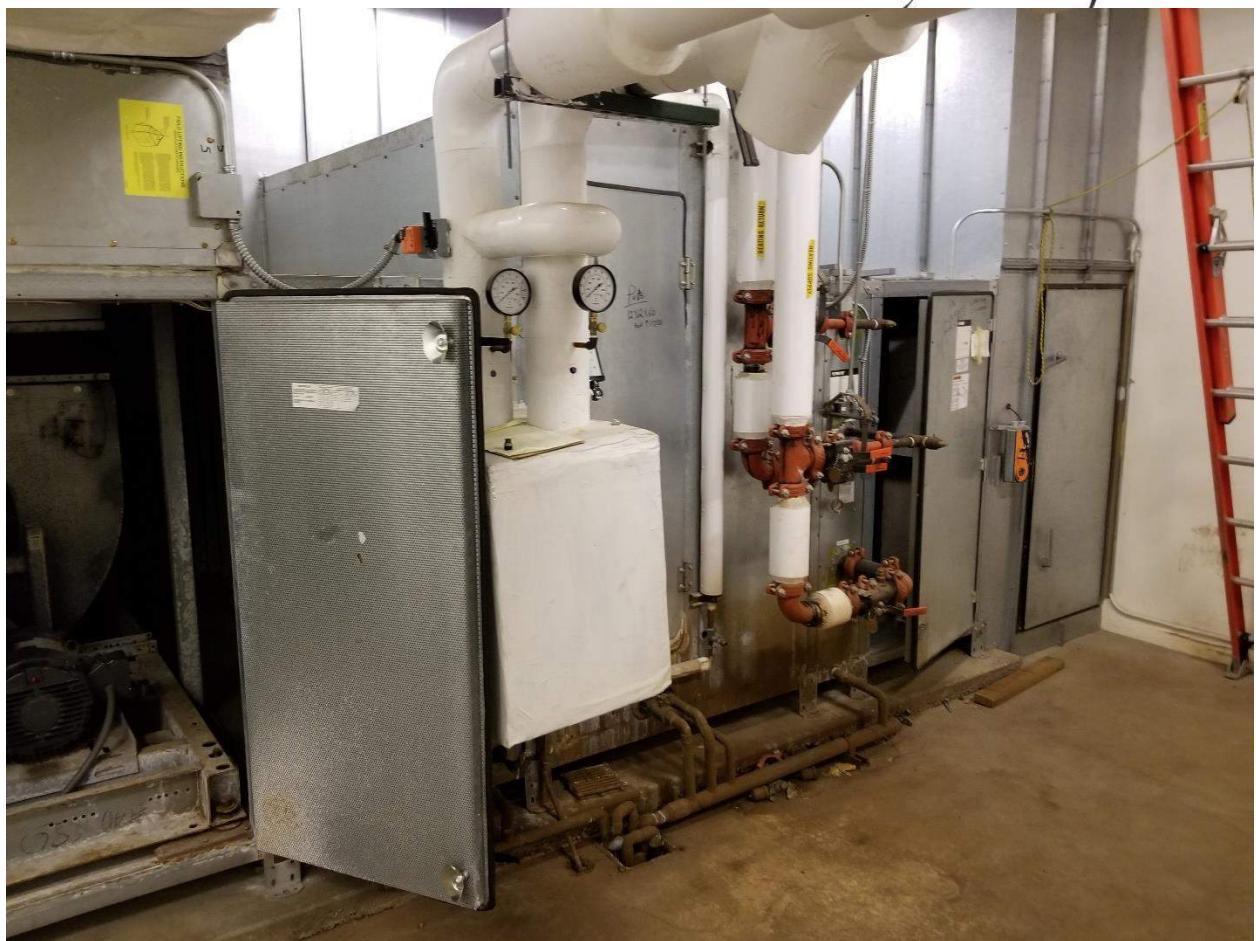
Figure 21 - AHU-3

- (2) Condition/History:
  - AHU-3 appears to be in moderate-to-good condition and (a.) appears well maintained. The old air washer section shows water damage and rust that should be repaired. This has also affected the cabinet floor and door to this section that should also be sealed/repaired. The heating coil is original and has some corrosion issues near the bottom of the coil, likely from being exposed to the excess moisture from the old air washer. The cooling coil appears to be in great condition. The unit was not running at the time of observation, so it is unknown if the supply fan is in good working condition, but upon visual inspection it appeared to be in moderate condition. There is some rust and corrosion on the supply fan, but nothing significant. The motor looked to be in good condition and more recently (+/- 5-10 years) replaced. The size of the currently installed motor (15 HP) is significantly less than what was originally designed: 25 HP. See more on this in the recommendations section of the report.

- f. See HVAC Controls Recommendations for additional recommendations.
- 3. AHU-3:
  - a. It is recommended that the heating coil is cleaned and finned, and the coil section is cleaned and sealed, as there are a few holes and corrosion on the access door from the previous evaporative cooler/air washer corrosion damage.

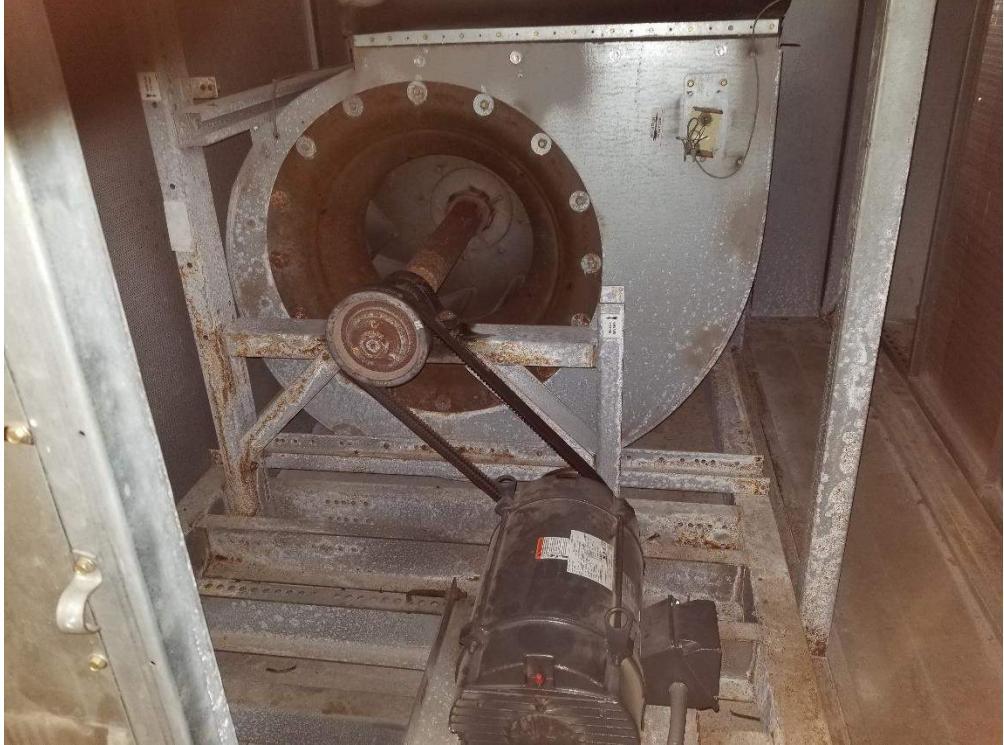
Figure 22 - AHU-3 Supply Fan and Motor

- b. The fan and motor should be tested and serviced to ensure good operating condition.

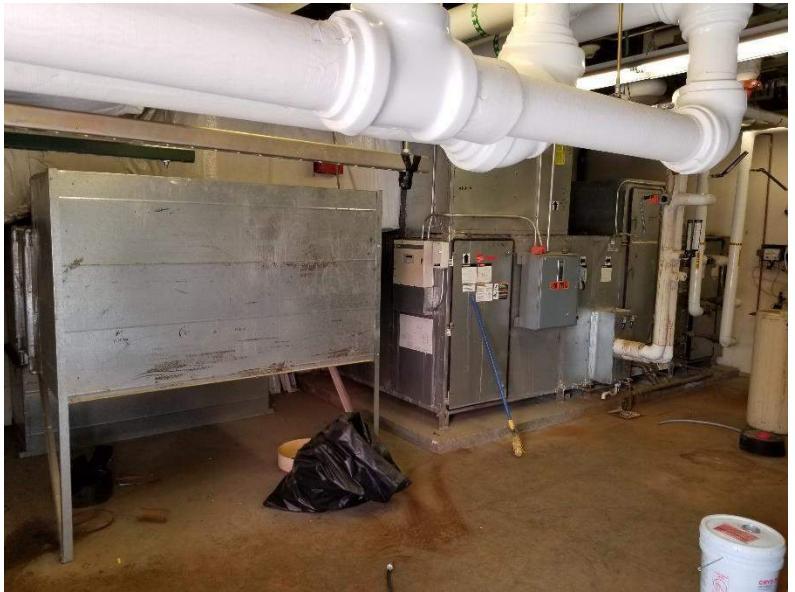
Figure 25 - AHU-6

- (2) Condition/History:
  - (a.) AHU-6 appears to be in good condition and appears well maintained. The old air washer section does not show significant rust or corrosion. The heating coil is original appears to be in good condition but needs to be cleaned as it appears the unit was in operation without the filters properly installed. The cooling coil appears to be in great condition. The unit was not running at the time of observation, so it is unknown if the supply fan is in good working condition, but upon visual inspection it appeared to be in moderate condition. There is some rust and corrosion on the supply fan, but nothing significant. The motor looked to be well-used and possibly in need of replacement. The size of the currently

- a. It is recommended that the heating coil is cleaned and finned, as the coils were found to be dirty at the time of observations.
- b. The fan and motor should be tested and serviced to ensure good operating condition. Even if the motor is operating to design capacity, due to the age and visual observation of the condition of the motor – the Owner may want to replace it in kind.

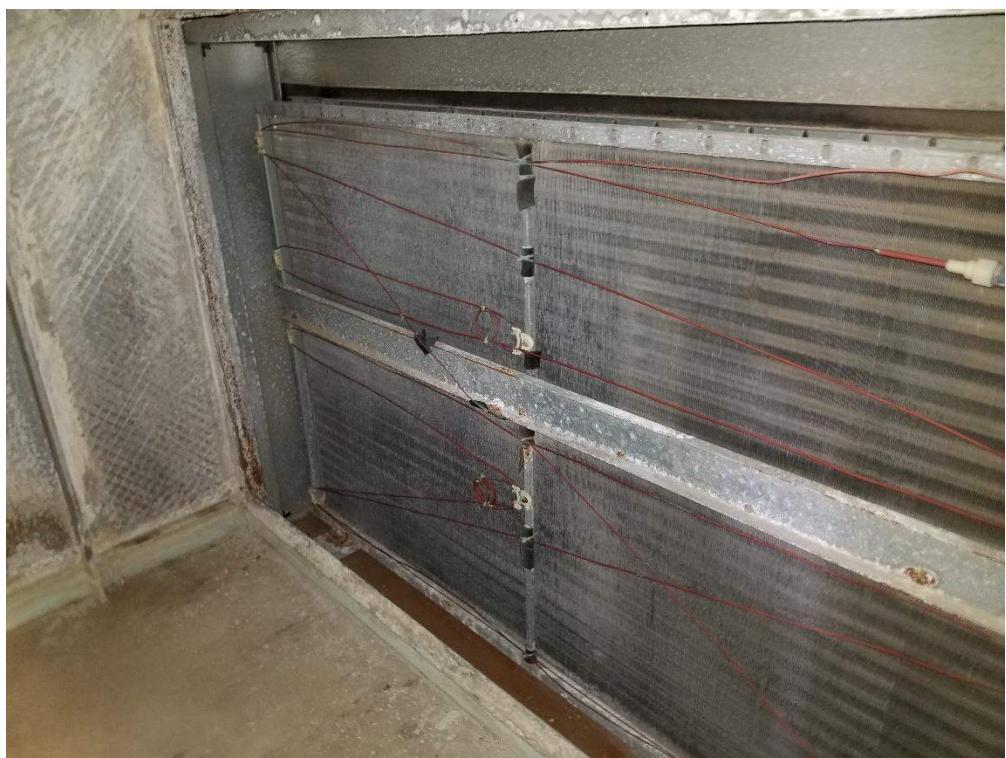
Figure 27 - AHU-6 Heating Coil and Old Air Washer Section

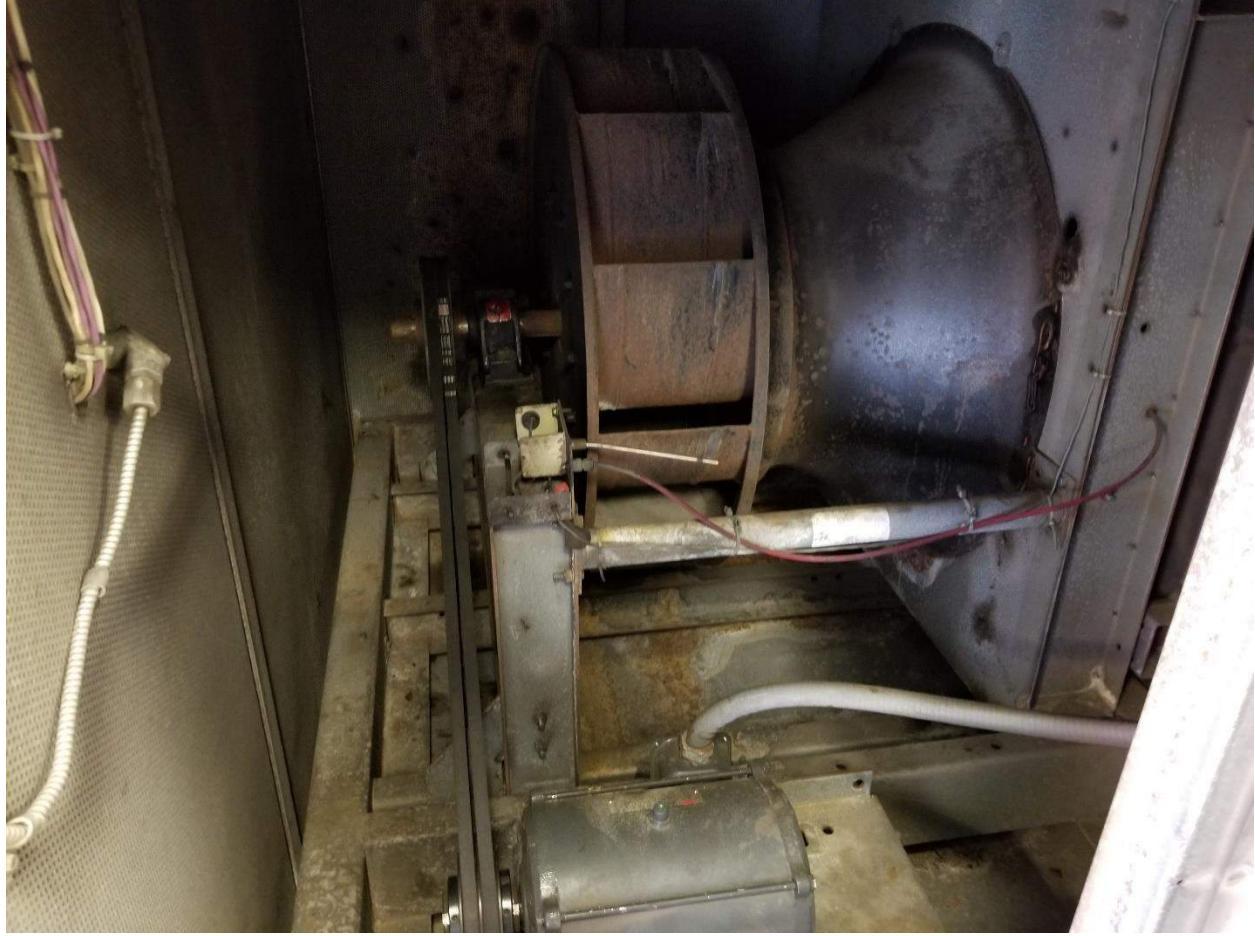
Figure 29 - AHU-6 Supply Fan and Motor

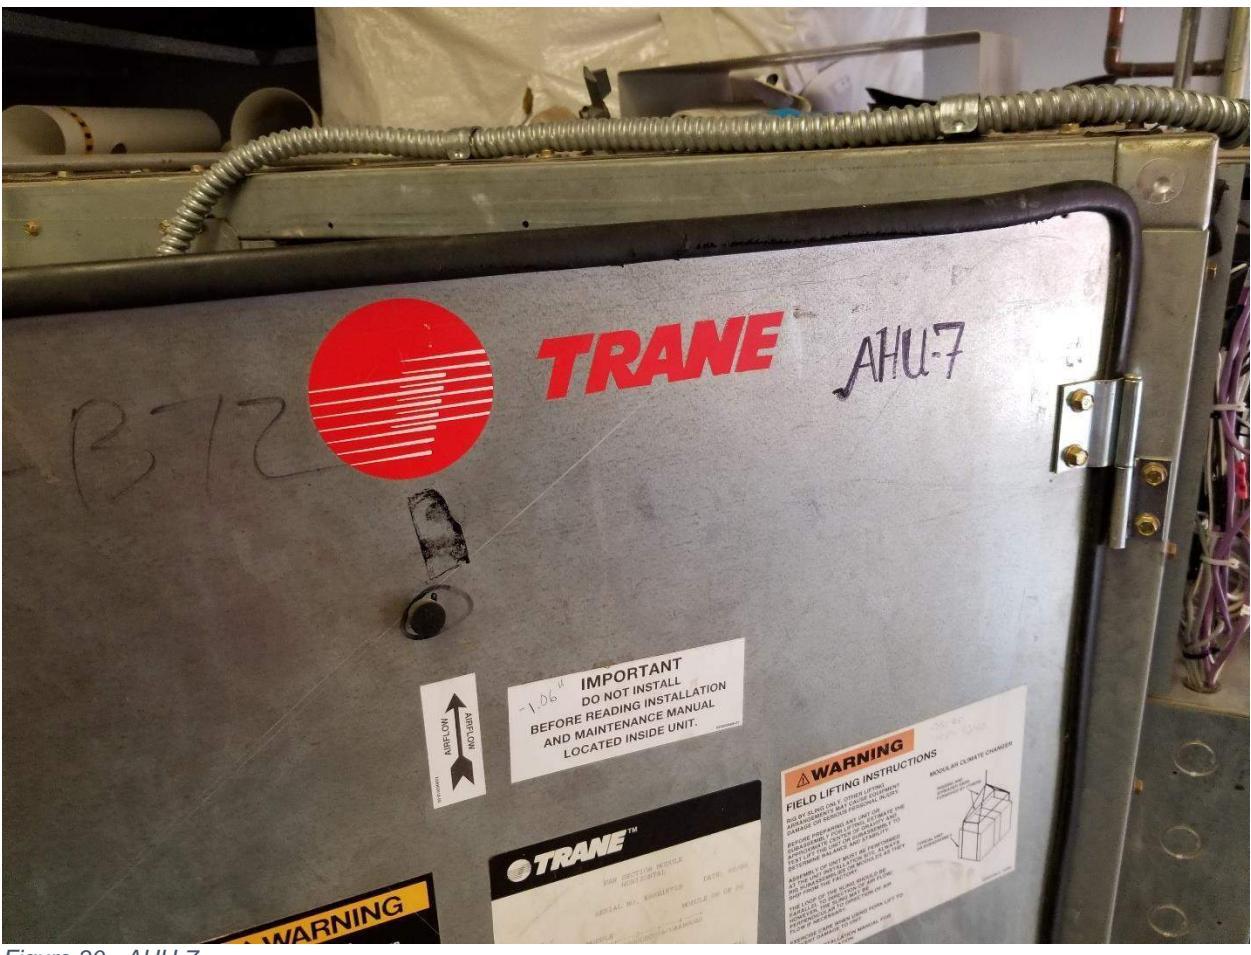
- (2) Condition/History:
  - (a.) AHU-7 appears to be in good condition. The heating coil is original appears to be in good condition but needs to be cleaned as it appears the unit was in operation with dirty or compromised filters. The cooling coil appears to be in great condition but also needs to be cleaned due to dust/dirt carry-over. Temperature sensors and freeze stat wiring was compromised and needs to be replaced. The mixed air/outside air dampers have an actuator with exposed wiring and likely a faulty actuator. An electrical junction box on the exterior of the unit was open with wires exposed. The unit was not running at the time of observation, so it is unknown if the supply fan is in good working condition. The motor looked to be in good condition and replaced in the past 5-10 years. The filters were dirty and in need of replacement.

Figure 30 - AHU-7

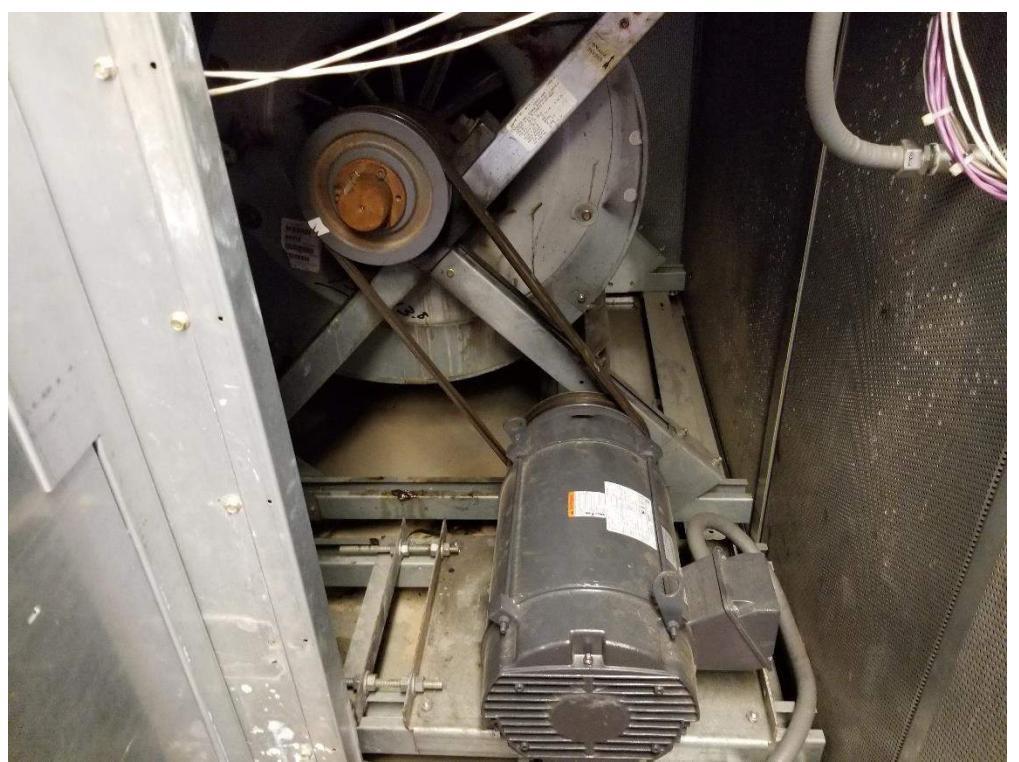
Figure 31 - AHU-7 Supply Fan and Motor Section

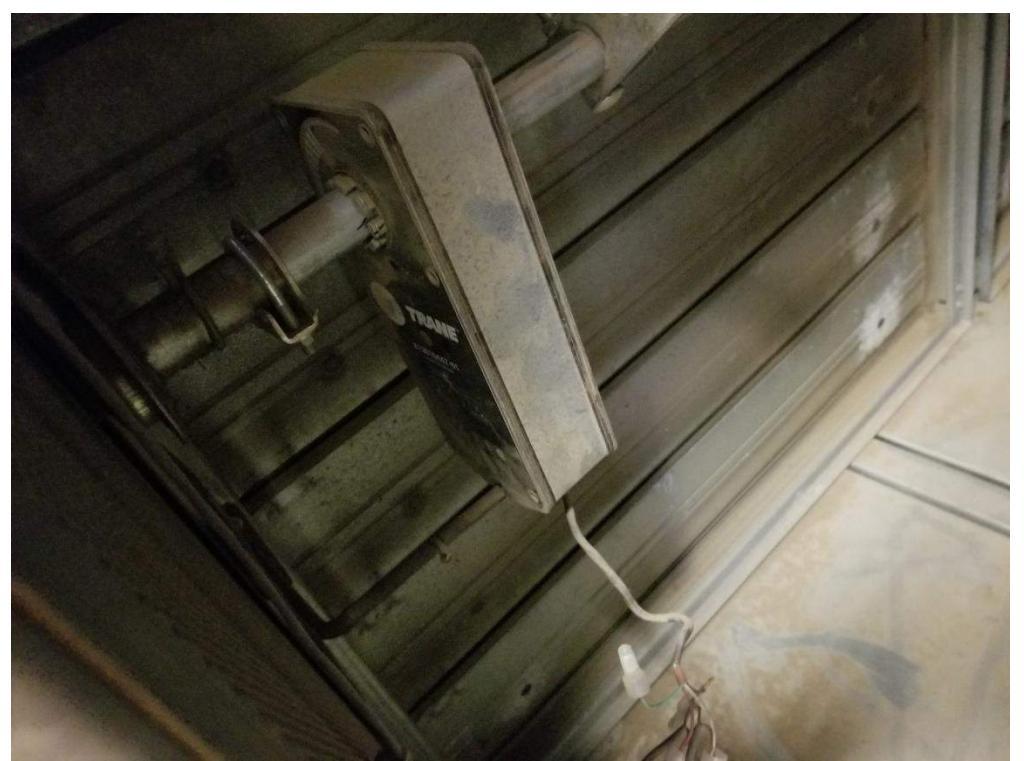
Figure 34 - AHU-7 Old Actuator

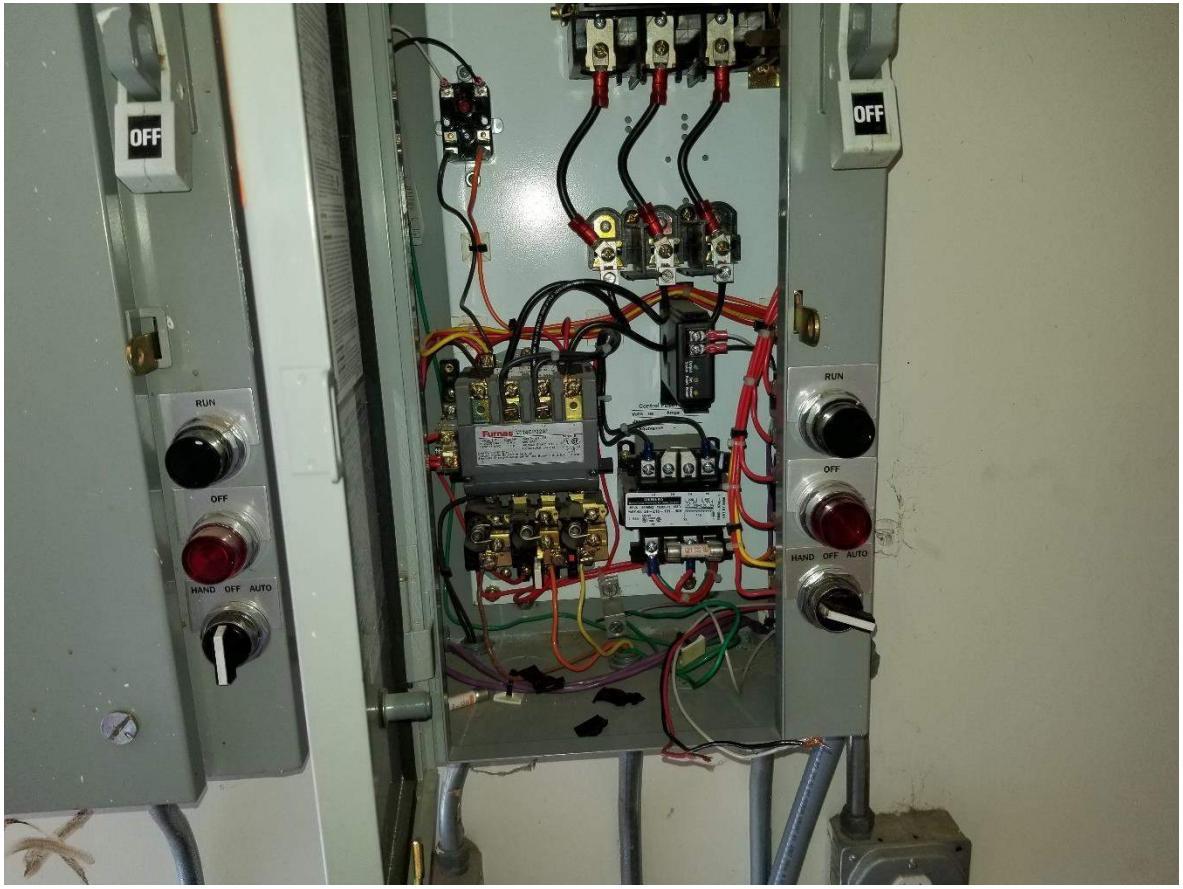
Figure 37 - AHU-6/AHU-7 Hydronic Pump Disconnect

- (b.) Though review of electrical systems were not included in the scope of work, it was noted that one of the pumps disconnects/controls was opened and disabled. This will need to be addressed in order to have an operational system.

a. The existing pumps also appear to be in good, operating condition. It is recommended that the seals are checked, and the pumps are serviced, if they have not already been. The starters/disconnects need to either be replaced or reconnected to be properly implemented into the new control strategy. See controls recommendations for more information.

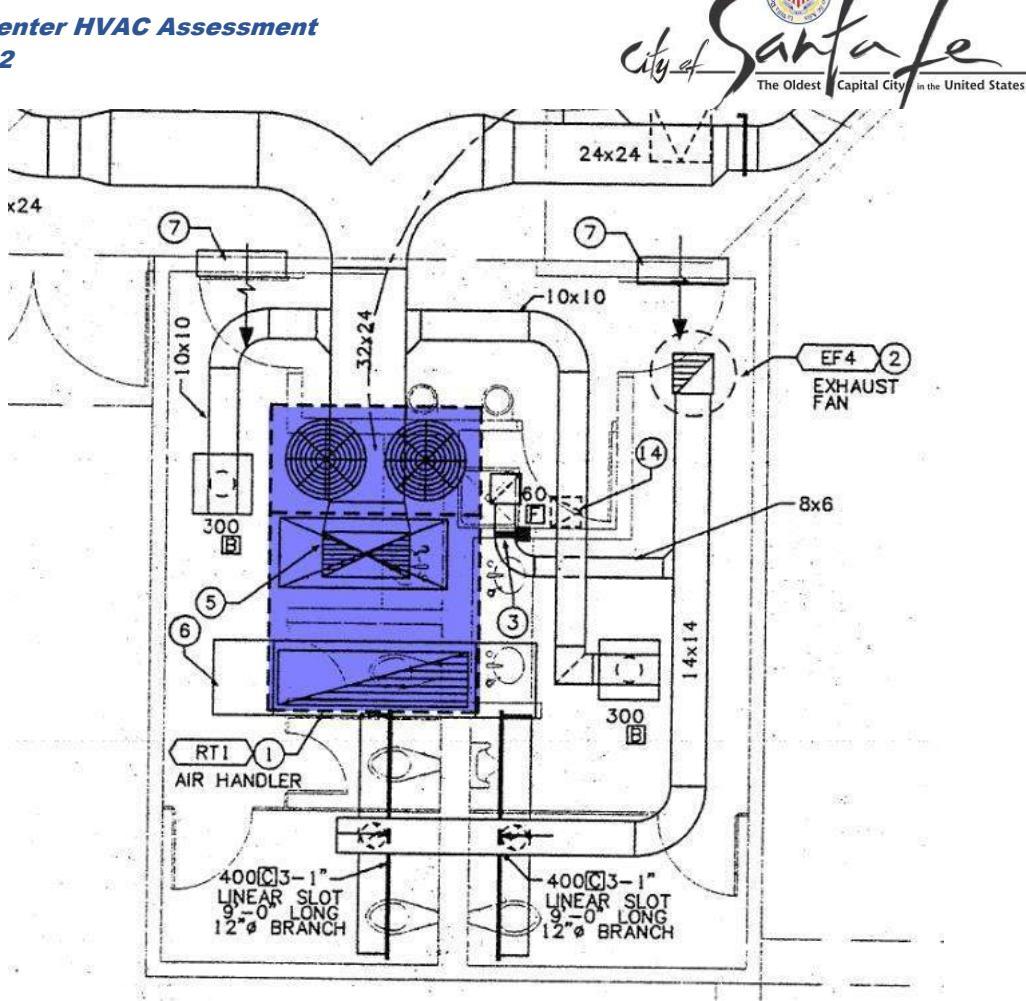
- (1) Age:
      - (a.) The existing RTU is from the original construction, which would make it approximately 25 years old. According to *ASHRAE*, the maximum serviceable lifespan of a single-zone packaged RTU is 15 years.

Figure 38 - RTU-1 - Tipton Hall

- Condition/History: (2)
  - (a.) RTU-1 appears to be in poor condition. At the time of observation, the access panels for the coil and fan were laying on the ground and it appears had been for some time. It could be assumed there is water damage, as well, as the cabinet shows signs of rust and corrosion is areas that typically do not exhibit this type of condition through operation. It is likely the compressors are inoperable and not charged, but this could not be verified. It is also unknown if the supply fan is operational. The evaporator coil is damaged, likely from hail.

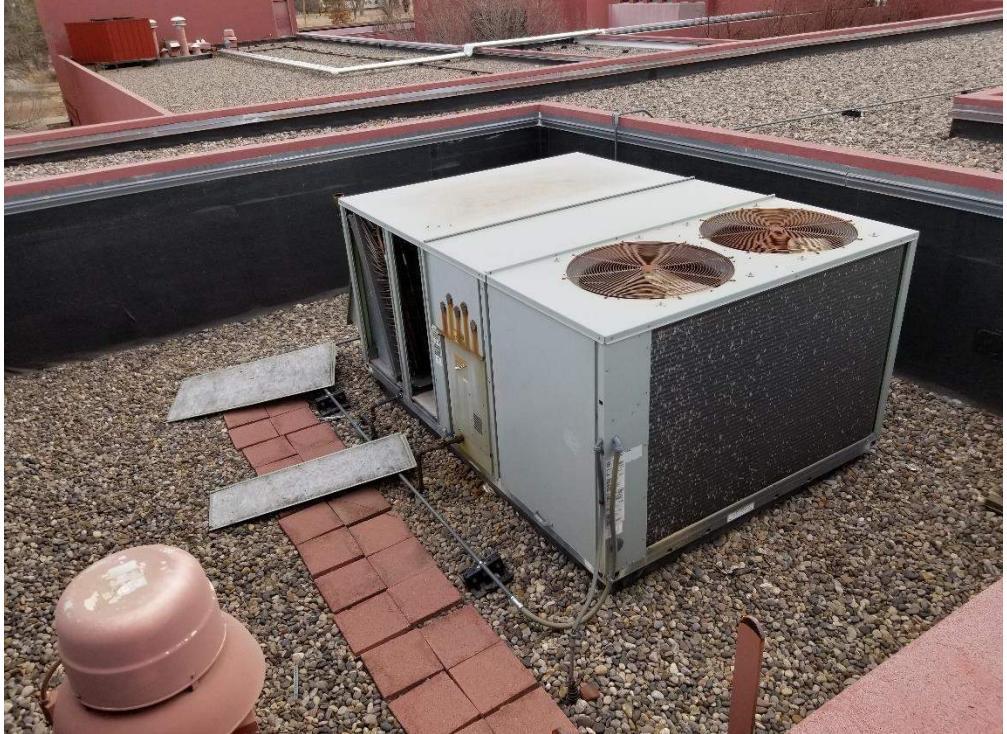
Figure 39 - RTU-1 - Tipton Hall

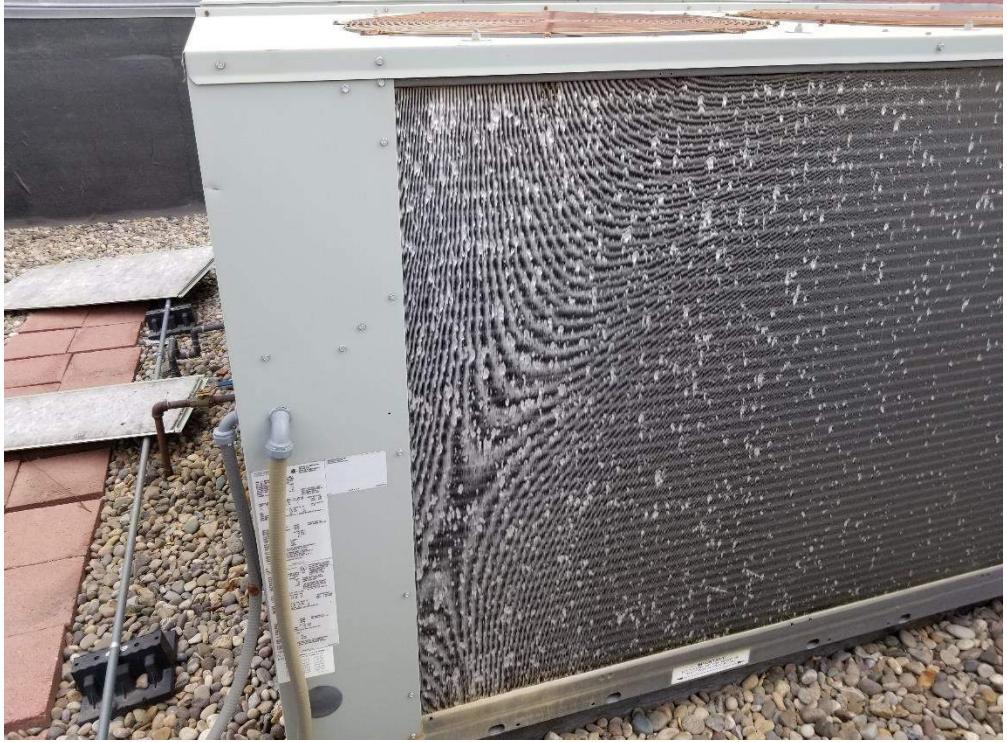
Figure 40 - RTU-1 - Evaporator Coil

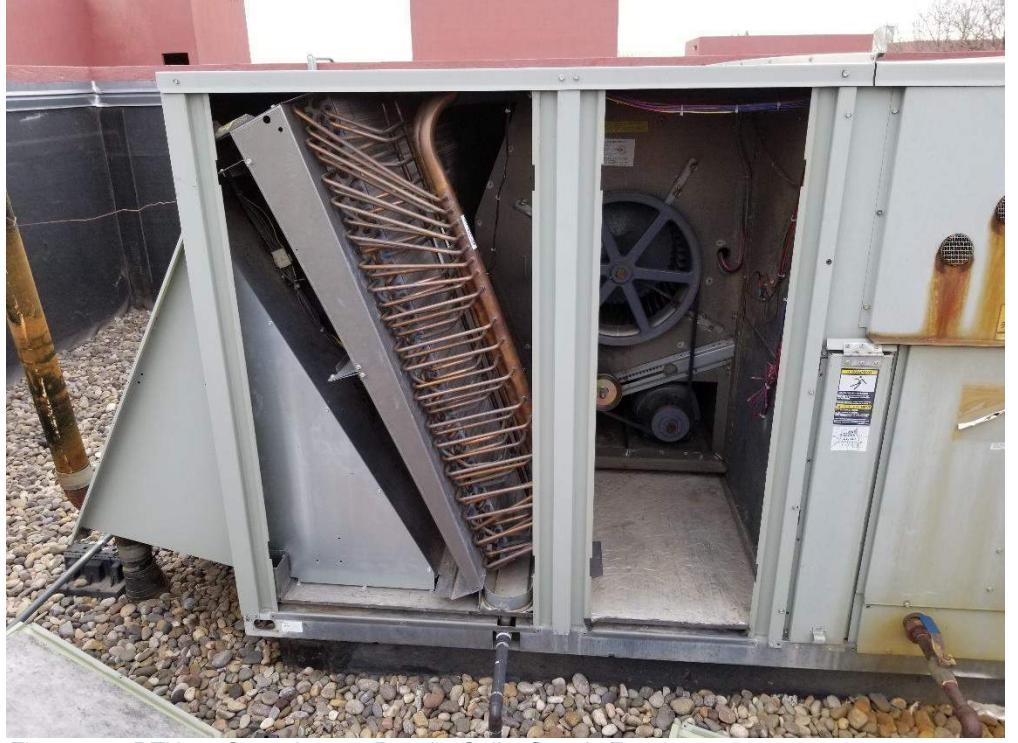
Figure 41 - RTU-1 - Open Access Panels: Coil + Supply Fan

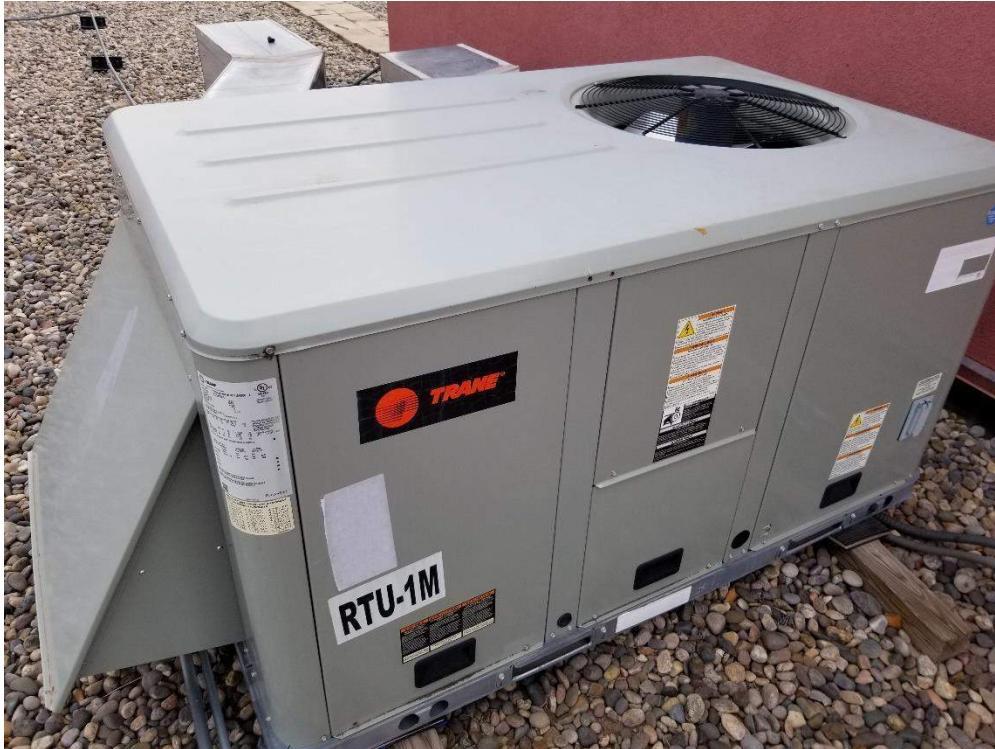
- (2) Condition/History:
      - (a.) RTU-1M appears to be in moderately good condition. The unit appears well maintained and in much better condition than the original equipment installed. It is assumed this unit relies solely on the VAV reheat terminal boxes for heating which could be a challenge in annual low temperatures. The unit was not operating at the time of observation, so it cannot be verified if

Figure 42 - RTU-1M - Marion Hall

- a. Provided the VAV re-heat terminal box is sized adequately for low discharge air temperatures, it is recommended this unit is serviced to ensure the compressors/refrigerant is charged per manufacturer's recommendations and the fan is verified to be operational.
- b. The filters should be replaced. If the City of Santa Fe wishes to meet ASHRAE's Pandemic Task Force recommendations for airborne pathogen mitigation, the filters should be replaced with MERV13 filters, and the fan/unit should be analyzed to determine if the fan needs to be upsized as a result of the added friction loss. If this is not done, the filters should be replaced with MERV 8 efficiency filters at a minimum.
- c. See HVAC Controls Recommendations for additional recommendations.
