# FACILITY ASSESSMENT REPORT

**Visual Arts Center**

January 4, 2023

January 4, 2023 WCI Project #: 21-600-030-10

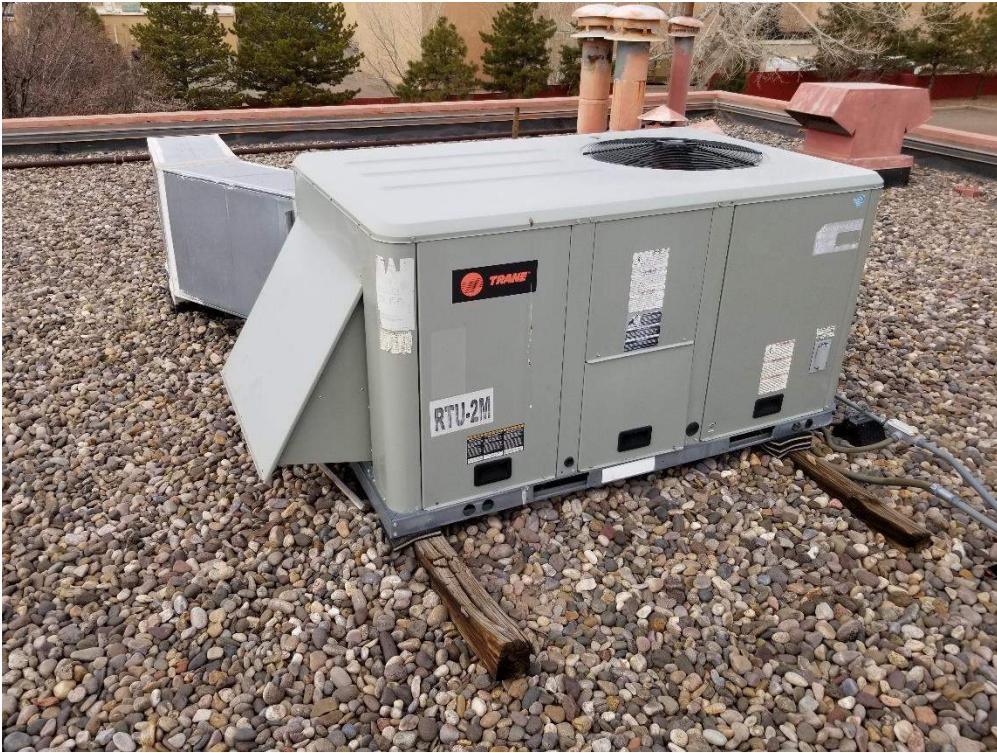
- (2) Condition/History:
    - (a.) RTU-2M appears to be in moderately good condition. The unit appears well maintained and in much better condition than the original equipment installed. It is assumed this unit relies solely on the VAV reheat terminal boxes for heating which could be a challenge in annual low temperatures. The unit was not operating at the time of observation, so it cannot be verified if

Figure 43 - RTU-2M - Marion Hall

- a. Provided the VAV re-heat terminal box is sized adequately for low discharge air temperatures, it is recommended this unit is serviced to ensure the compressors/refrigerant is charged per manufacturer's recommendations and the fan is verified to be operational.
- b. The filters should be replaced. If the City of Santa Fe wishes to meet ASHRAE's Pandemic Task Force recommendations for airborne pathogen mitigation, the filters should be replaced with MERV13 filters, and the fan/unit should be analyzed to determine if the fan needs to be upsized as a result of the added friction loss. If this is not done, the filters should be replaced with MERV 8 efficiency filters at a minimum.
- c. See HVAC Controls Recommendations for additional recommendations.
