# FACILITY ASSESSMENT REPORT

**Benildus Hall**

# FACILITY ASSESSMENT REPORT BENILDUS HALL

January 11, 2023 WCI Project #: 21-600-030-10

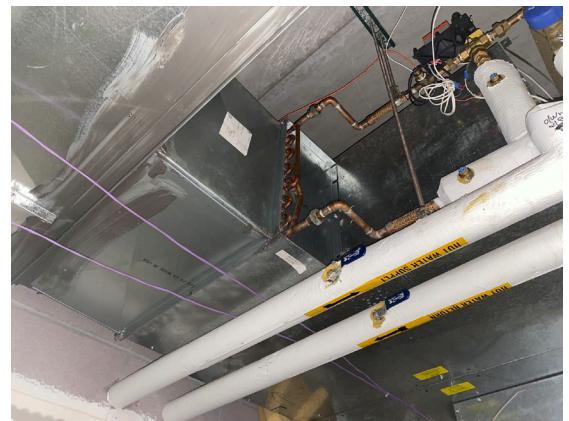
HVAC lines | A17

Portions of ductwork and plumbing throughout the building were visible above the ceiling tiles and appear to be insulted (A17).
