March 8, 2010

RE: Asbestos Survey-College of Santa Fe
Task 1 - Main Campus
Task 2 - T-Buildings & Barracks
ATC Project No. 44-39545-0001

Building T-64 Sample Location Map

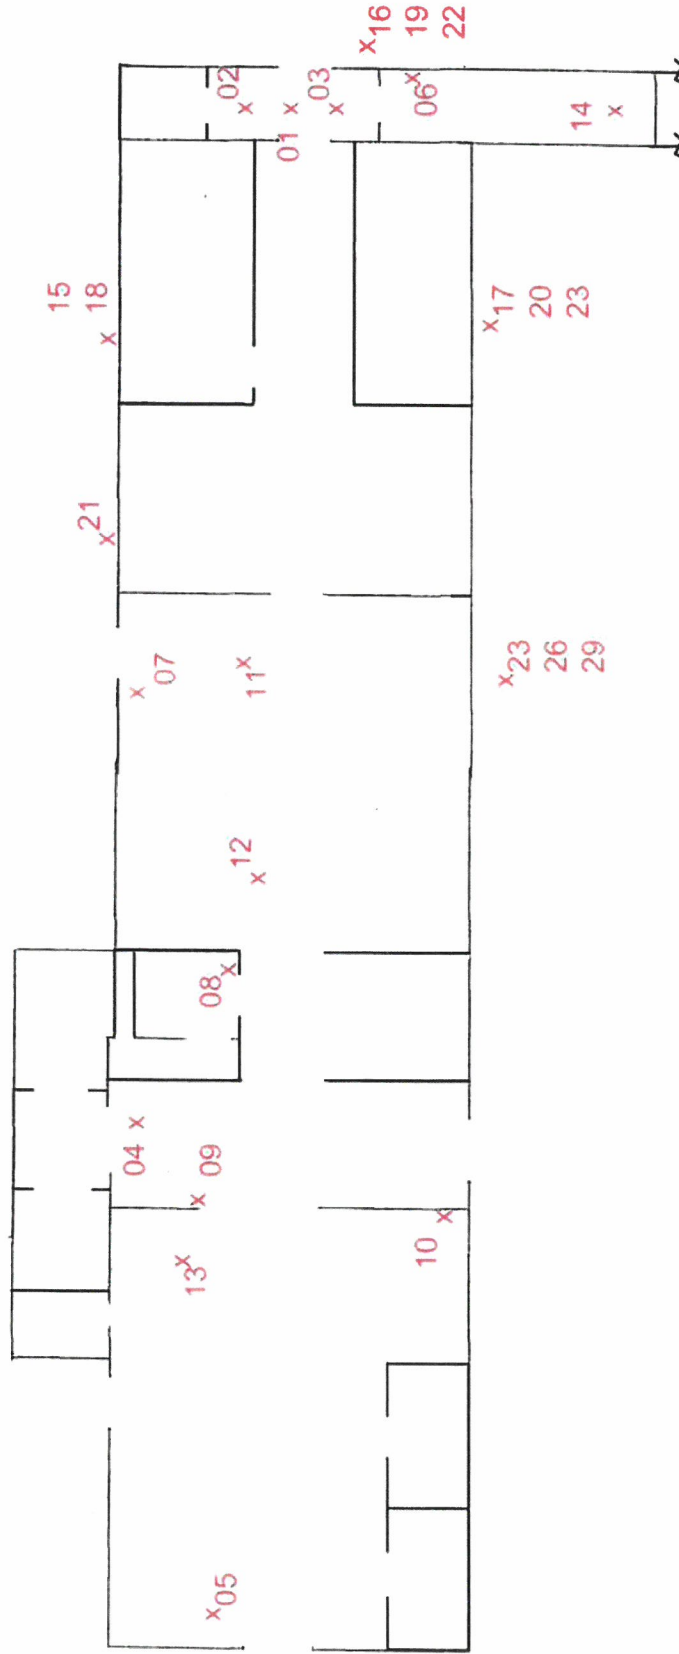
The exterior window glazing and a roof core tested “trace” for asbestos; however, the lab noted that the trace result in the roof core sample appeared to be located in roofing mastic. Additional analysis of those samples using the EPA Point Counting method confirmed that those materials contained less than one percent (1.0%) asbestos, thus not meeting the definition of an “asbestos-containing material” under the OSHA Asbestos in Construction Standard (29CFR1926.1101). However, certain precautions set out in paragraph (g) of the Standard are universal and apply to all work with asbestos, regardless of airborne exposures, or asbestos content of previously installed materials. These requirements are to utilize wet methods, to the extent feasible, (paragraph (g)(1)(ii)); and to promptly clean up and dispose in closed containers, waste and debris contaminated with asbestos (paragraph (g)(1)(iii)).

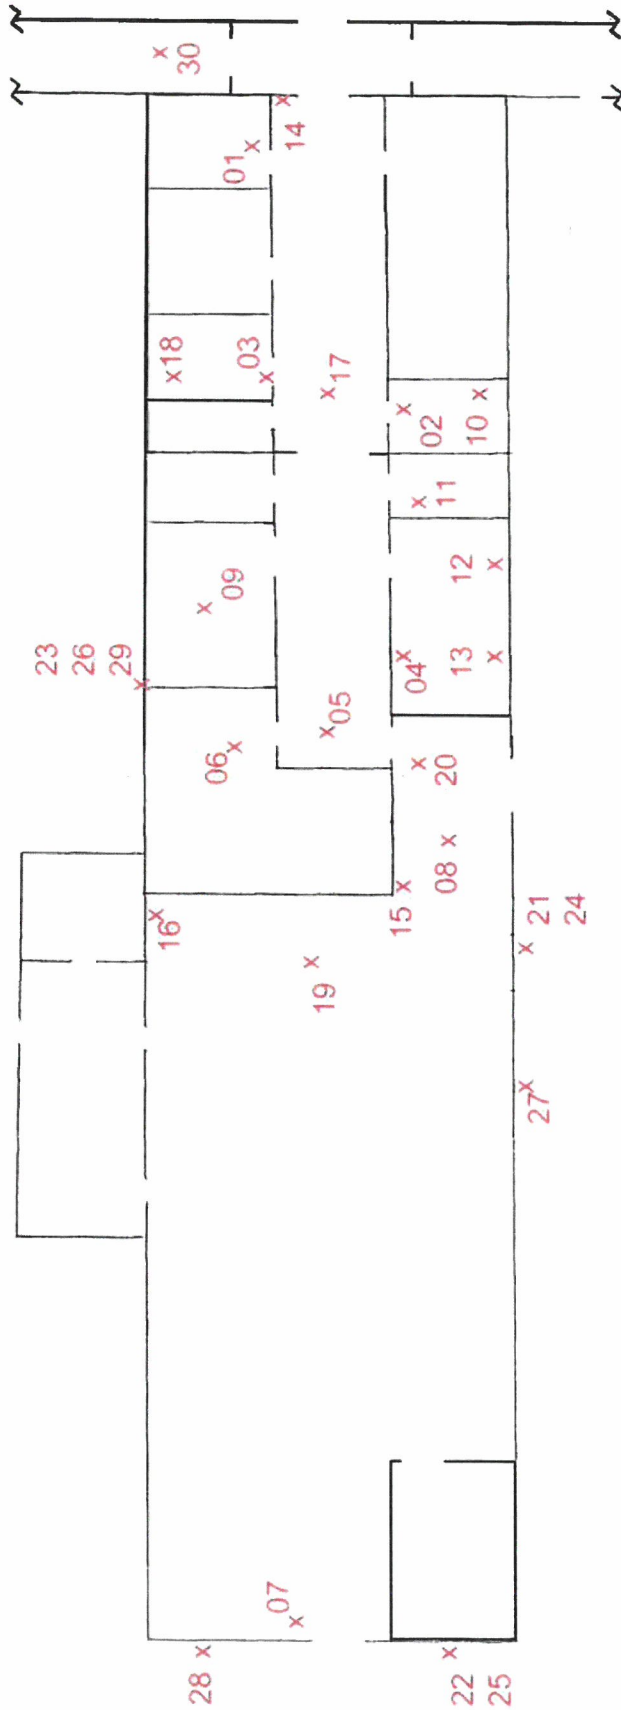
Building T-65 Sample Location Map

The results of the asbestos survey conducted at Building T-65 **indicated six suspect materials that were sampled and were determined to be asbestos-containing materials (ACM)**. The identified Asbestos Containing Materials are as follows; 2 different 12'X 12" floor tiles, pipe insulation, exterior window caulk, exterior cement shingle siding and roof flashing mastic- as listed above in Table 1. Assumed asbestos containing hard fittings and ACM pipe insulation was observed in the ceiling space and is presumed to exist in the crawl space under the building
