Site Accessibility Evaluation
Americans with Disabilities Act
Title II (Public Services: State and Local Government)

CITY MAIN LIBRARY
145 Washington Ave
Santa Fe, NM 87501

Report Date: 02/03/2025

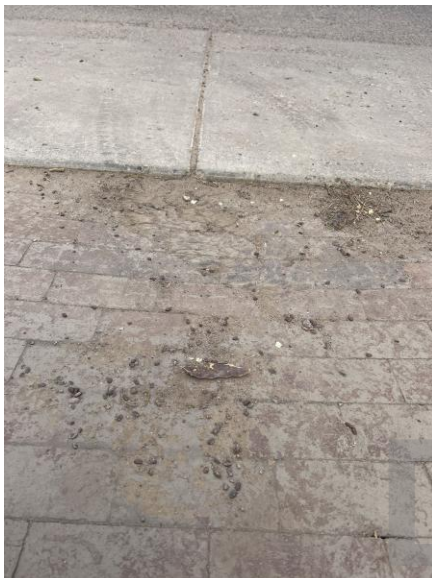
Finding: 5

EXTERIOR SITE: E2 Curb Ramp Crossing at Nusbaum Street

Recommendation:

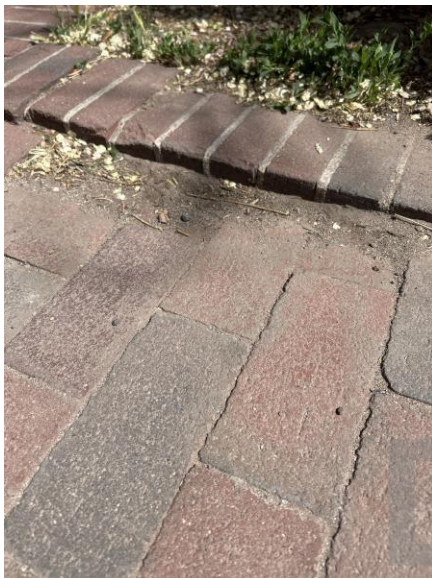
Finding: 10

EXTERIOR SITE: E4 Southeast Corner of Marcy Street and Washington Avenue Intersection

Recommendation:

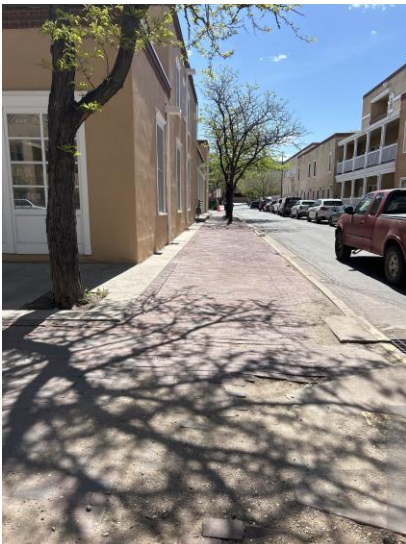
Finding: 12

EXTERIOR SITE: E5 Path of Travel Along Nusbaum Street to Driveway

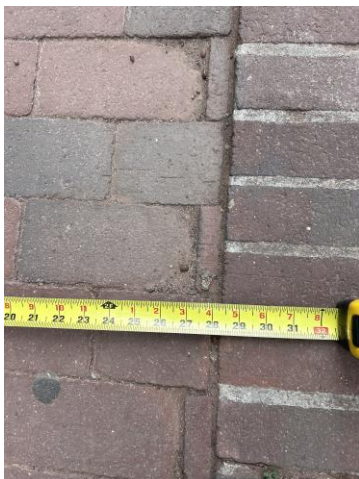
Finding: 13

EXTERIOR SITE: E5 Path of Travel Along Nusbaum Street to Driveway

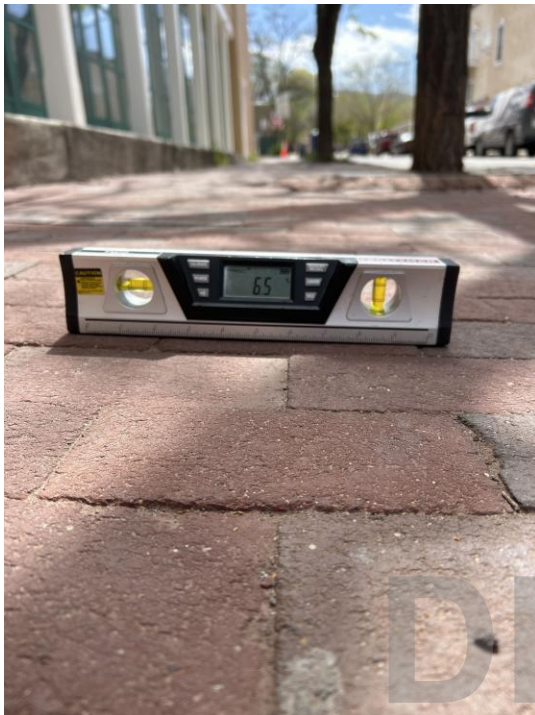
Finding: 14

EXTERIOR SITE: E5 Path of Travel Along Nusbaum Street to Driveway

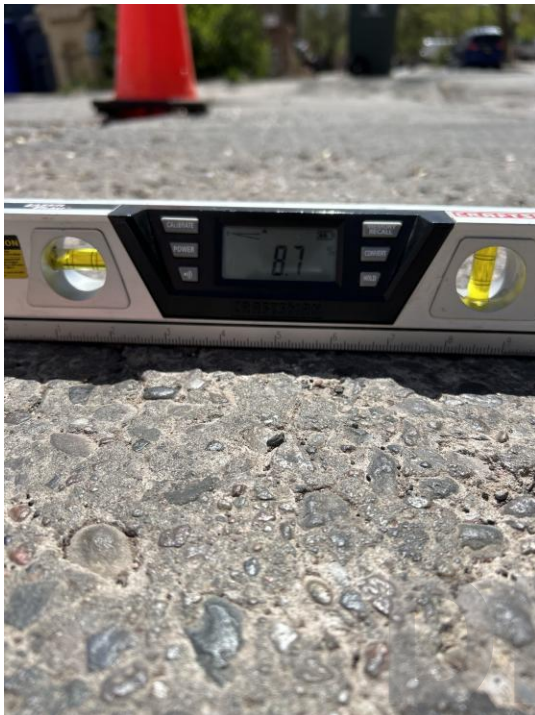
Finding: 15

EXTERIOR SITE: E6 Path of Travel from Lot from Marcy Street

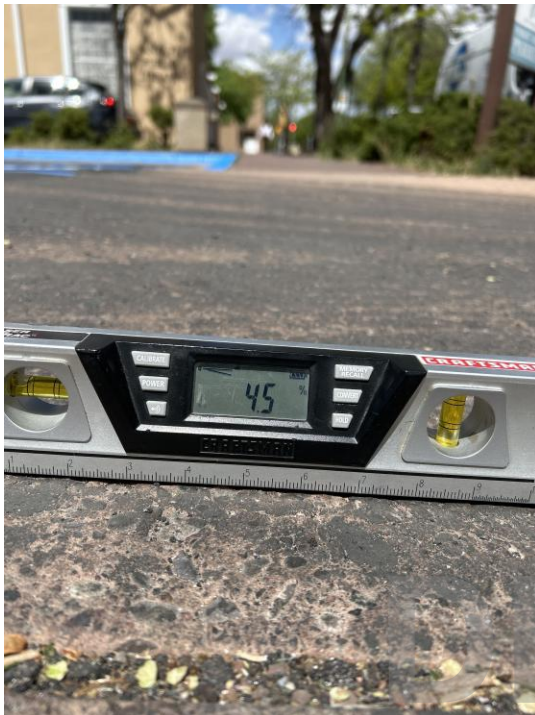
Finding: 16

EXTERIOR SITE: E6 Path of Travel from Lot from Marcy Street

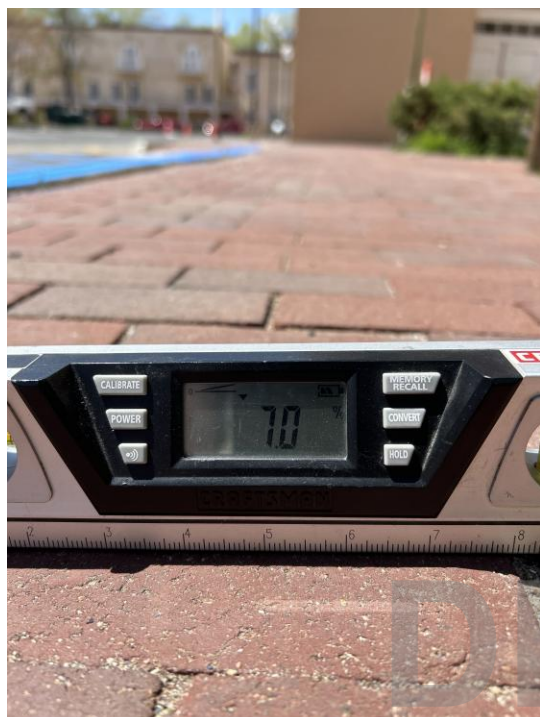
Finding: 17

EXTERIOR SITE: E6 Path of Travel from Lot from Marcy Street

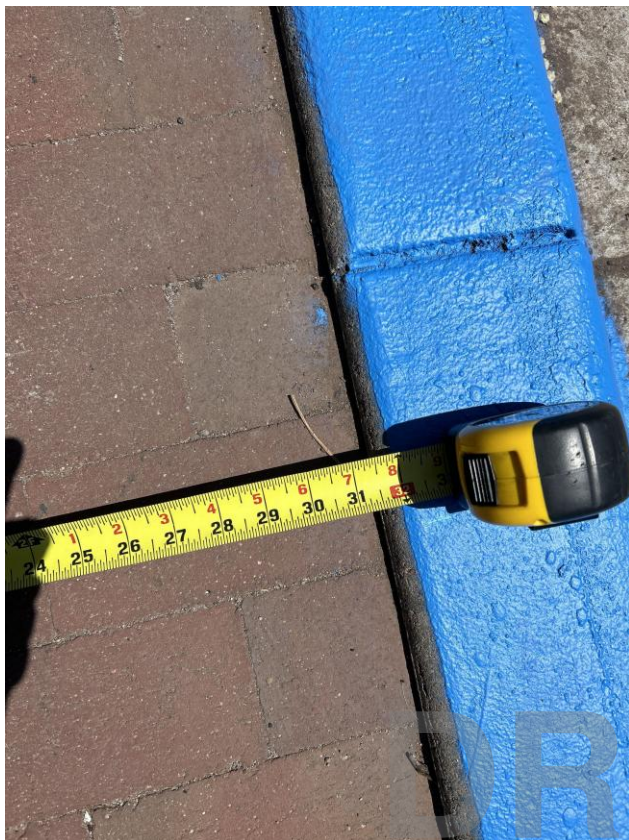
Finding: 18

EXTERIOR SITE: E7 Path of Travel Along Lot from Nusbaum Street

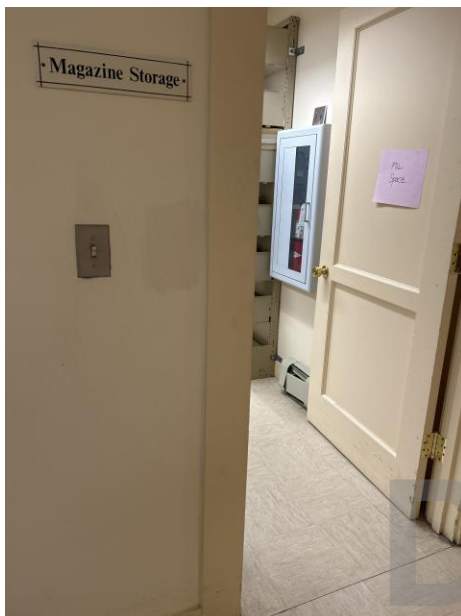
Finding: 25

Compliant room identification signs are missing.

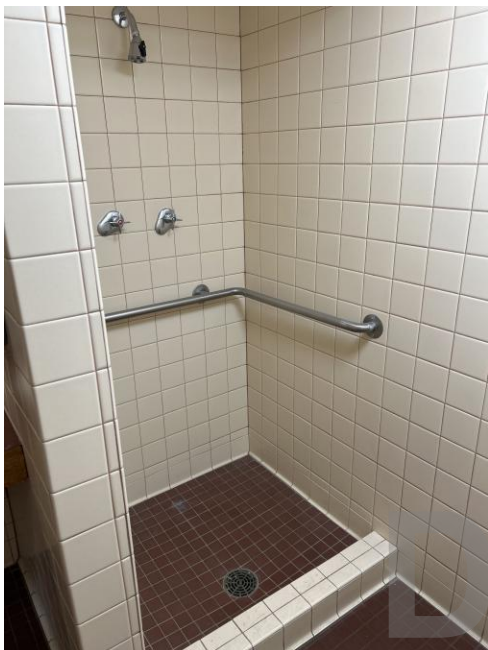
Basement Level: B3 Women's Staff Restrooms and Lockers

The stall does not have the required minimum clear floor space or maneuvering clearances for the toilet, Grab bars are missing and/or incorrectly installed, accessories, such as toilet seat covers, toilet paper holders, and garbage cans are either too high, without clear floor space or both, the floor level changes greater than a 1/2 inch at the floor drains.
